2024 ANNUAL STORMWATER MANAGEMENT REPORT

University of North Texas
1155 Union Circle #311040
Denton, Denton County, Texas
76203-5017

Re: Phase II MS4 Annual Report Transmittal for University of North Texas
TPDES General Permit Authorization: TXR040066

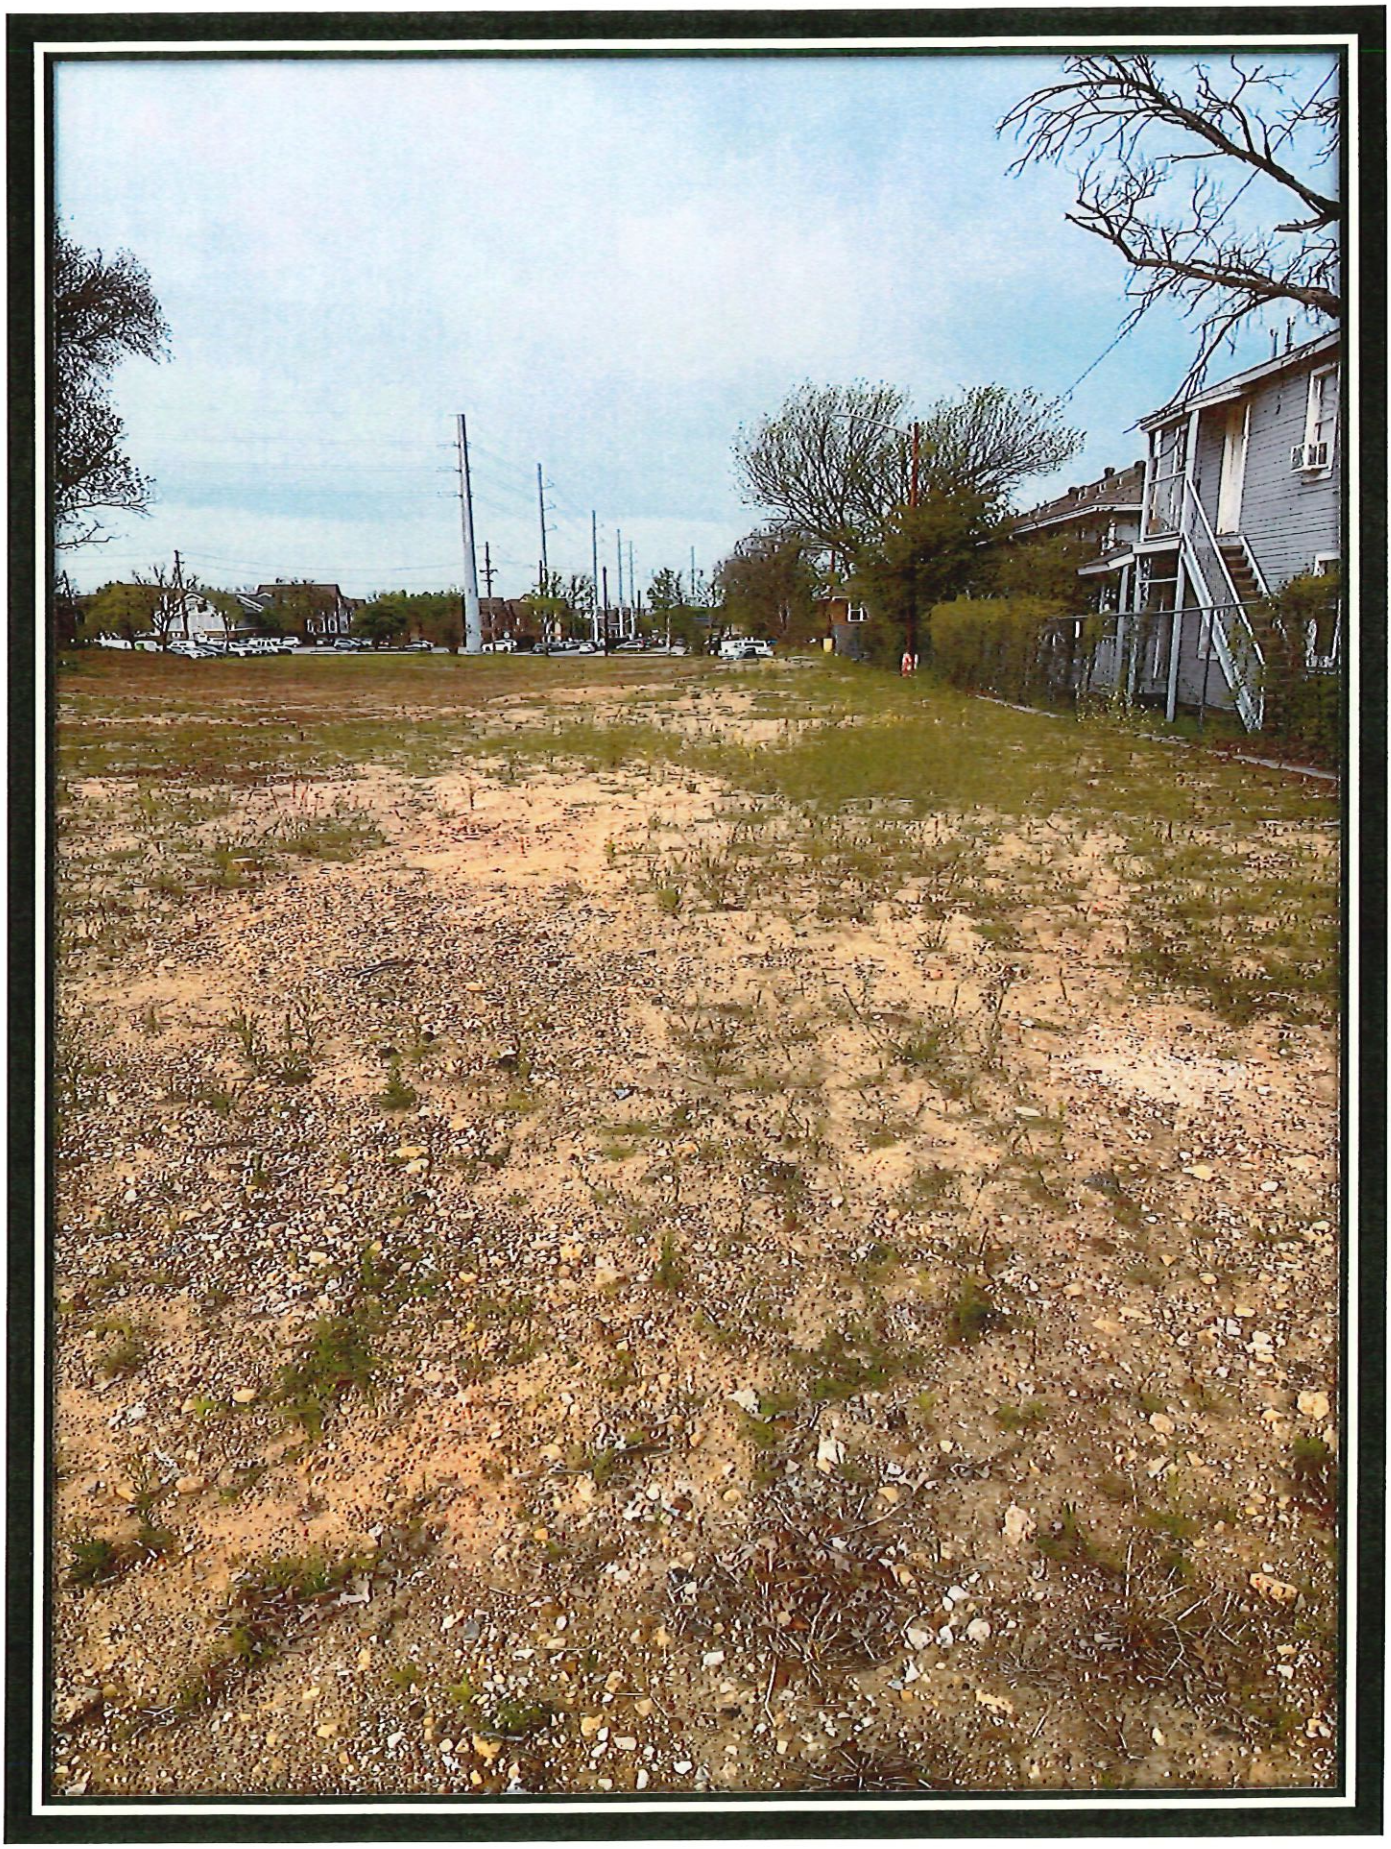
Stormwater Inspection. Former College Inn lot – view is to the west. Vegetation is sparse along the eastern half of the property on 03.29.2024.

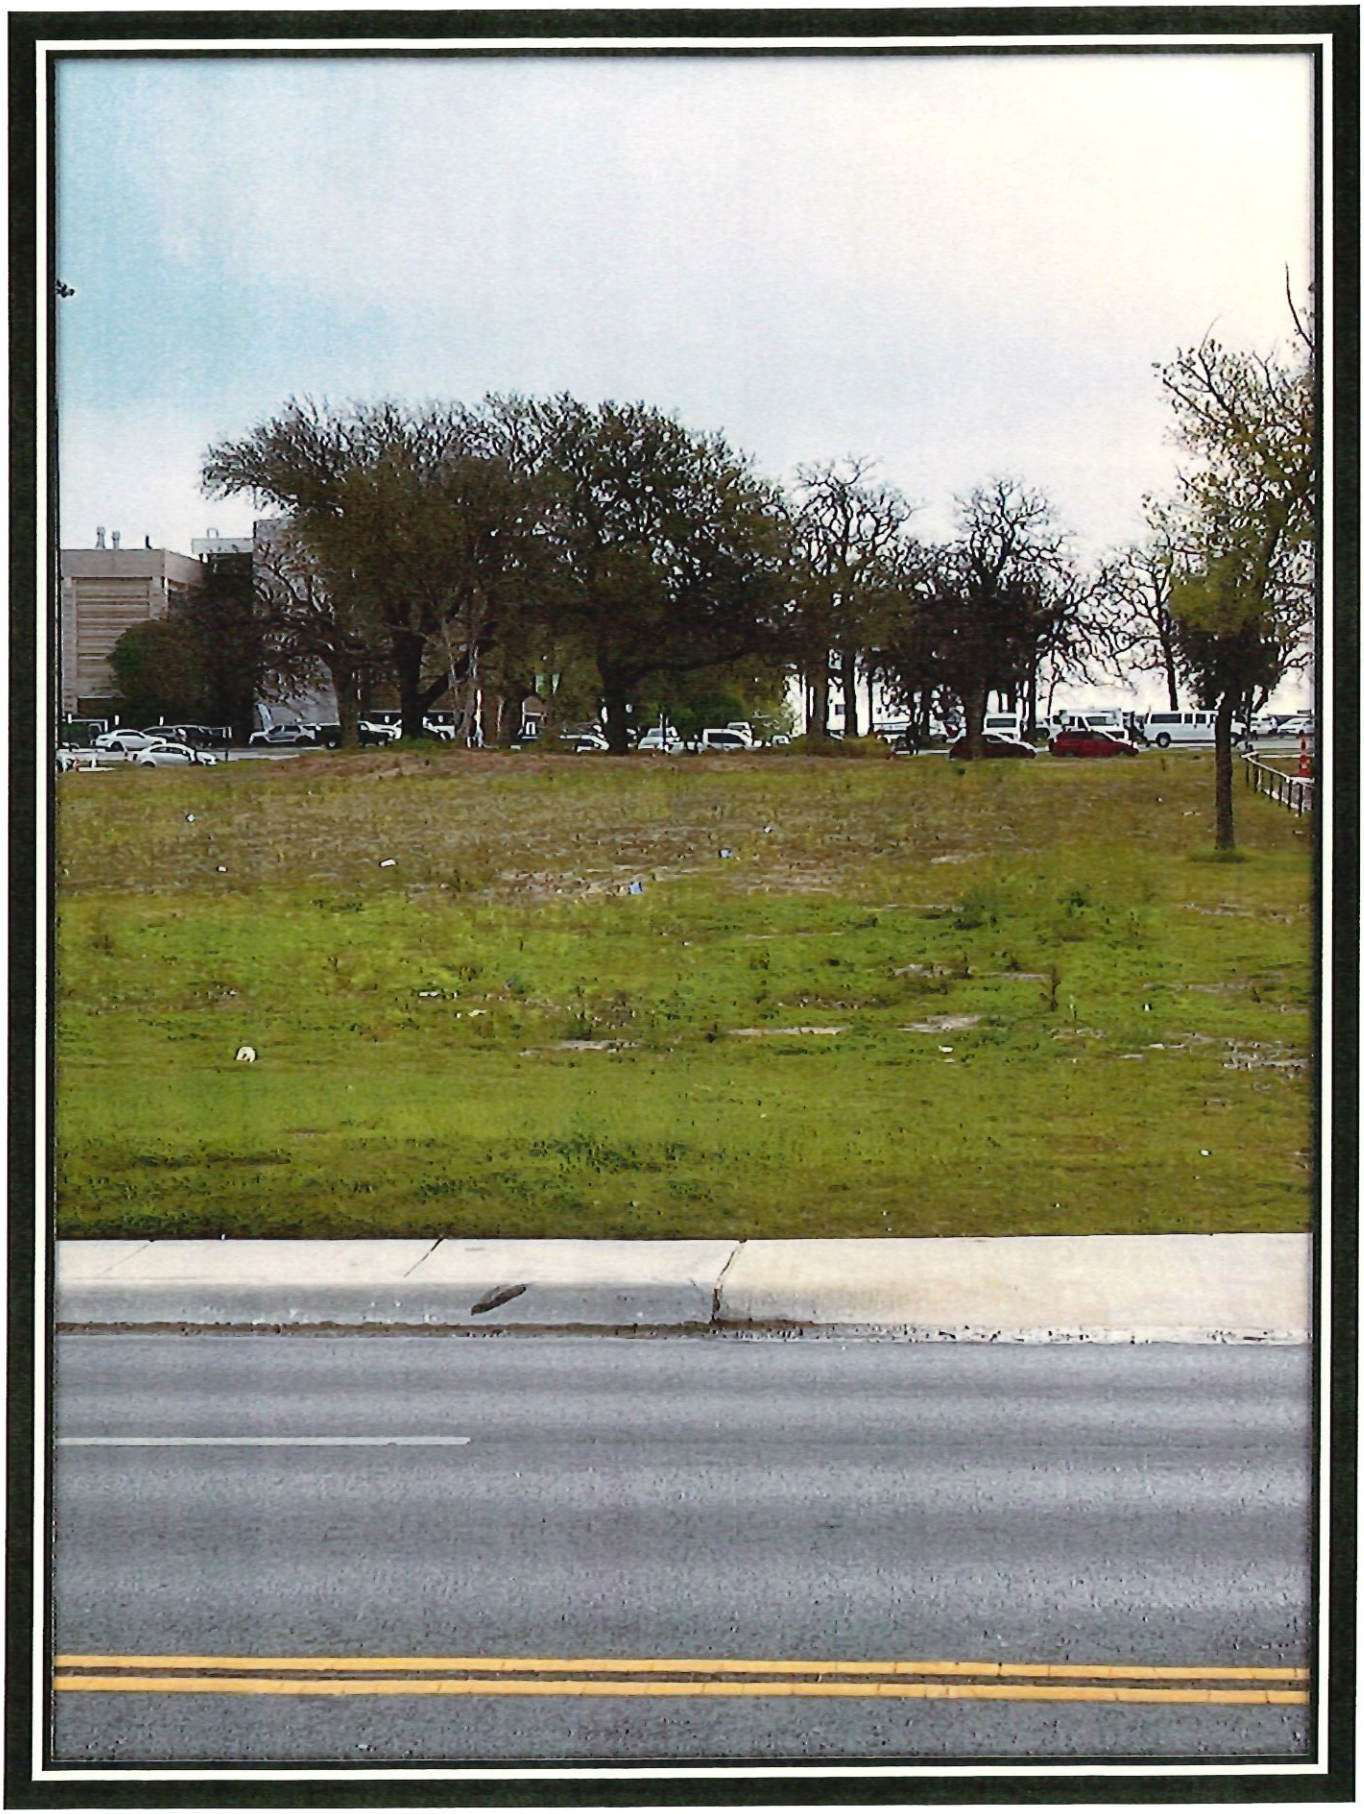
Stormwater Inspection. Former College Inn lot – view is to the east. Vegetation is more prevalent on the western half of the property – 03.29.2024.

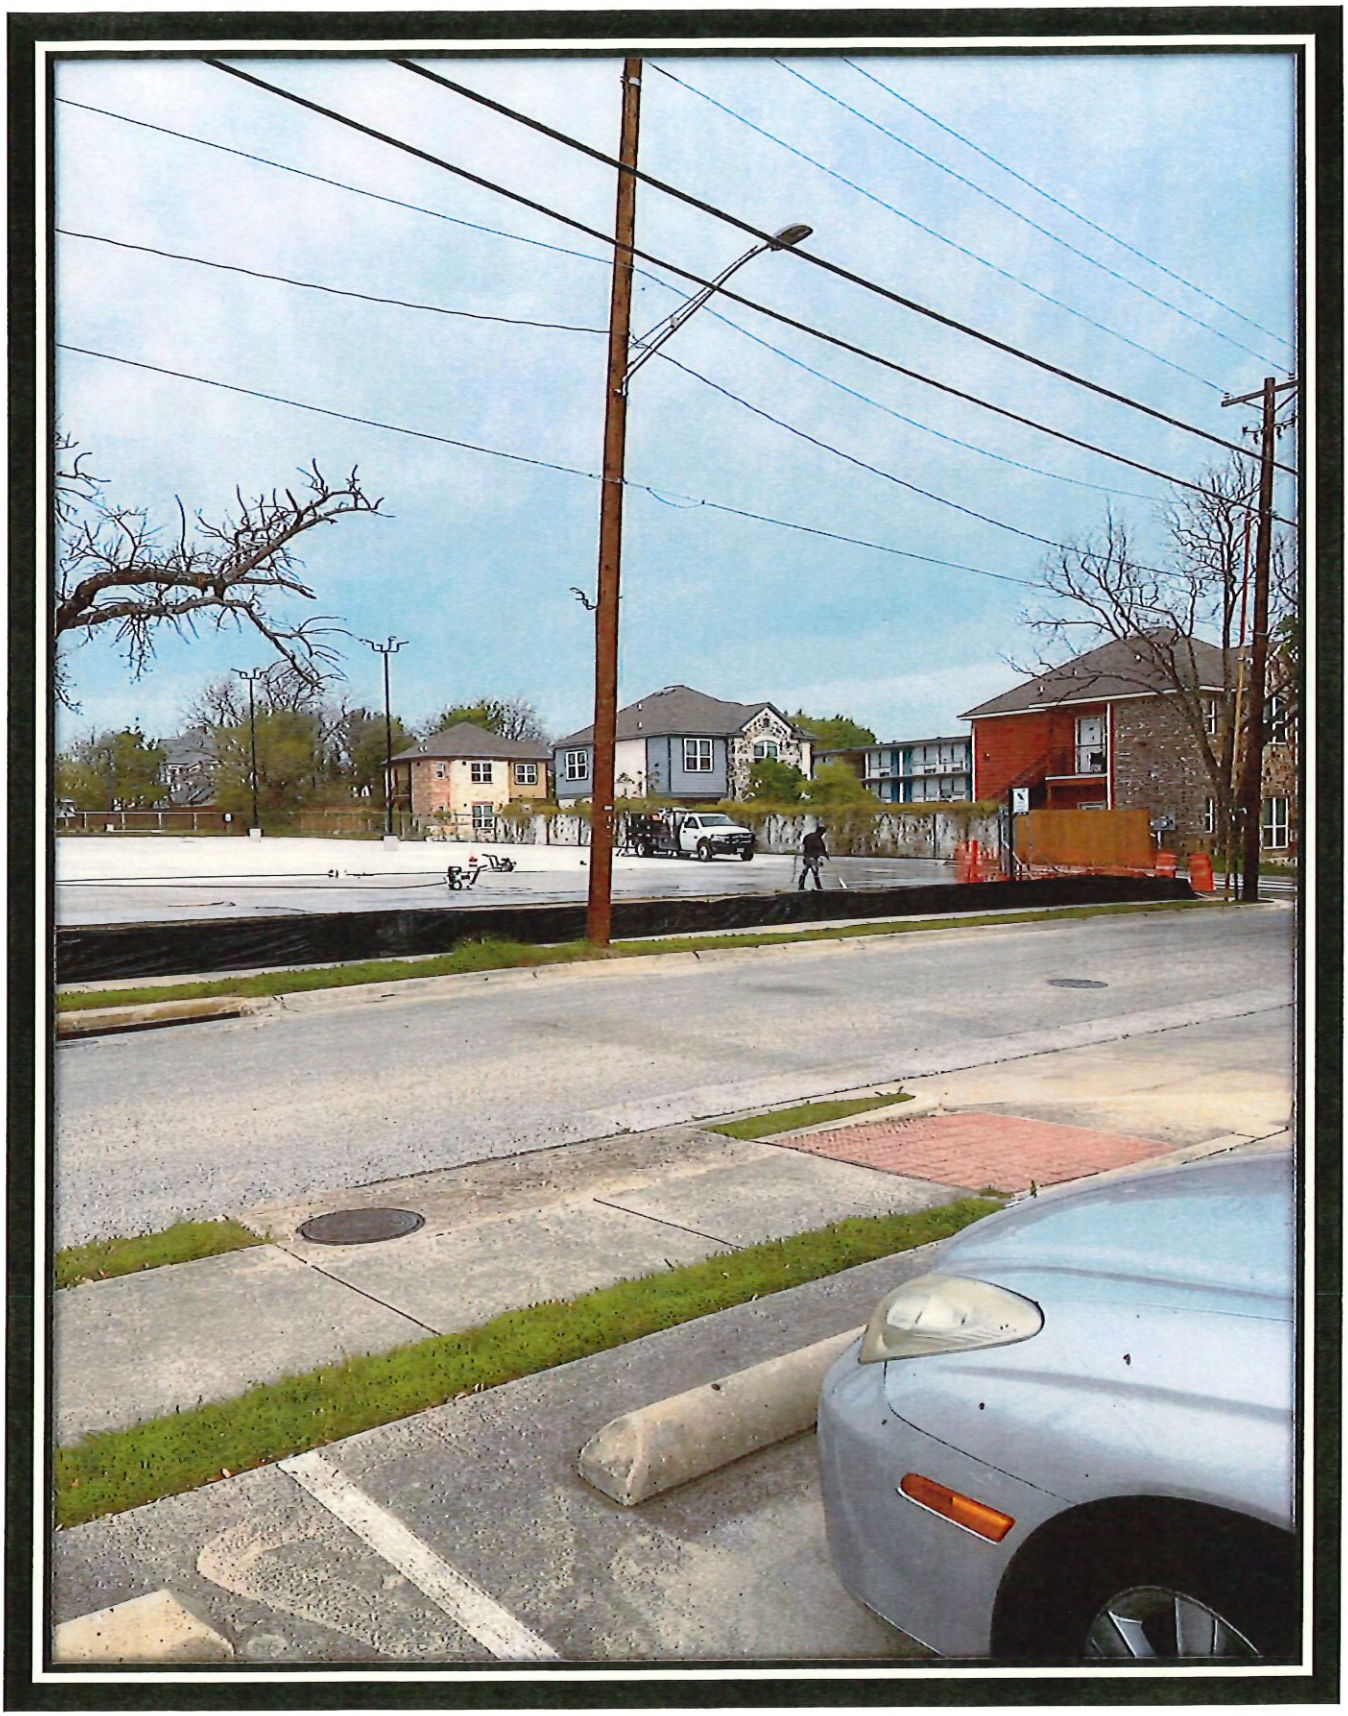
East side of new Parking Lot 59 (former Oak Street Hall site) being power-washed. Silt fencing will remain in place until vegetation can be re-established. View is to the northwest. Wash water was not draining into storm drain curb inlets (03.29.2024).

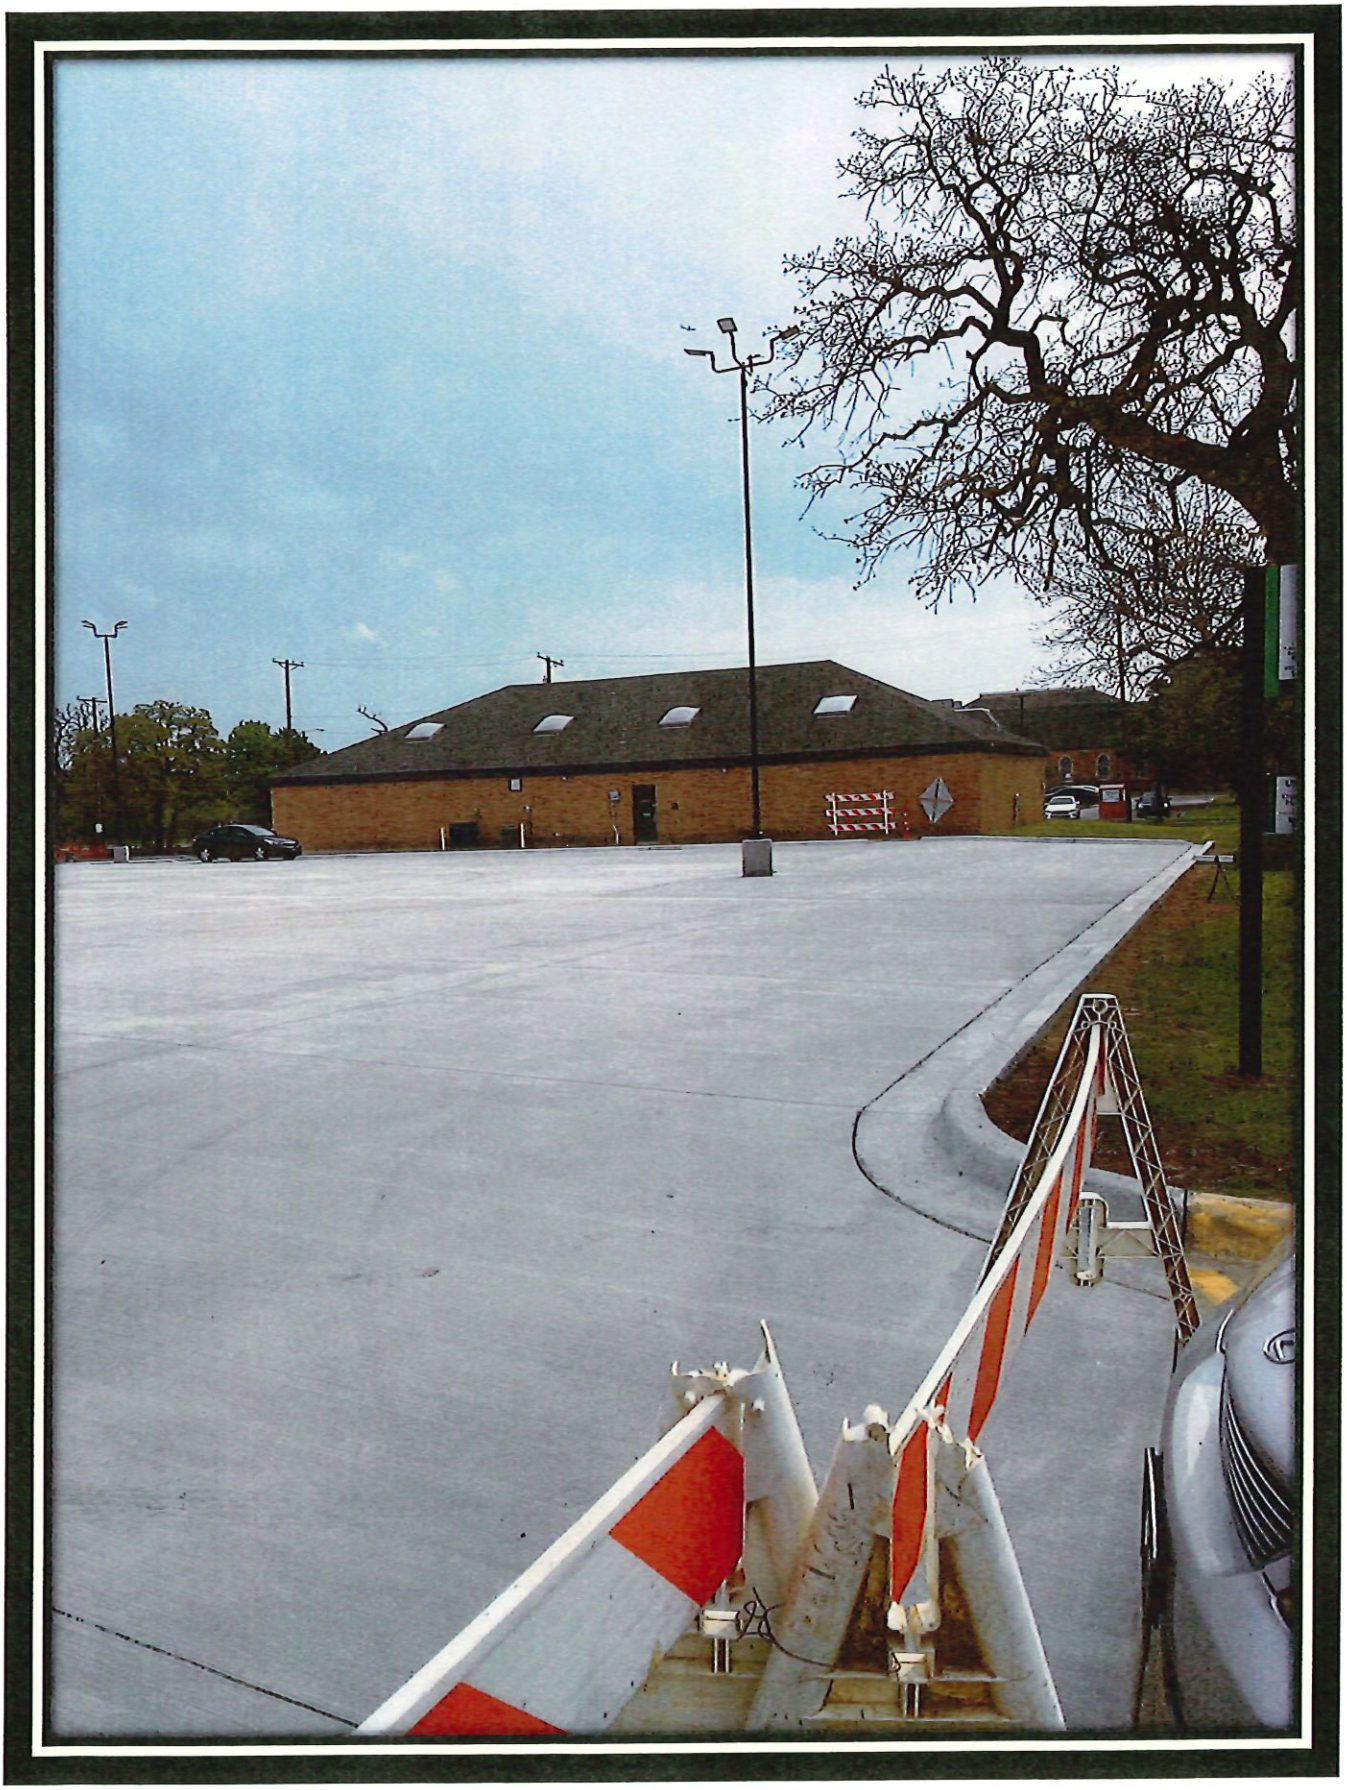
Parking Lot 59 (former Oak Street Hall site). View is to the east (03.29.2024).

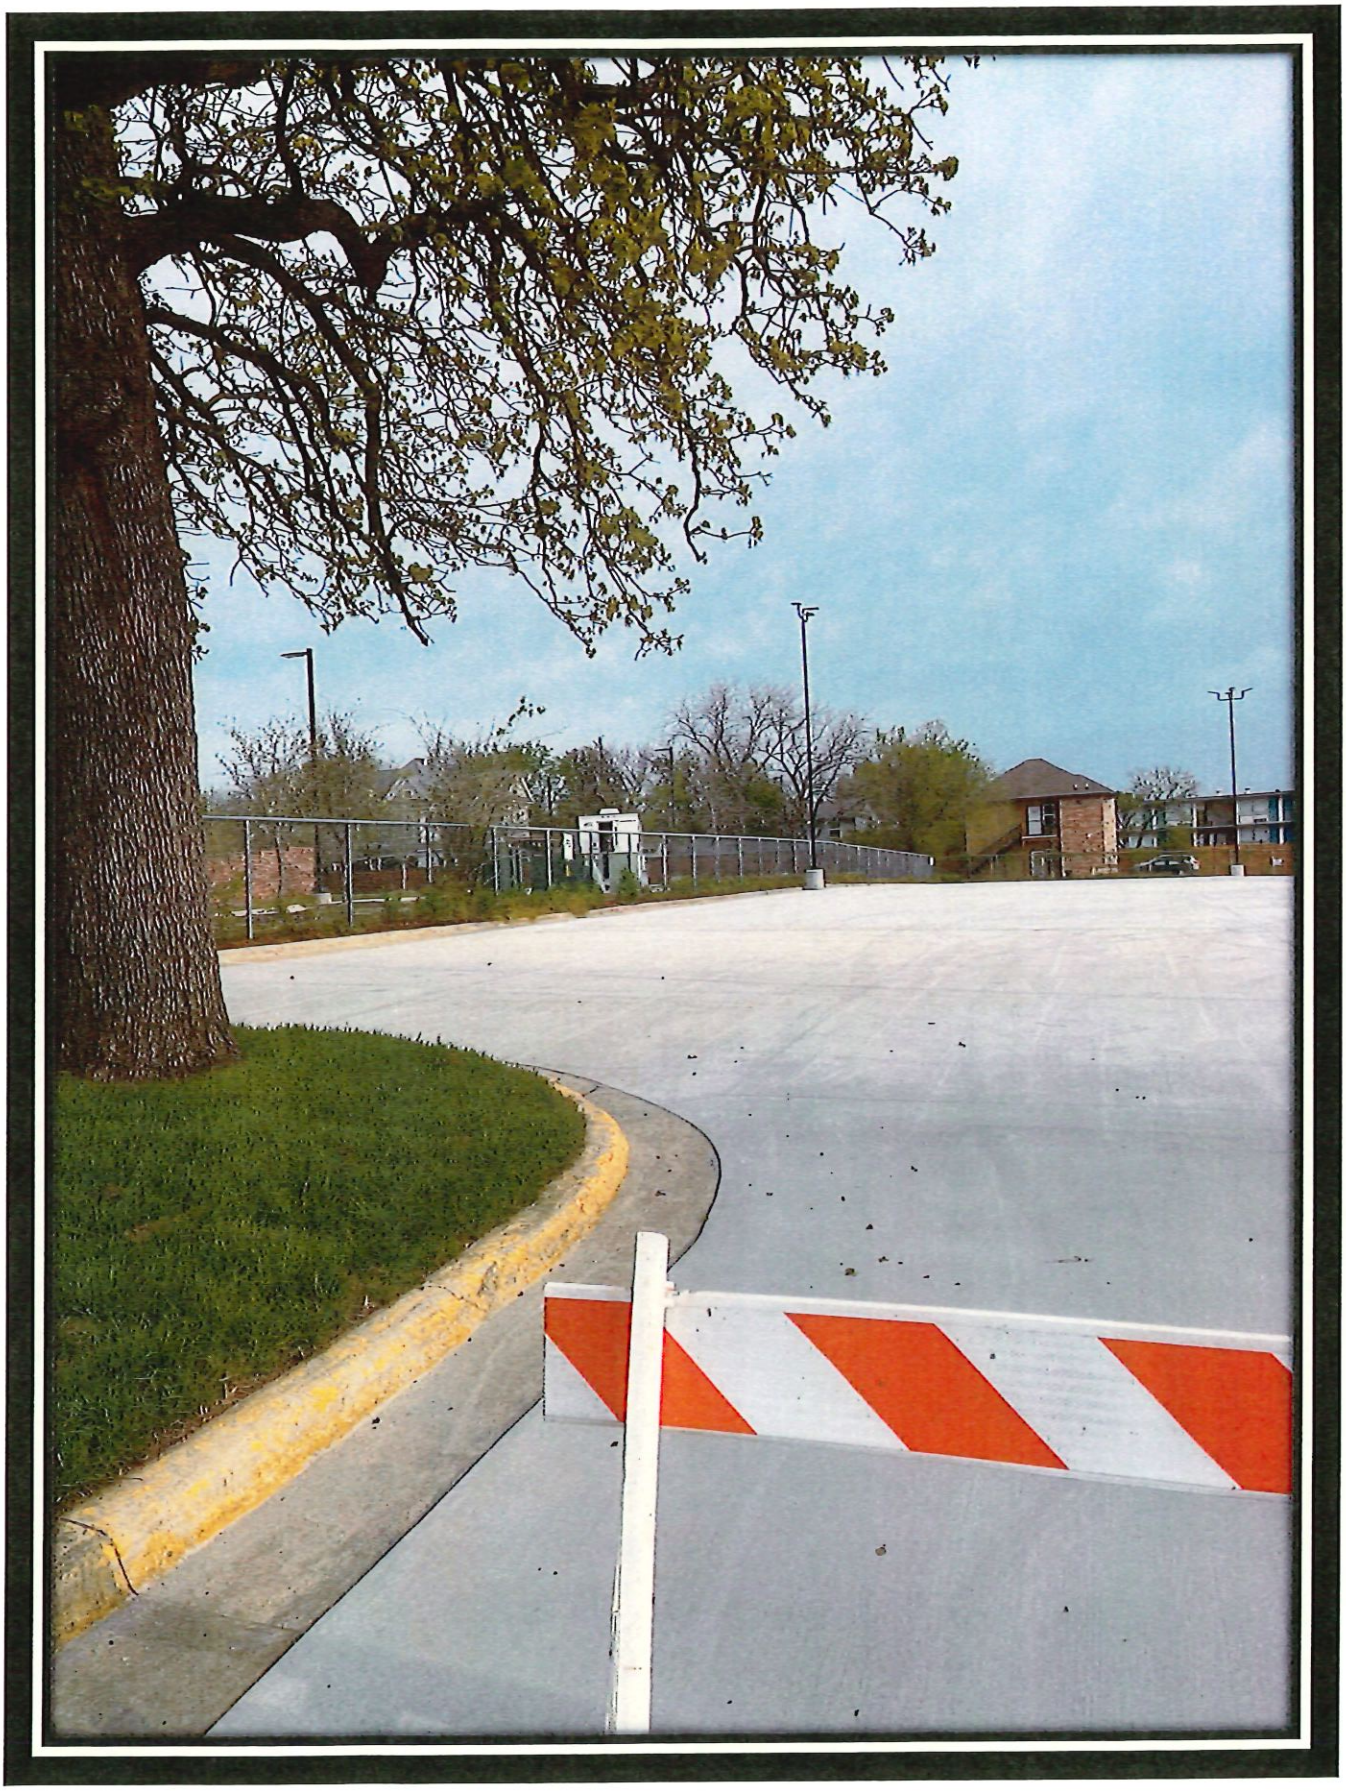
Parking Lot 59 (former Oak Street Hall site). View is to the northwest (03.29.2024).

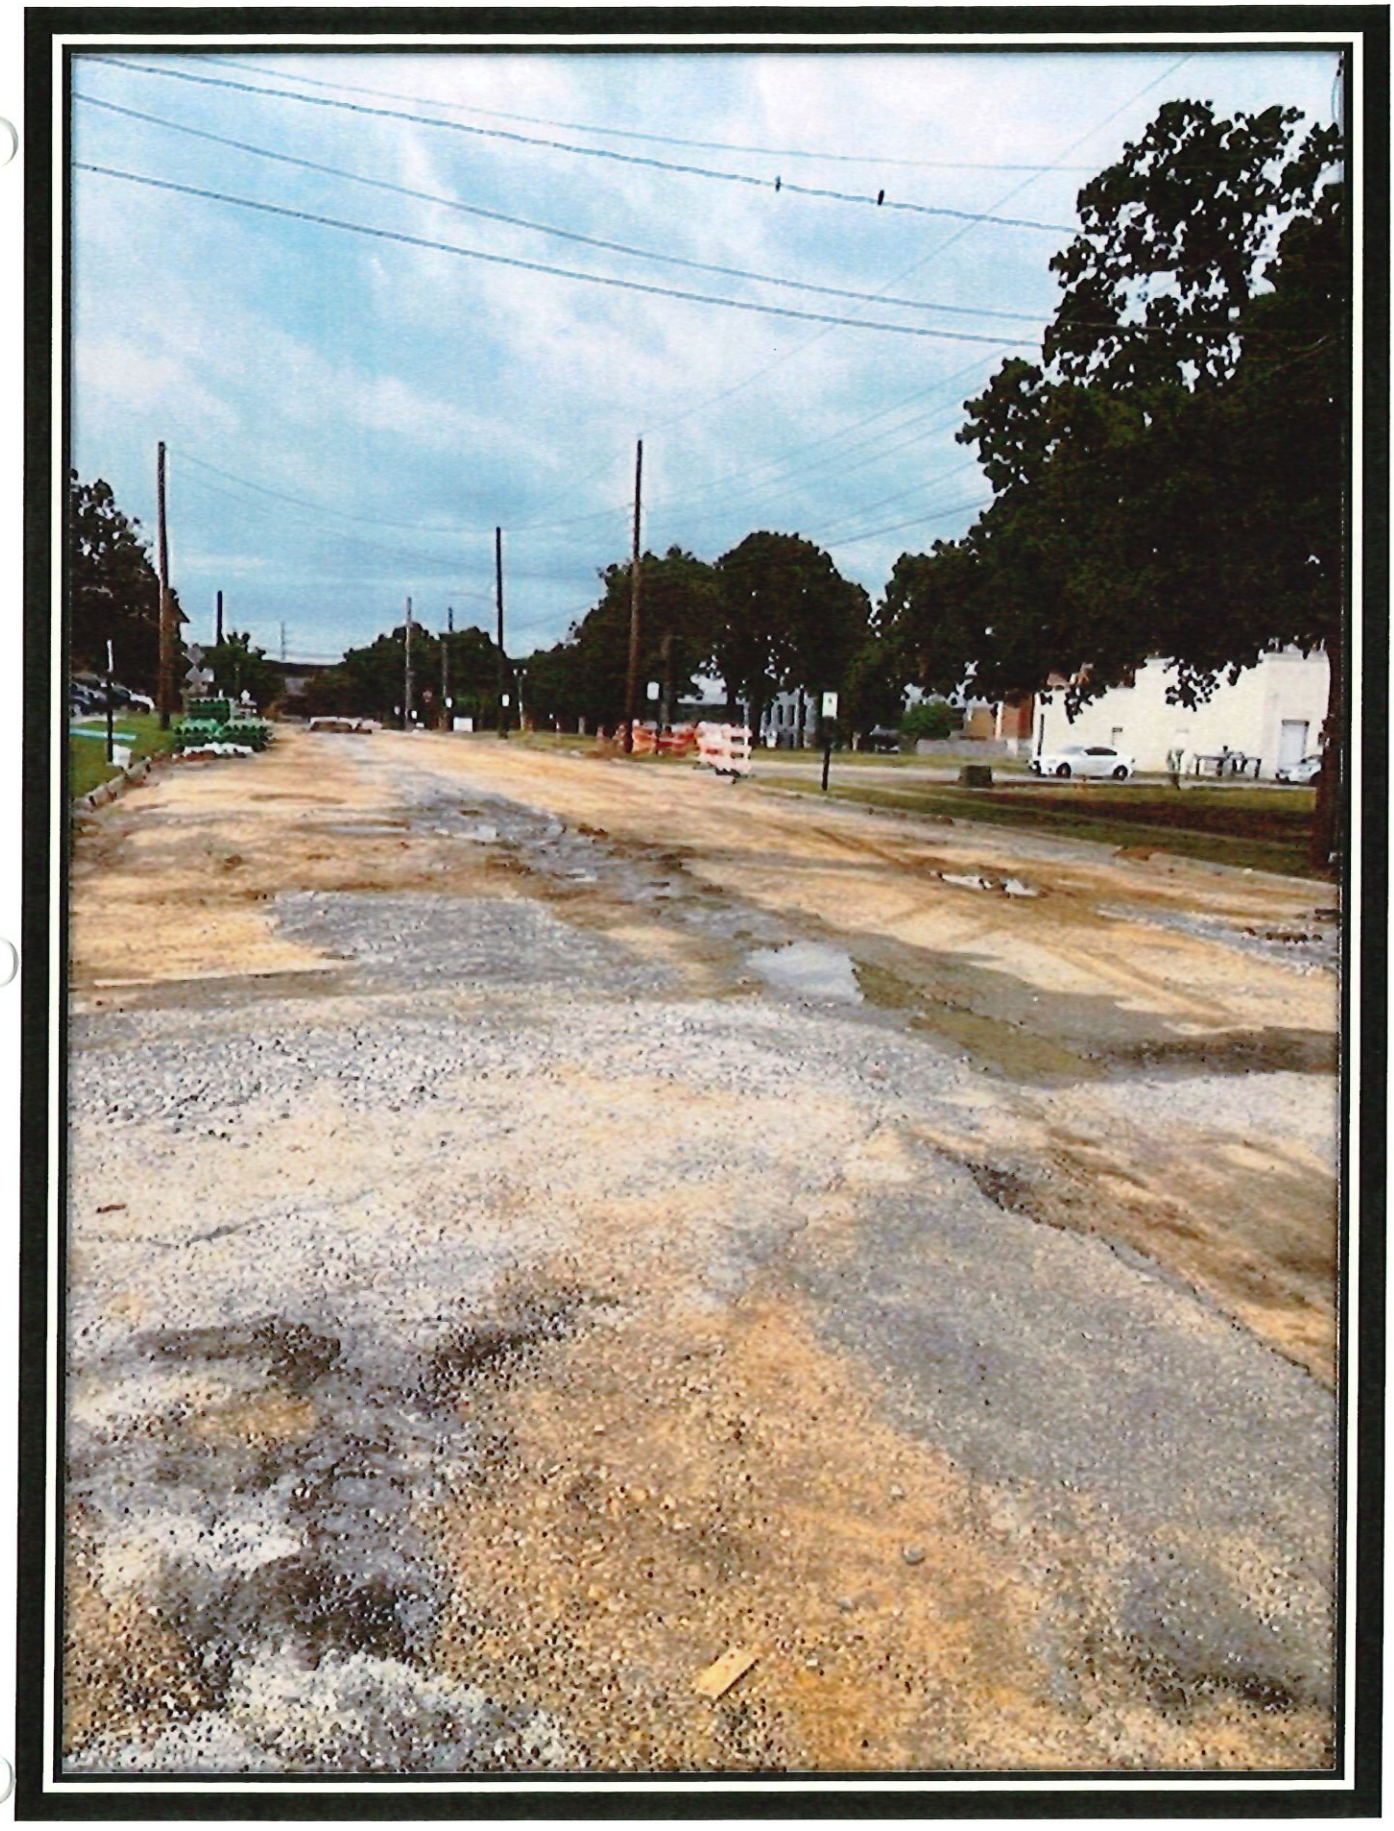
View to the south along Avenue D toward Chestnut.

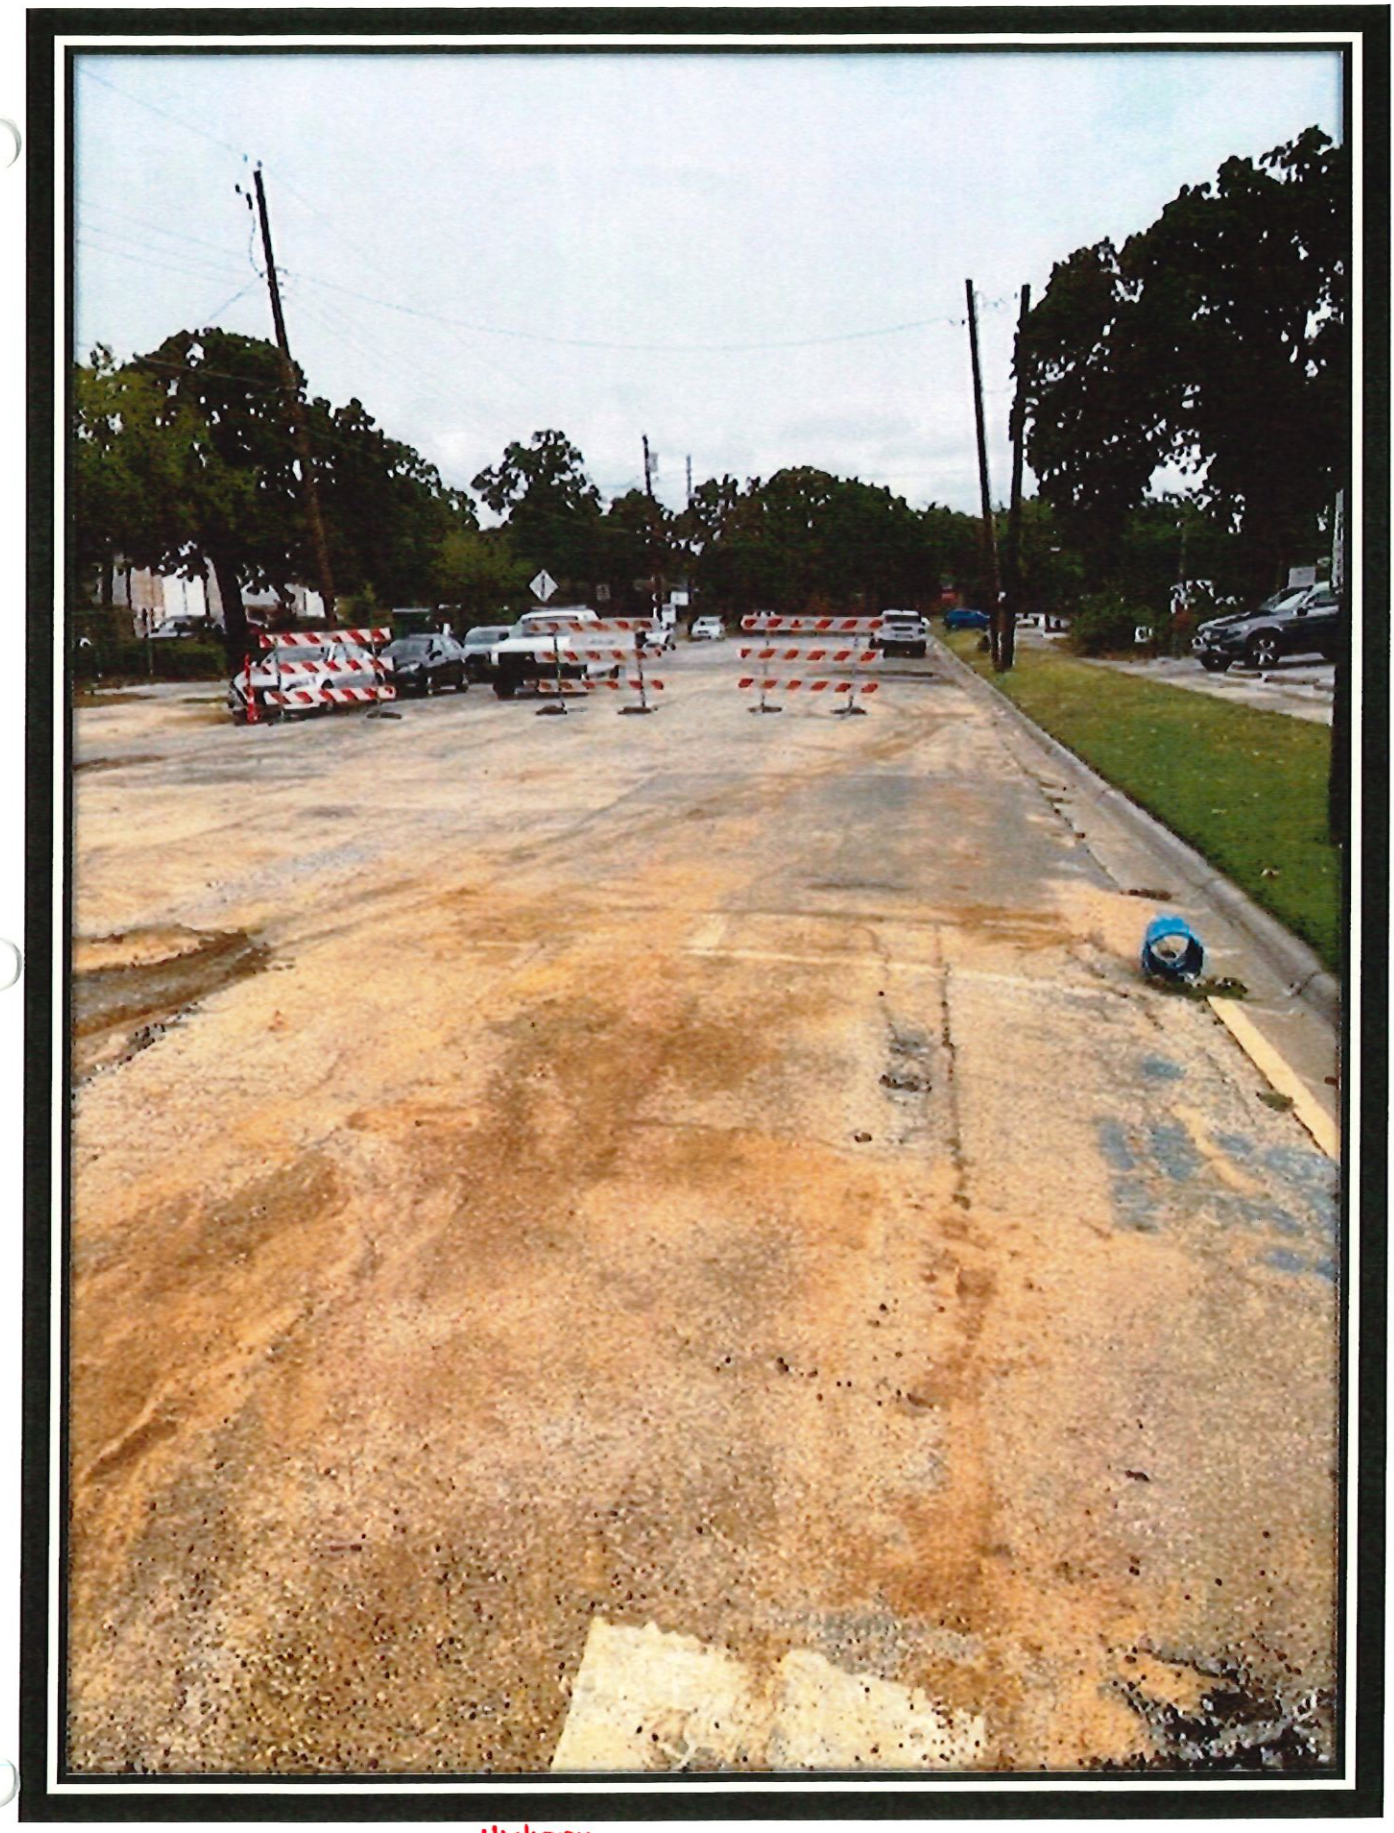
View north along Avenue D (toward W. ~~Oak~~ Hickory St.)

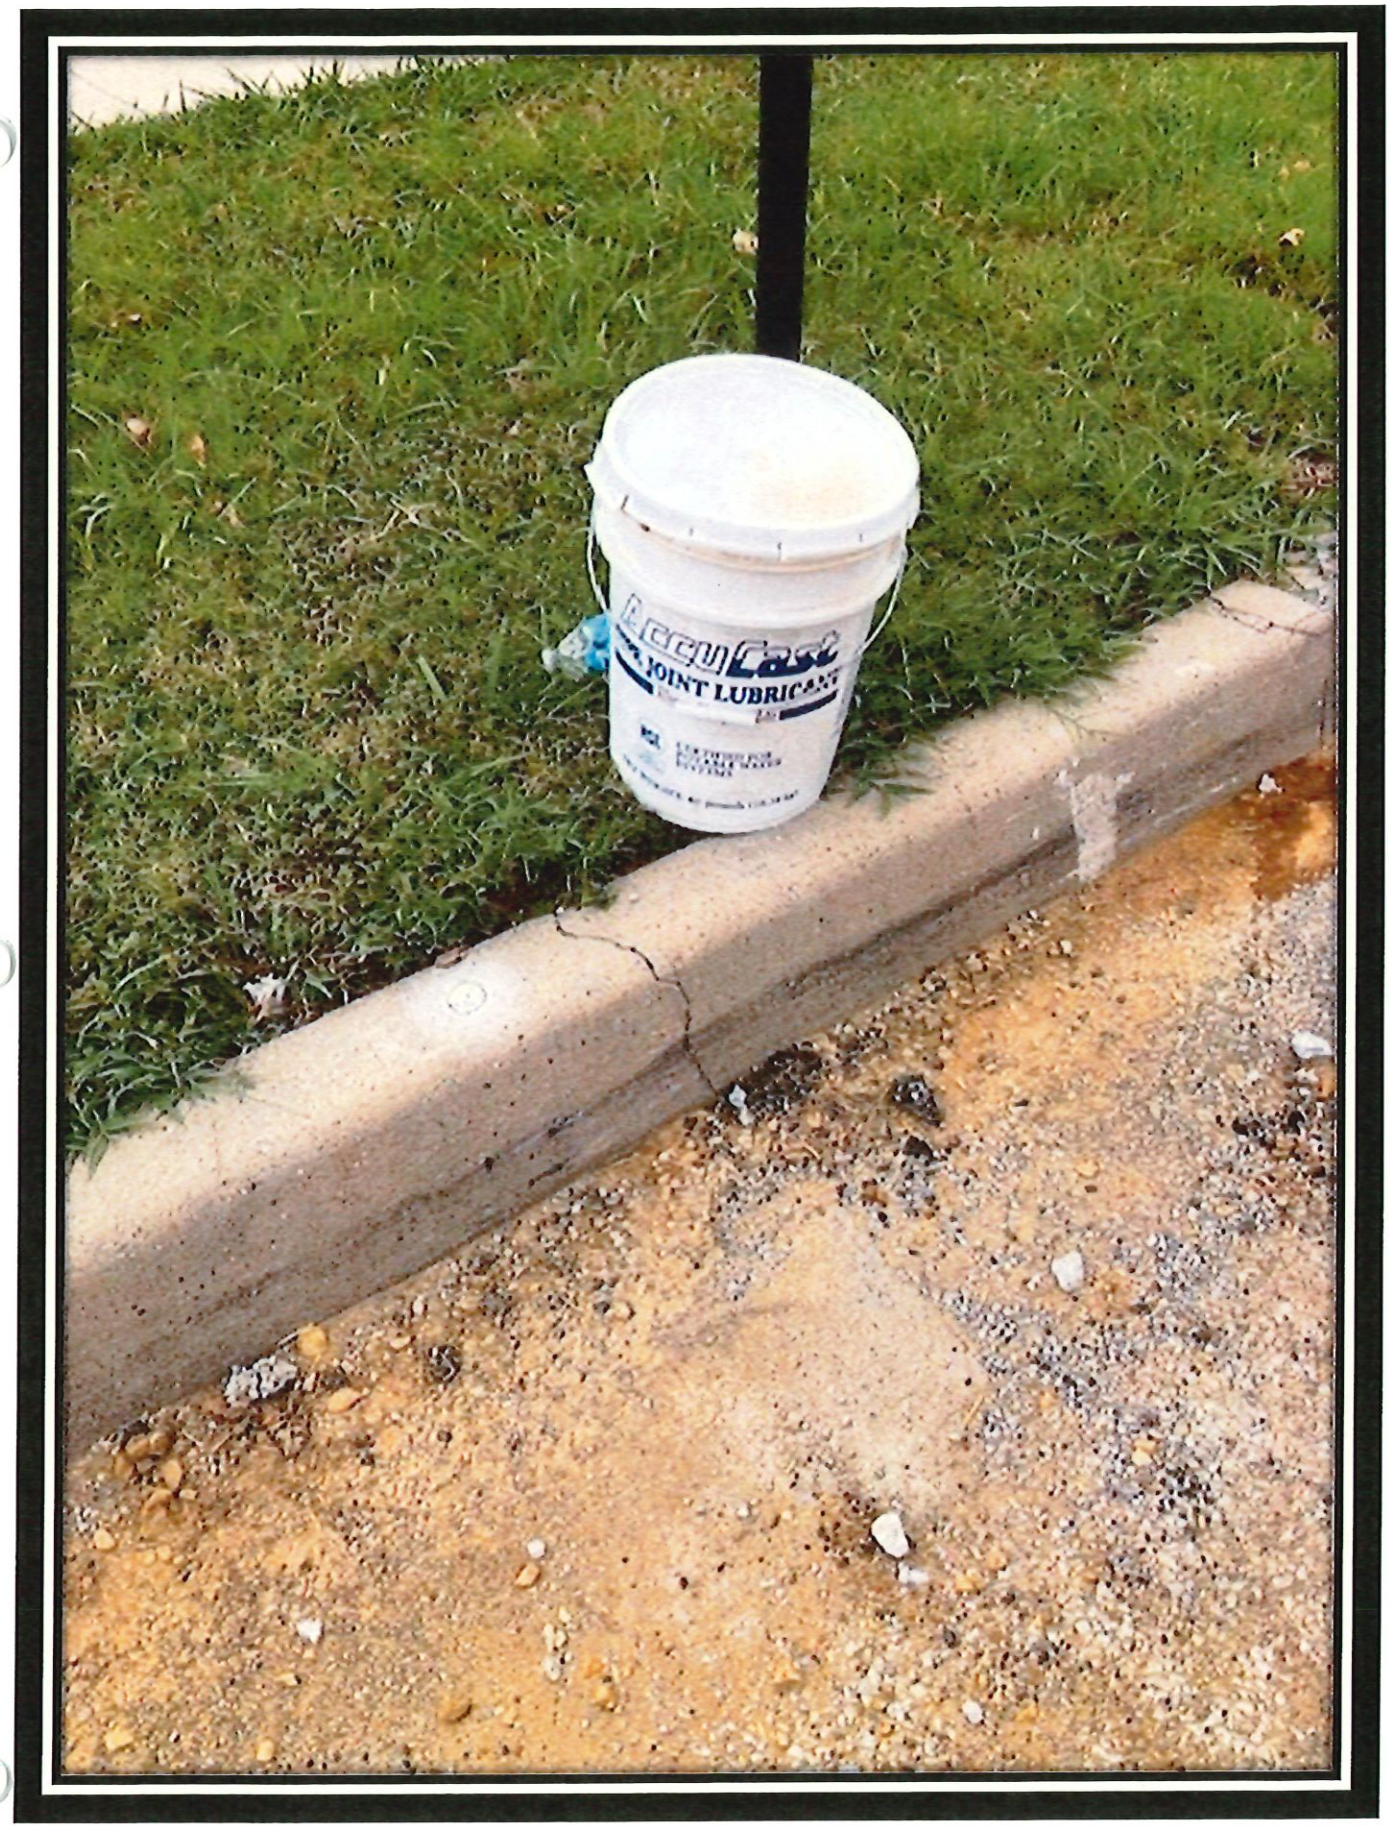
Partially open 5 gallon bucket of pipe joint lubricant.

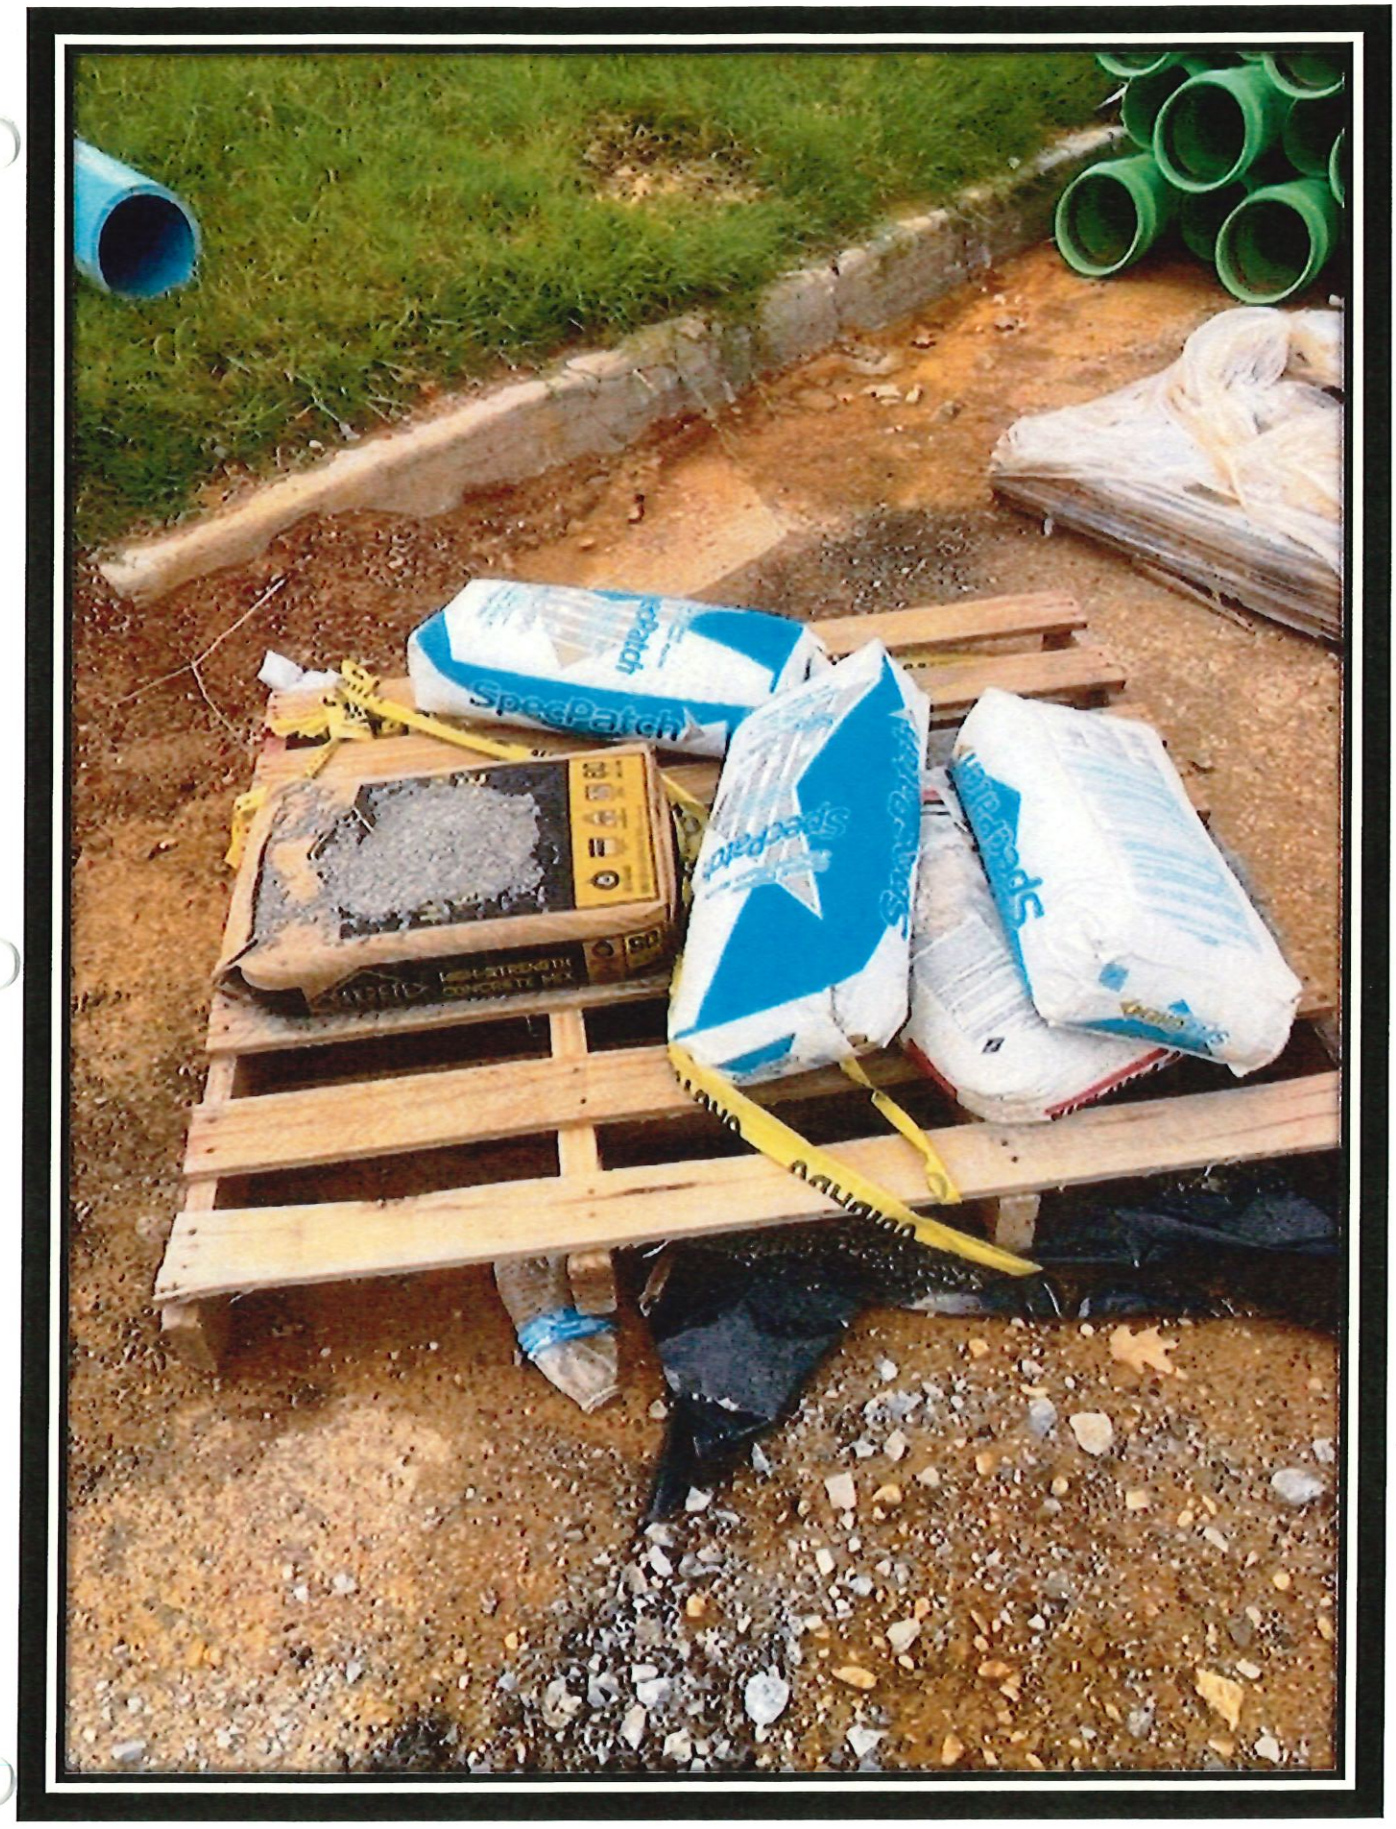
Pallet of wet bags of concrete and concrete patch and miscellaneous trash on Avenue D.
