2024 ANNUAL STORMWATER MANAGEMENT REPORT

University of North Texas
1155 Union Circle #311040
Denton, Denton County, Texas
76203-5017

Re: Phase II MS4 Annual Report Transmittal for University of North Texas
TPDES General Permit Authorization: TXR040066

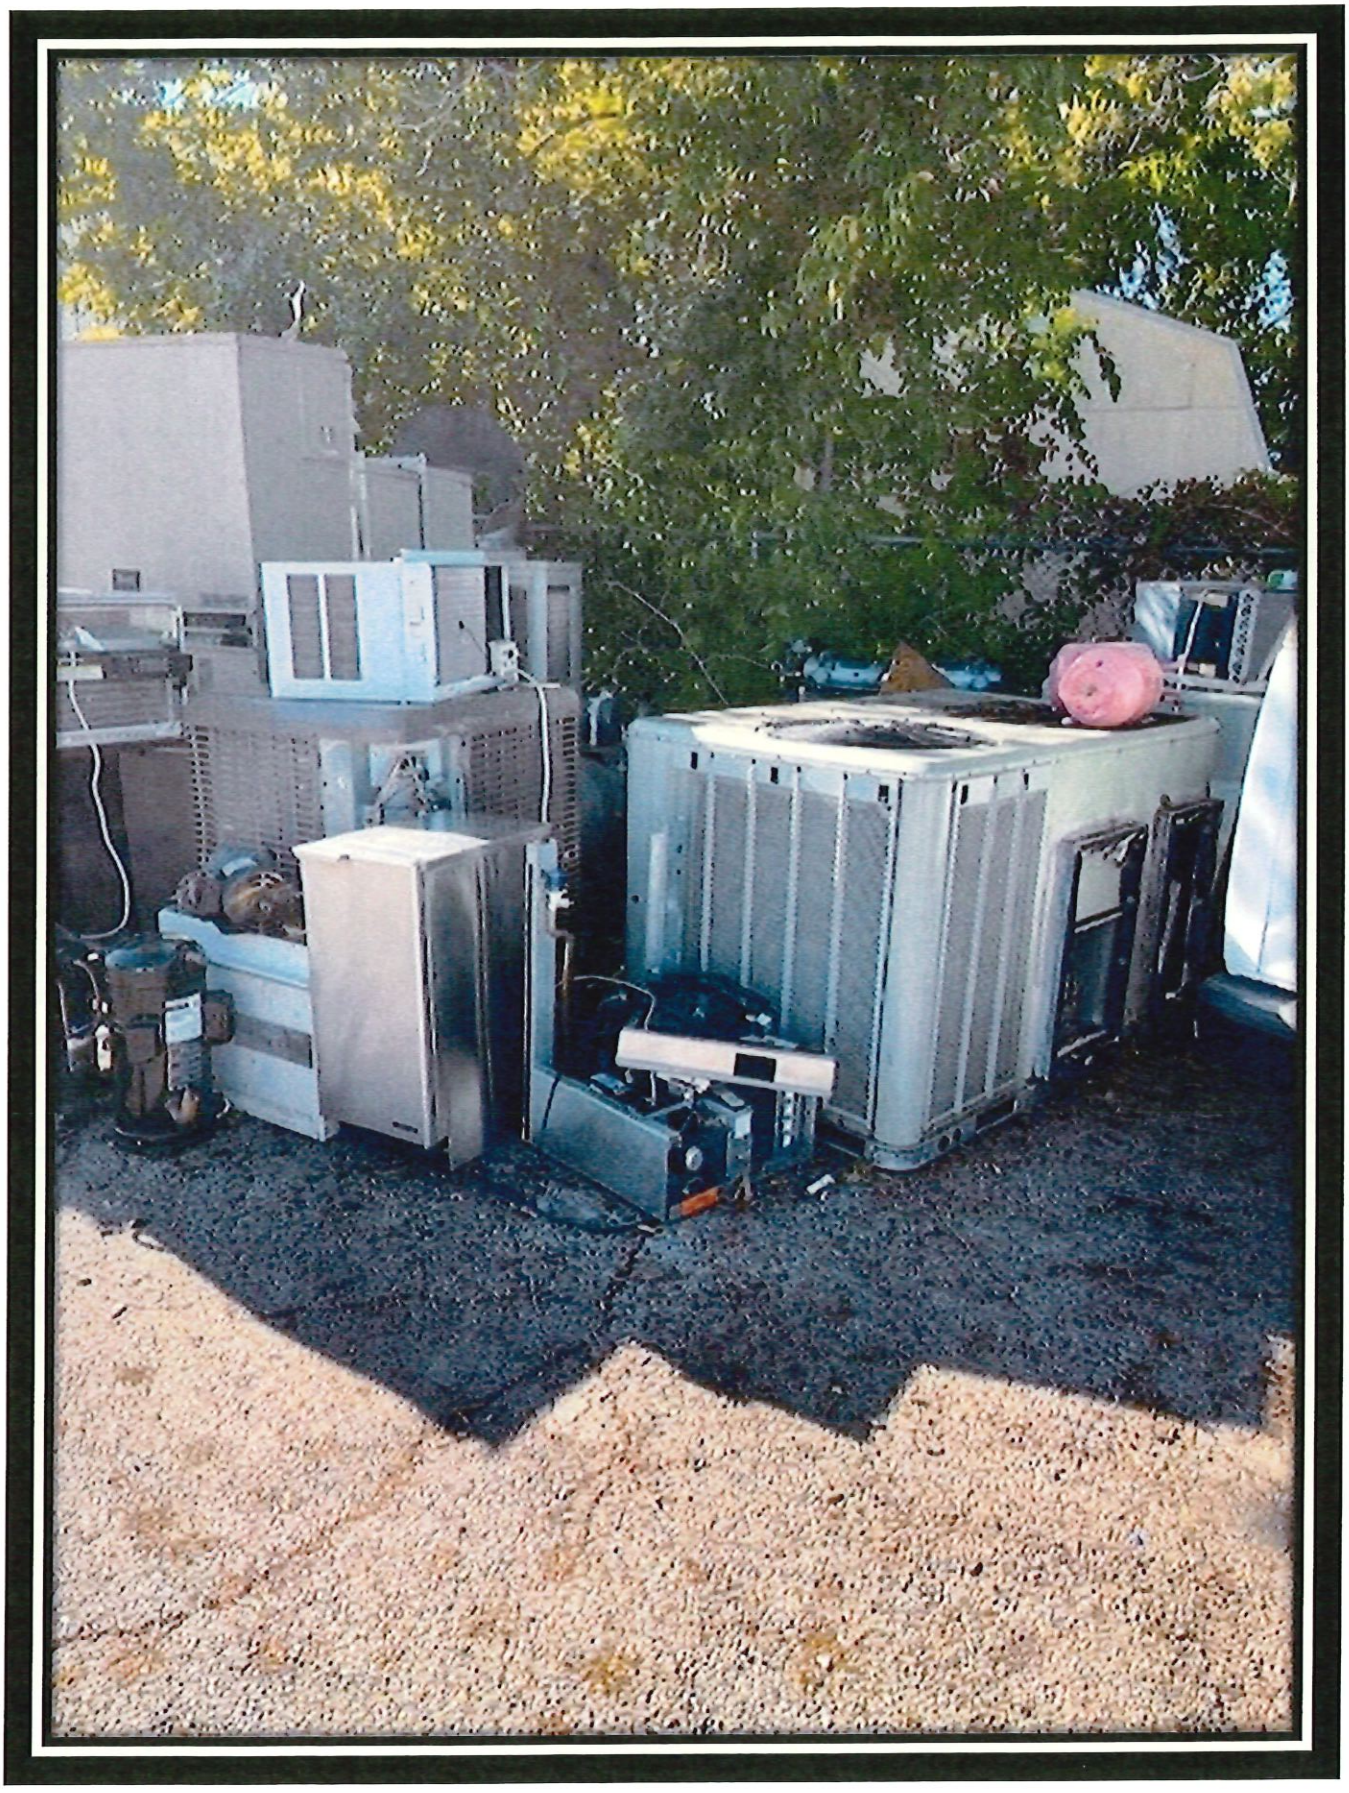
Closeup view of Facilities Laydown Yard. Old A/C and heating units, motors, air compressors, empty Freon canisters and various pieces of equipment.

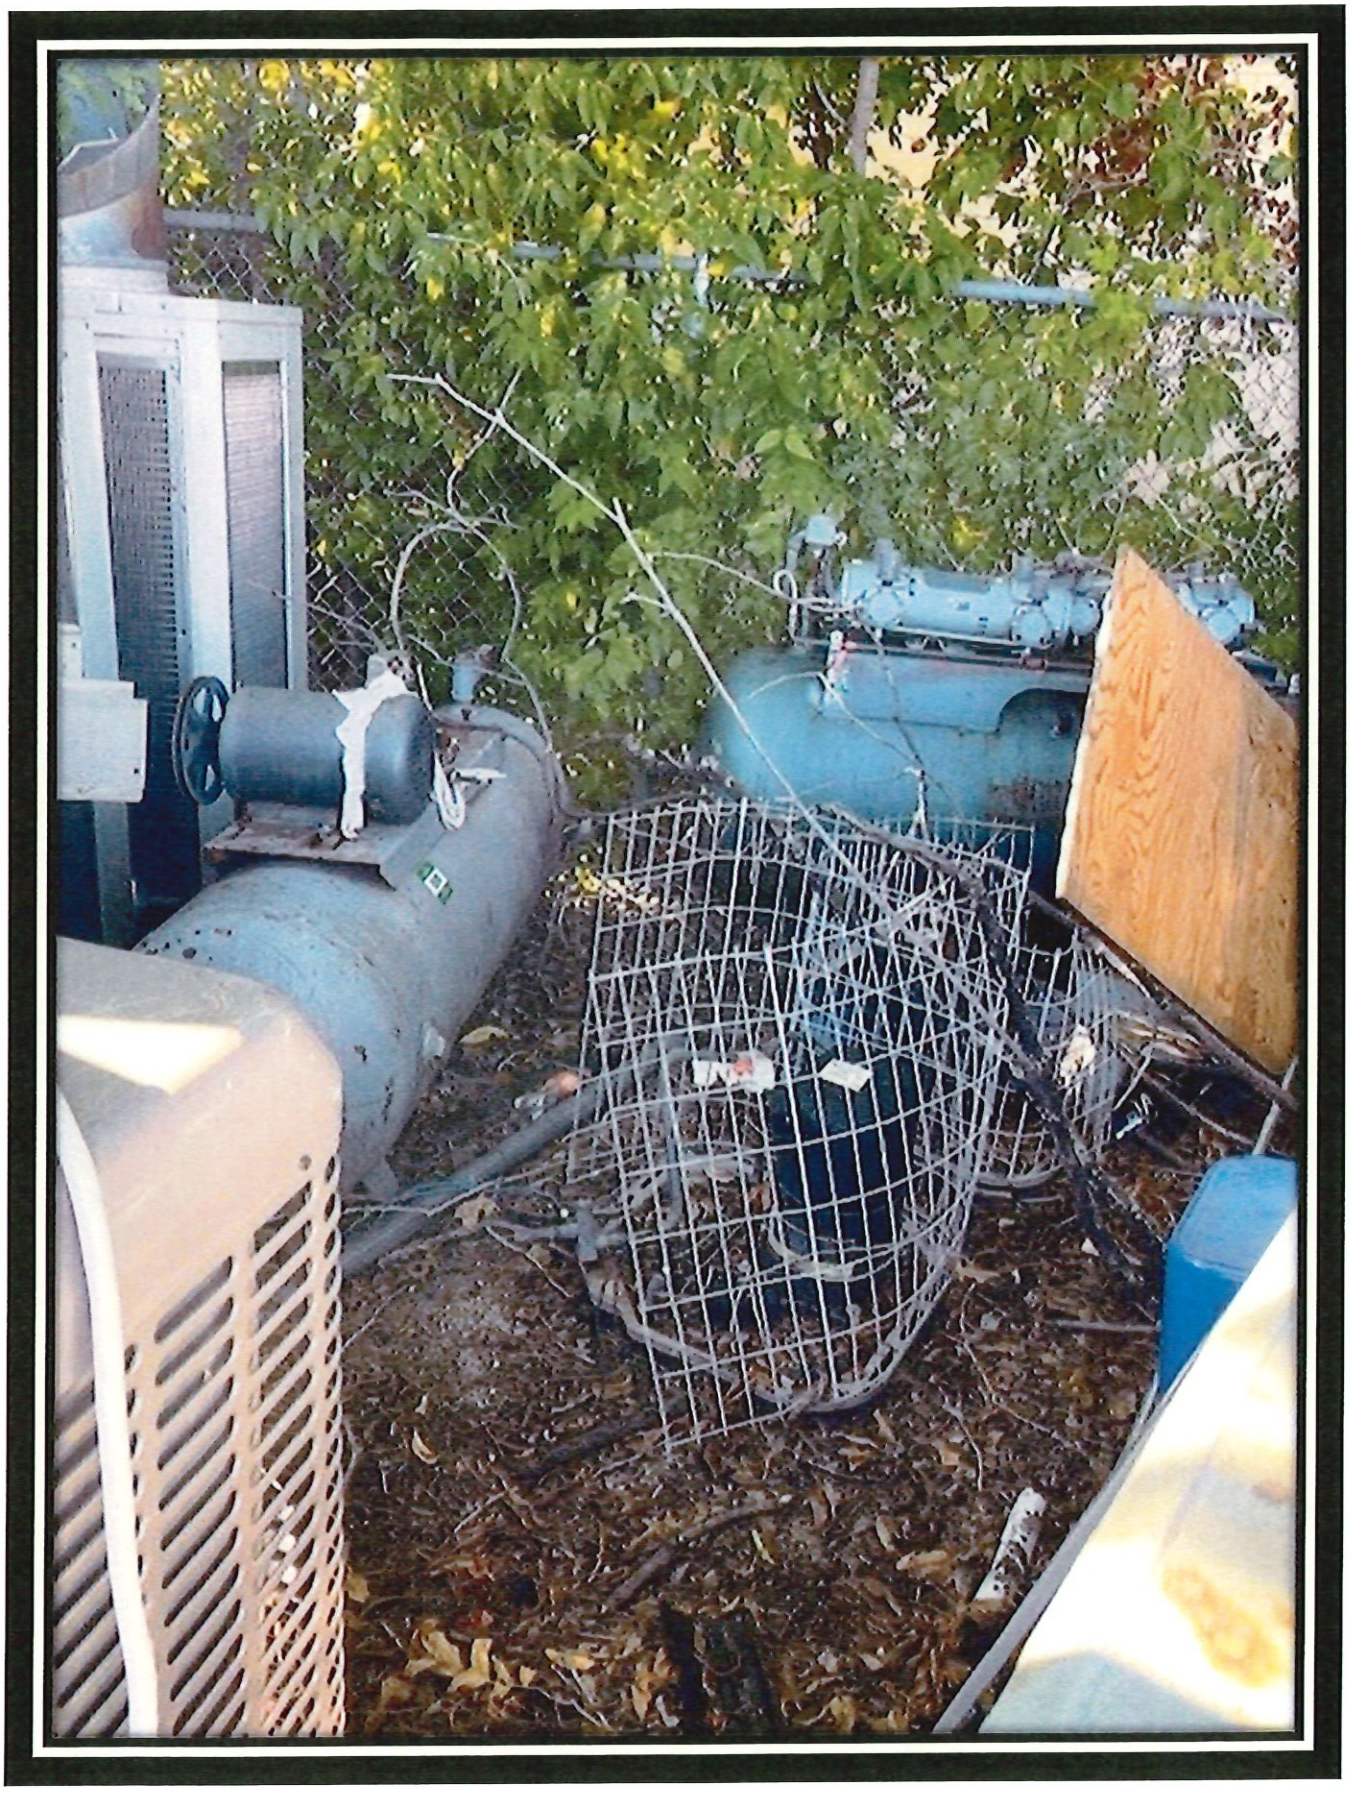
Facilities Laydown Yard near Moving and Storage. Air compressors and various other pieces of equipment.

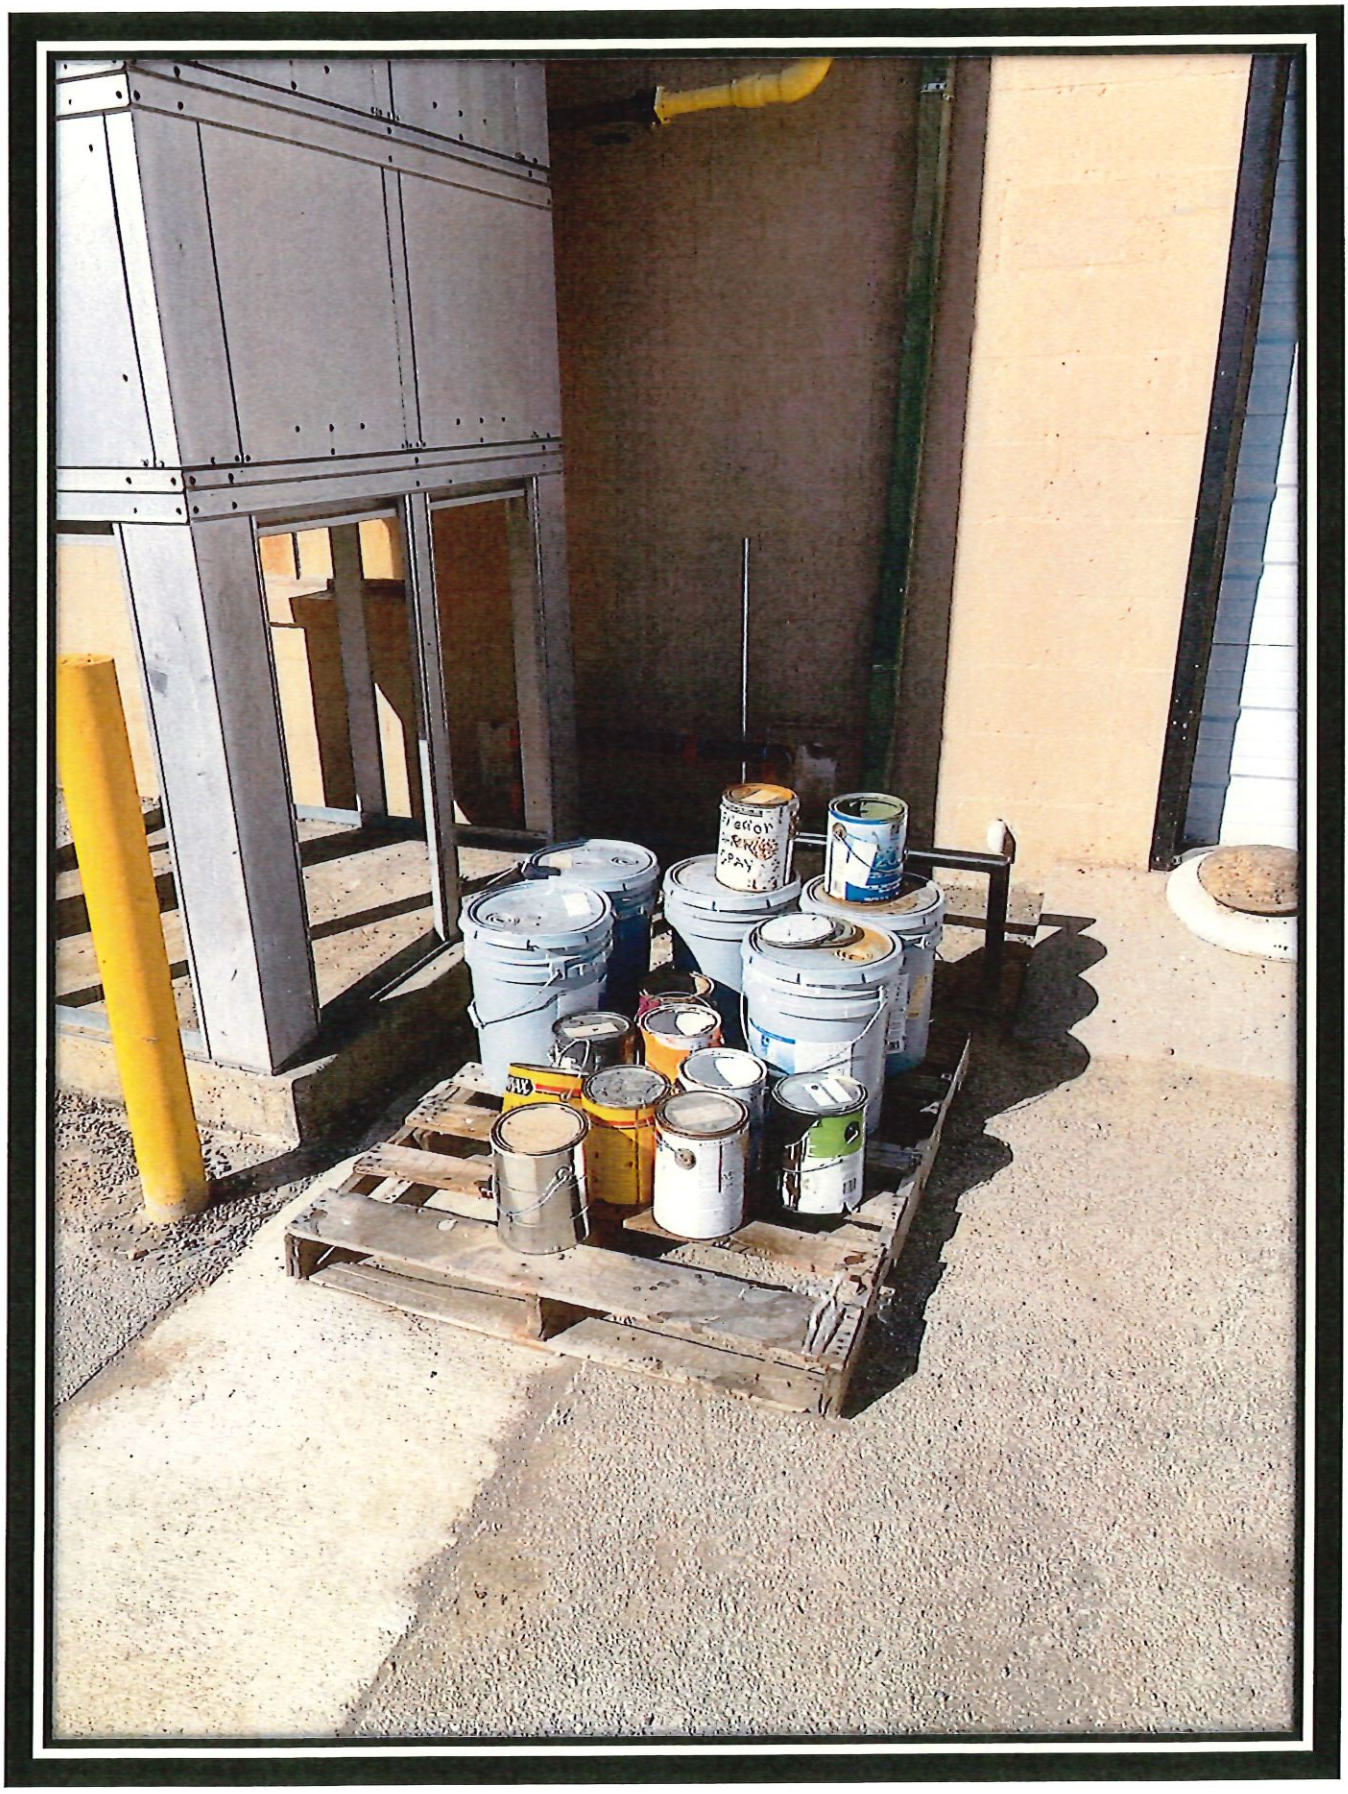
Pallet of paint buckets on the east side of the Paint Shop. Open containers are empty but allowed to dry out before disposing of the buckets into a waste container.

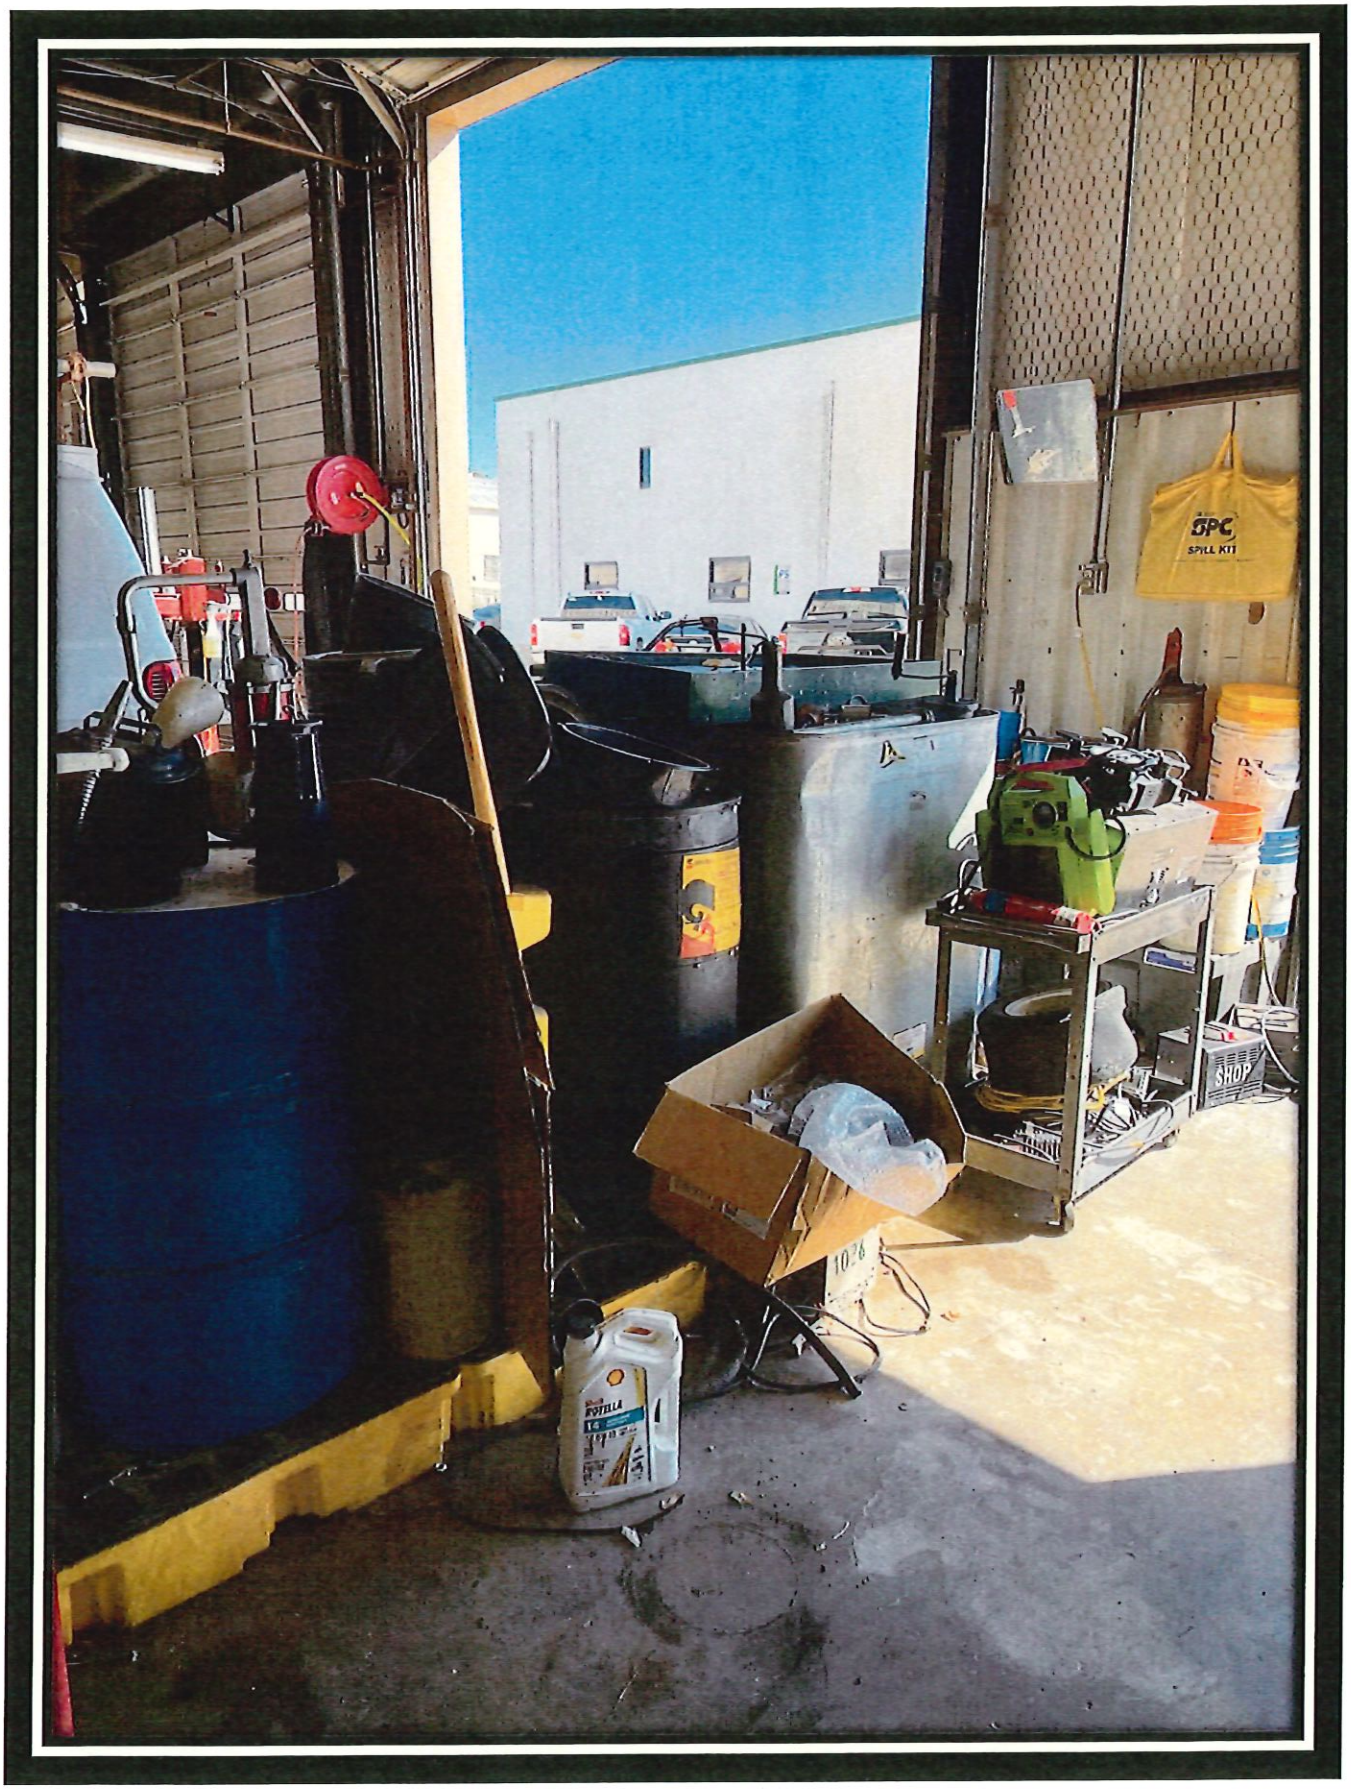
Facilities Automotive used oil and motor vehicle fluids storage on containment pallets inside an automotive bay.

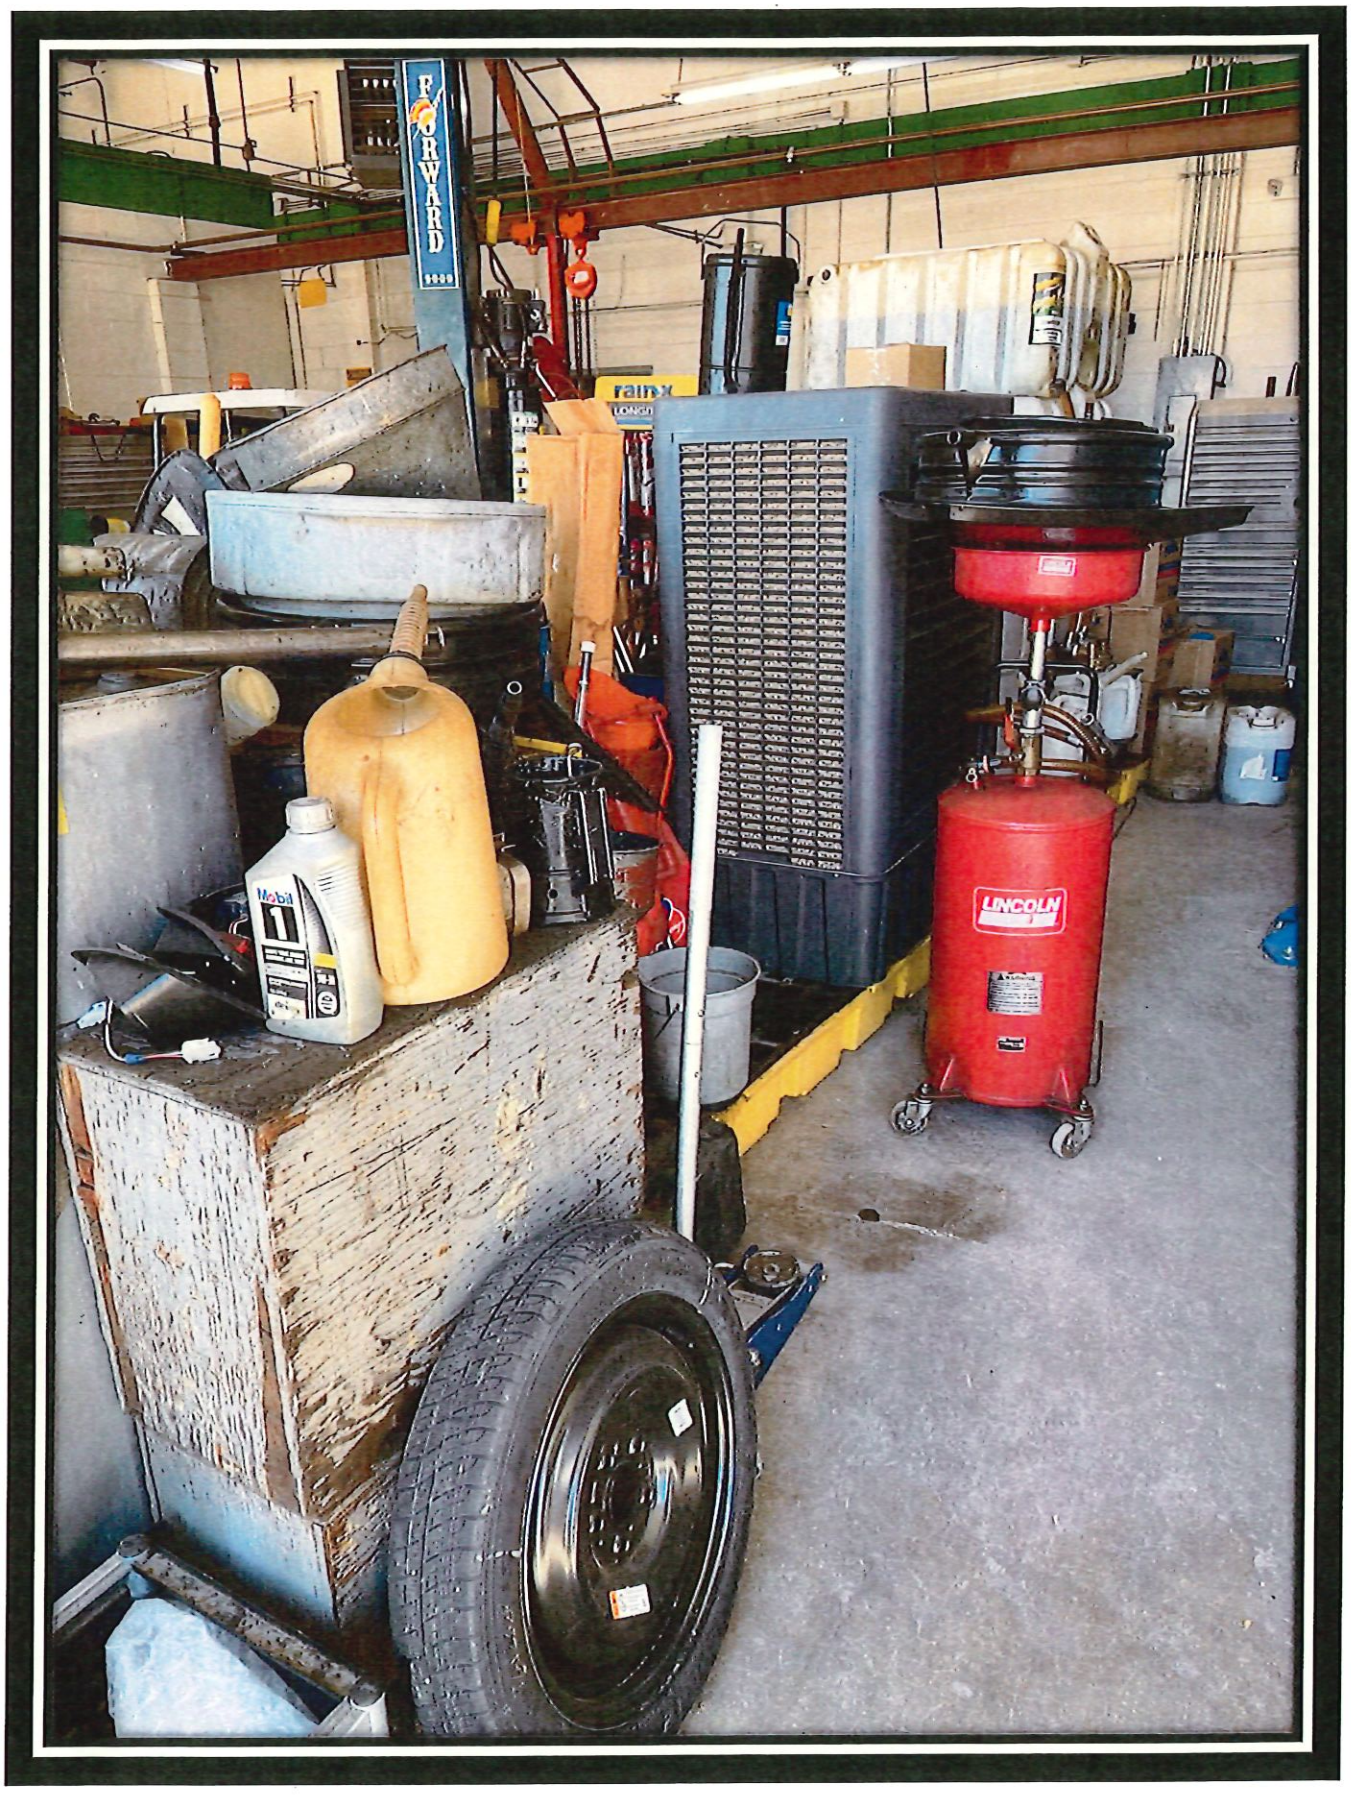
Lincoln Industrial portable oil drain catcher for draining oil from vehicles. The unit can recover the oil in the canister and then it's transferred into the used oil tote by connecting it to the shop's air compressor.

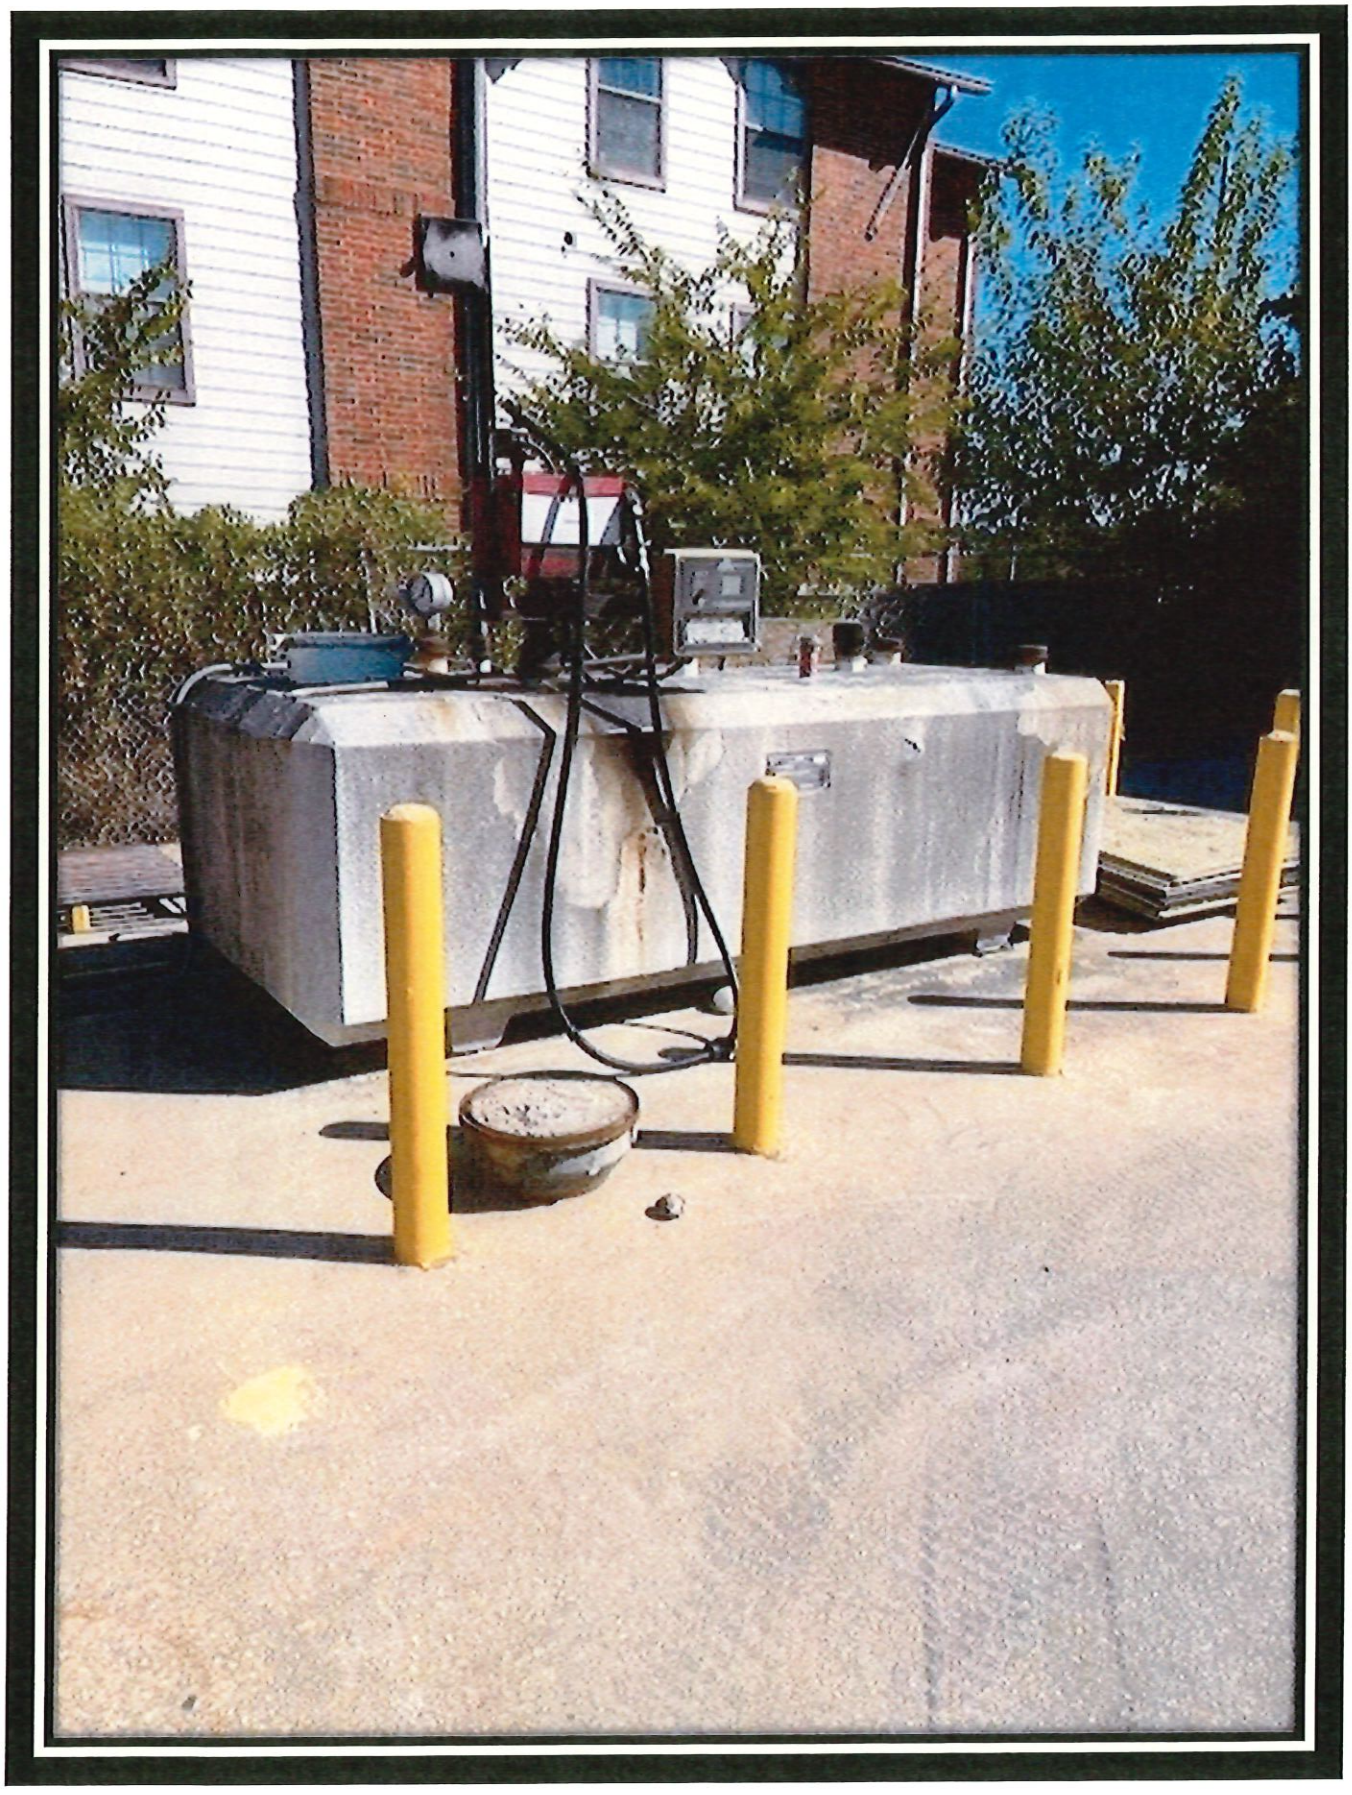
500 gallon diesel above ground storage tank at Facilities Groundskeeping. The tank is double contained inside the concrete vault.

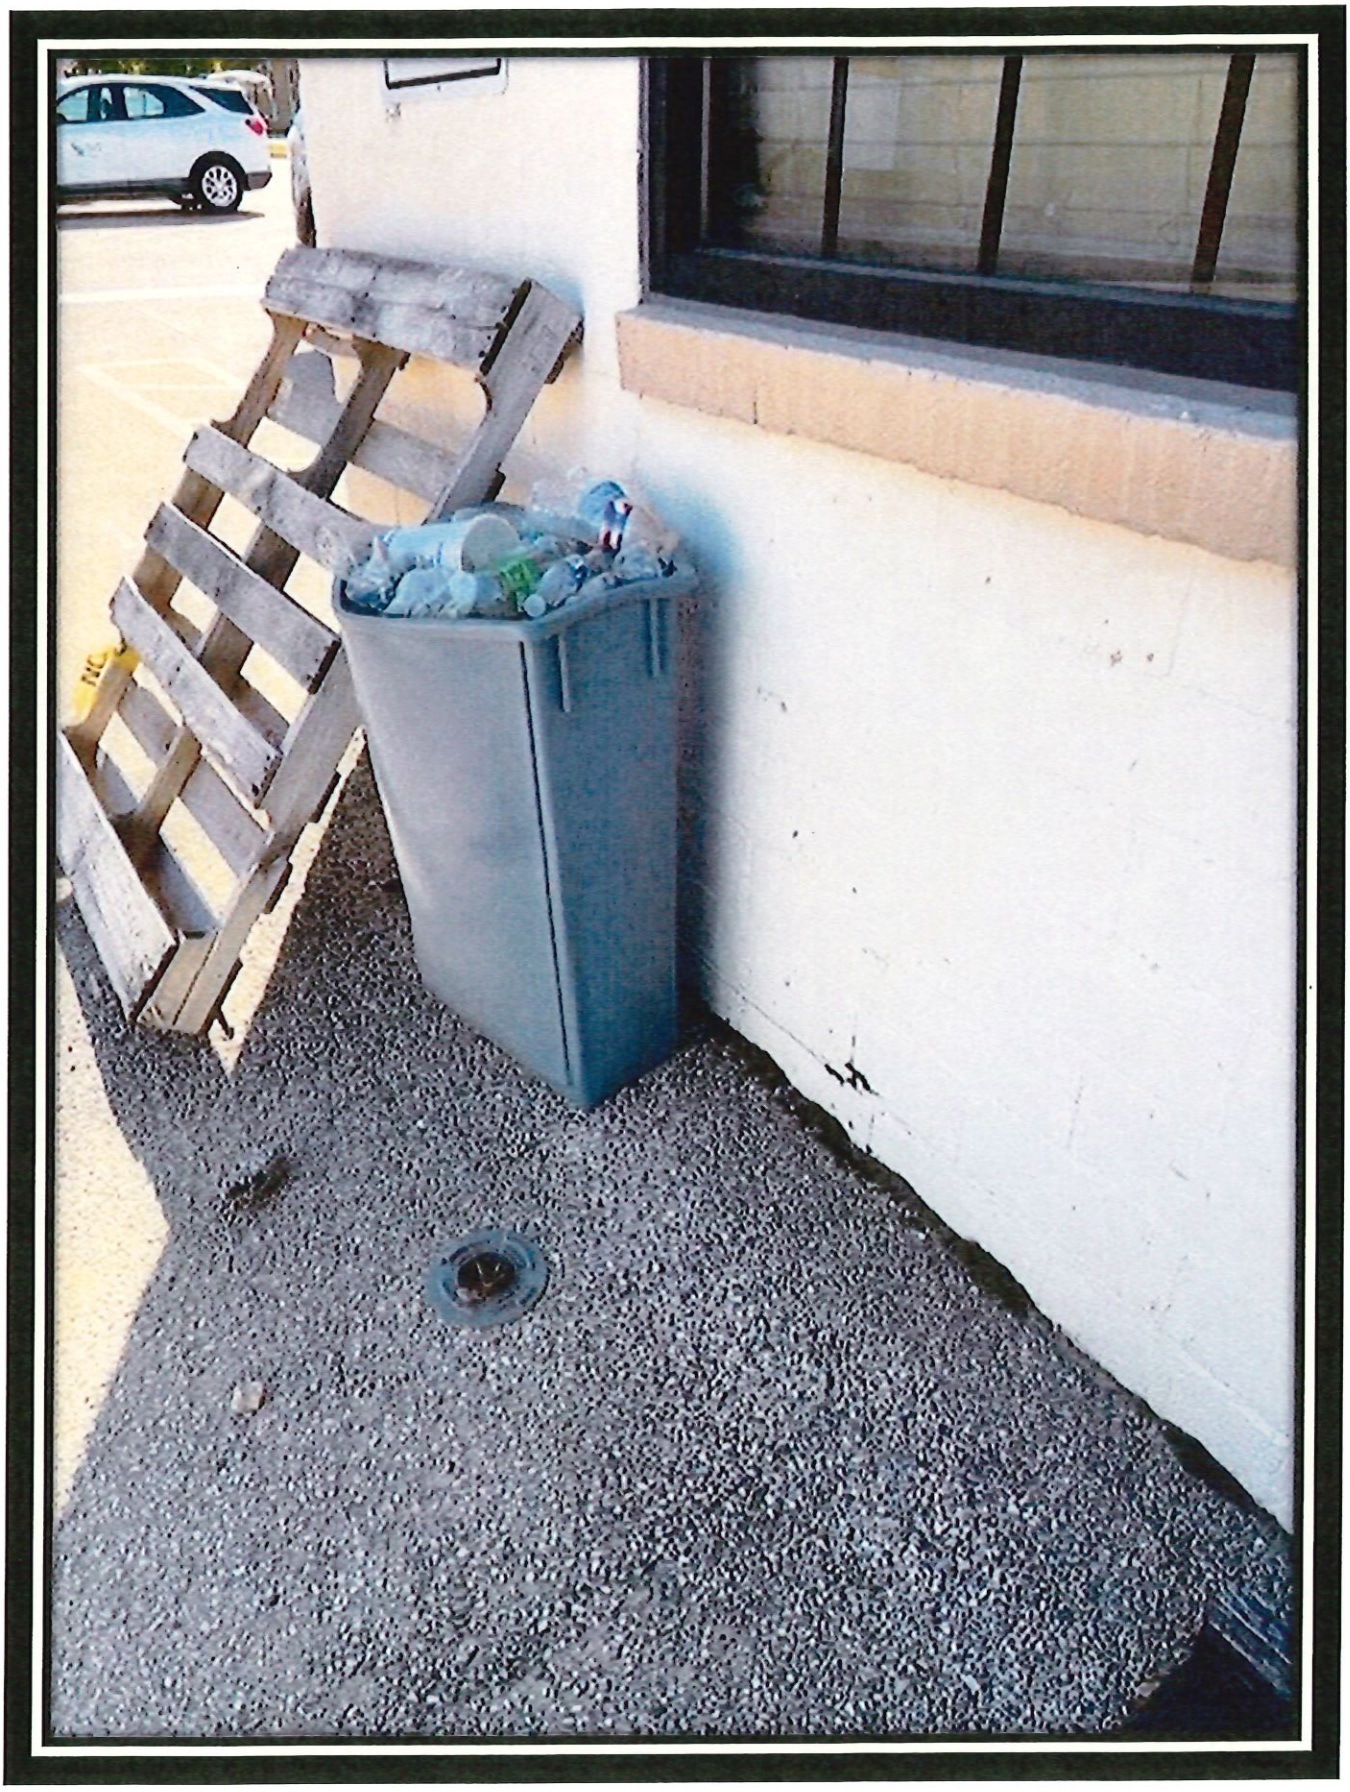
Overflowing recyclables in a plastic waste bin at Facilities. The bin will be emptied into a larger recycle bin for removal by the City of Denton.

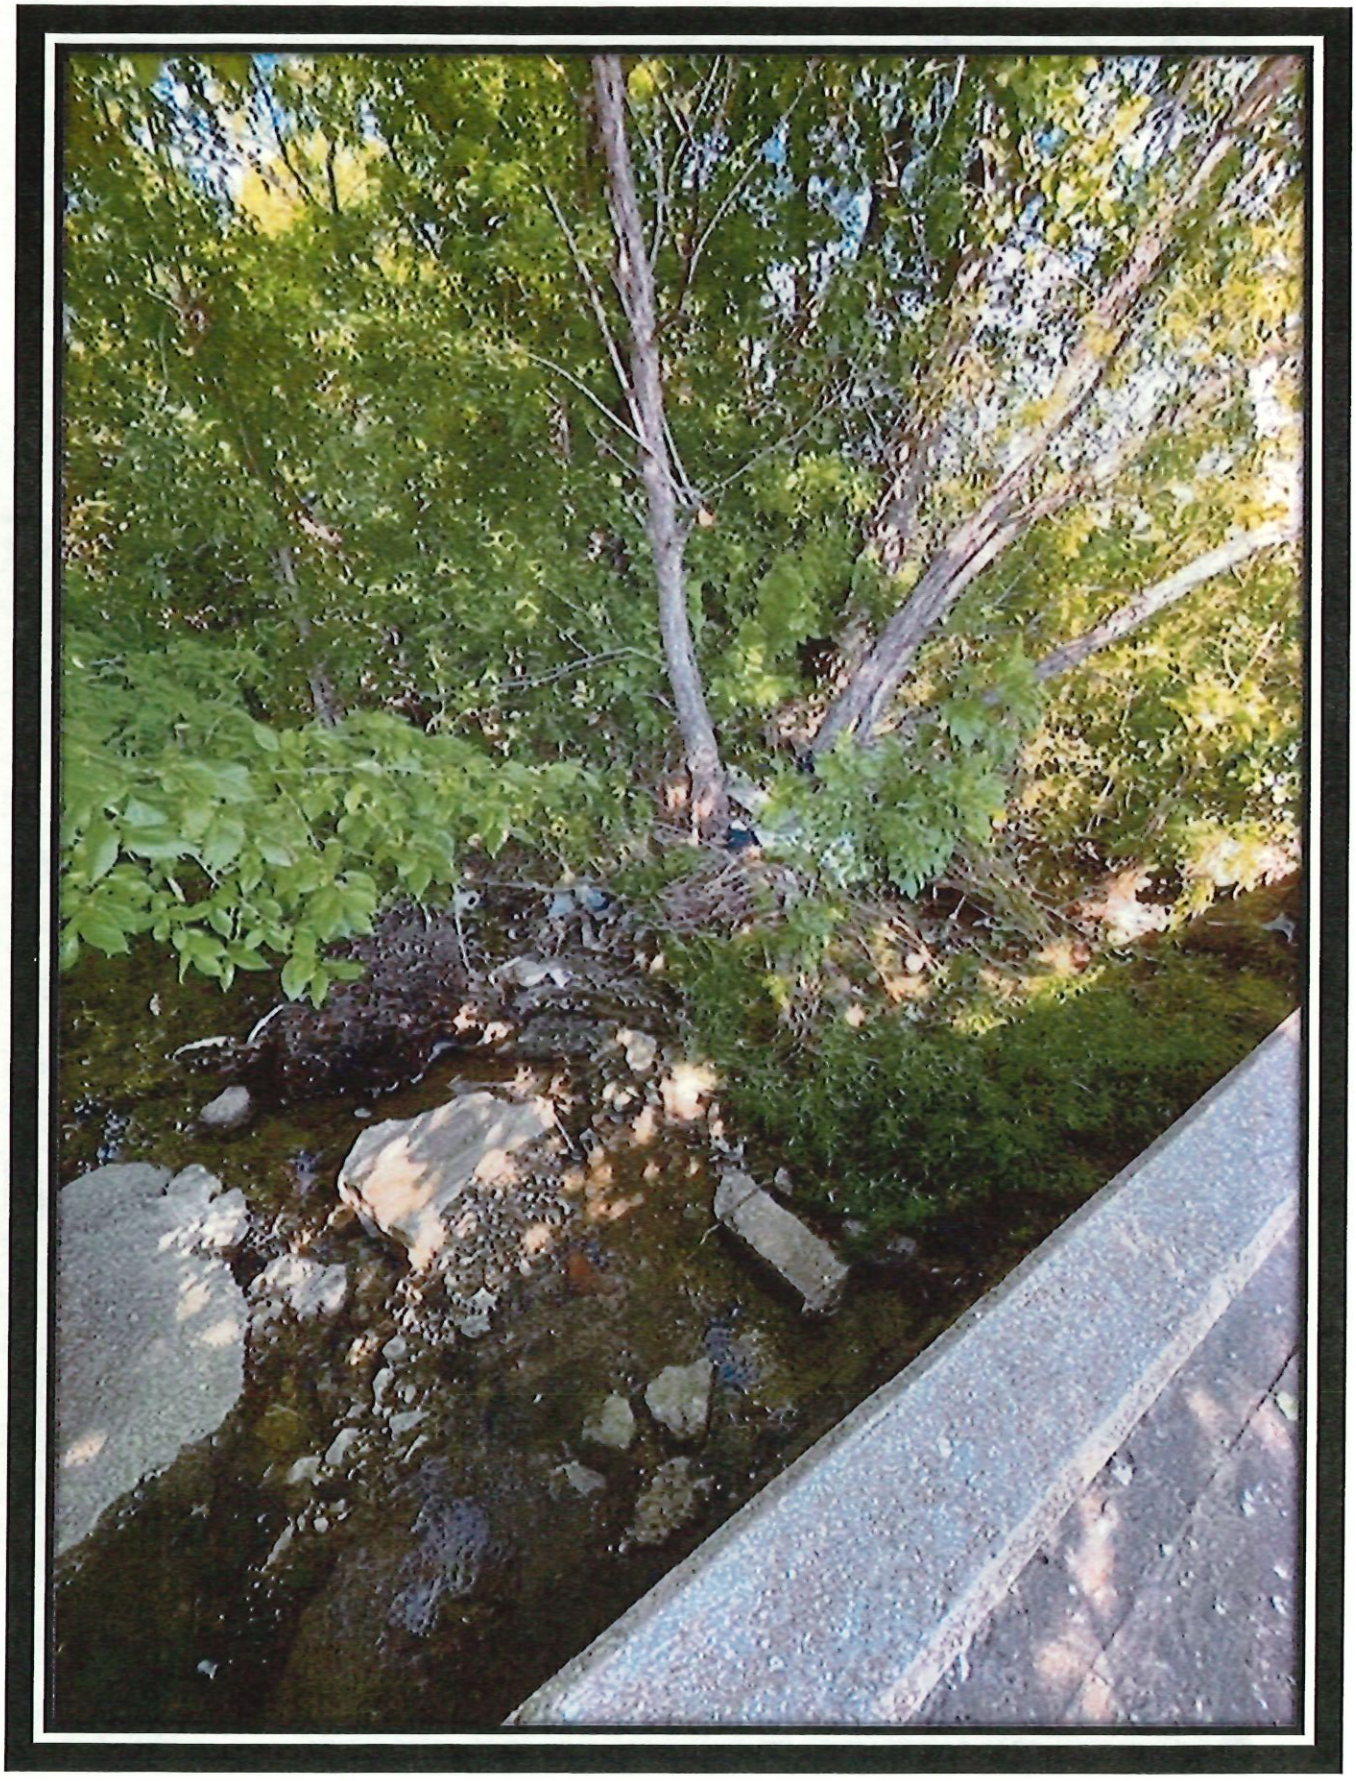
Outfall MC_005 inside the Intramural Fields. Water is clear and flowing. Some trash in the stream. View is to the northwest. 06.07.2024

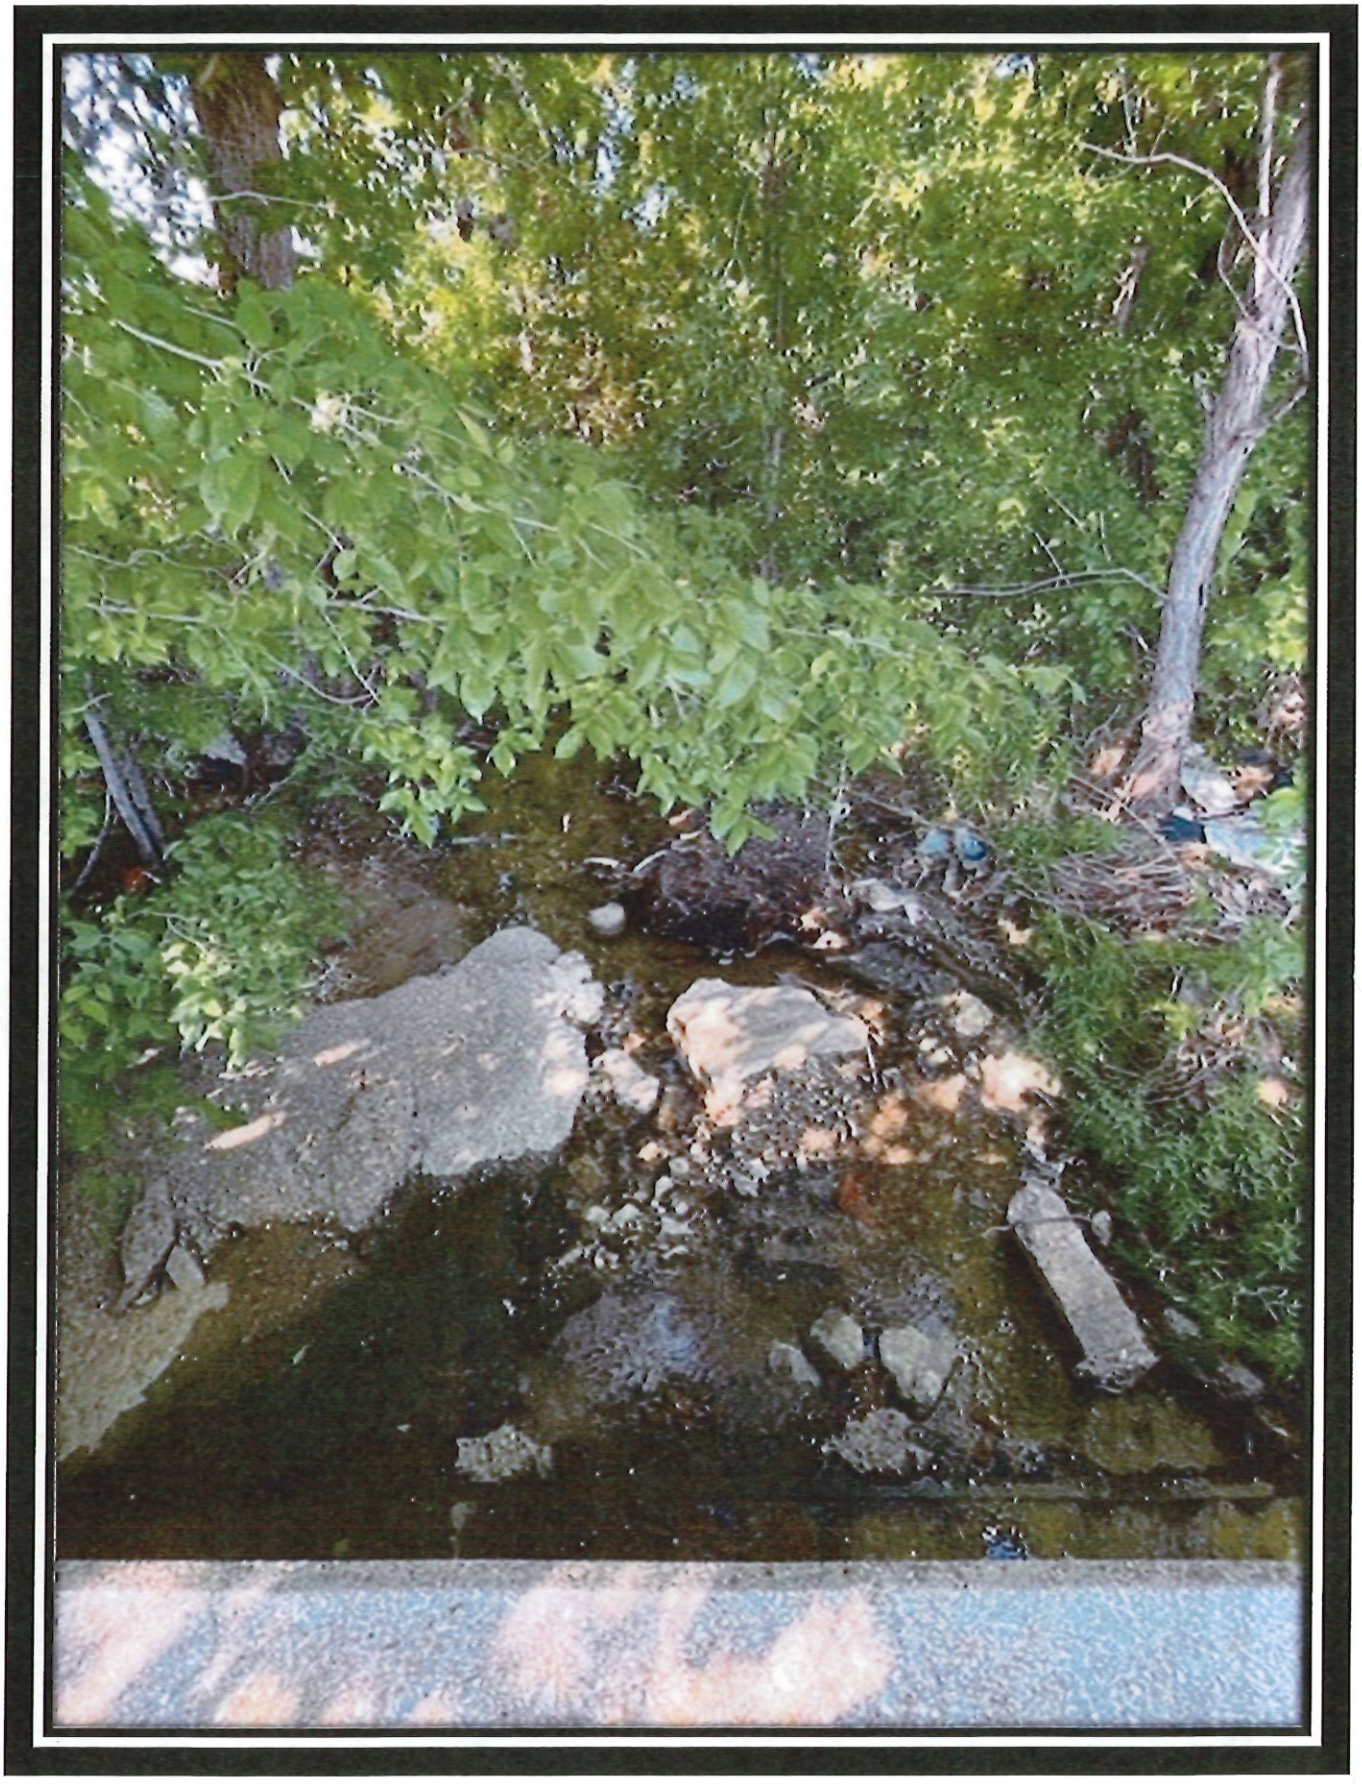
Outfall MC_005 inside the Intramural Fields. Water is clear and flowing. Some trash in the stream. View is to the west. 06.07.2024
