2024 ANNUAL STORMWATER MANAGEMENT REPORT

University of North Texas
1155 Union Circle #311040
Denton, Denton County, Texas
76203-5017

Re: Phase II MS4 Annual Report Transmittal for University of North Texas
TPDES General Permit Authorization: TXR040066

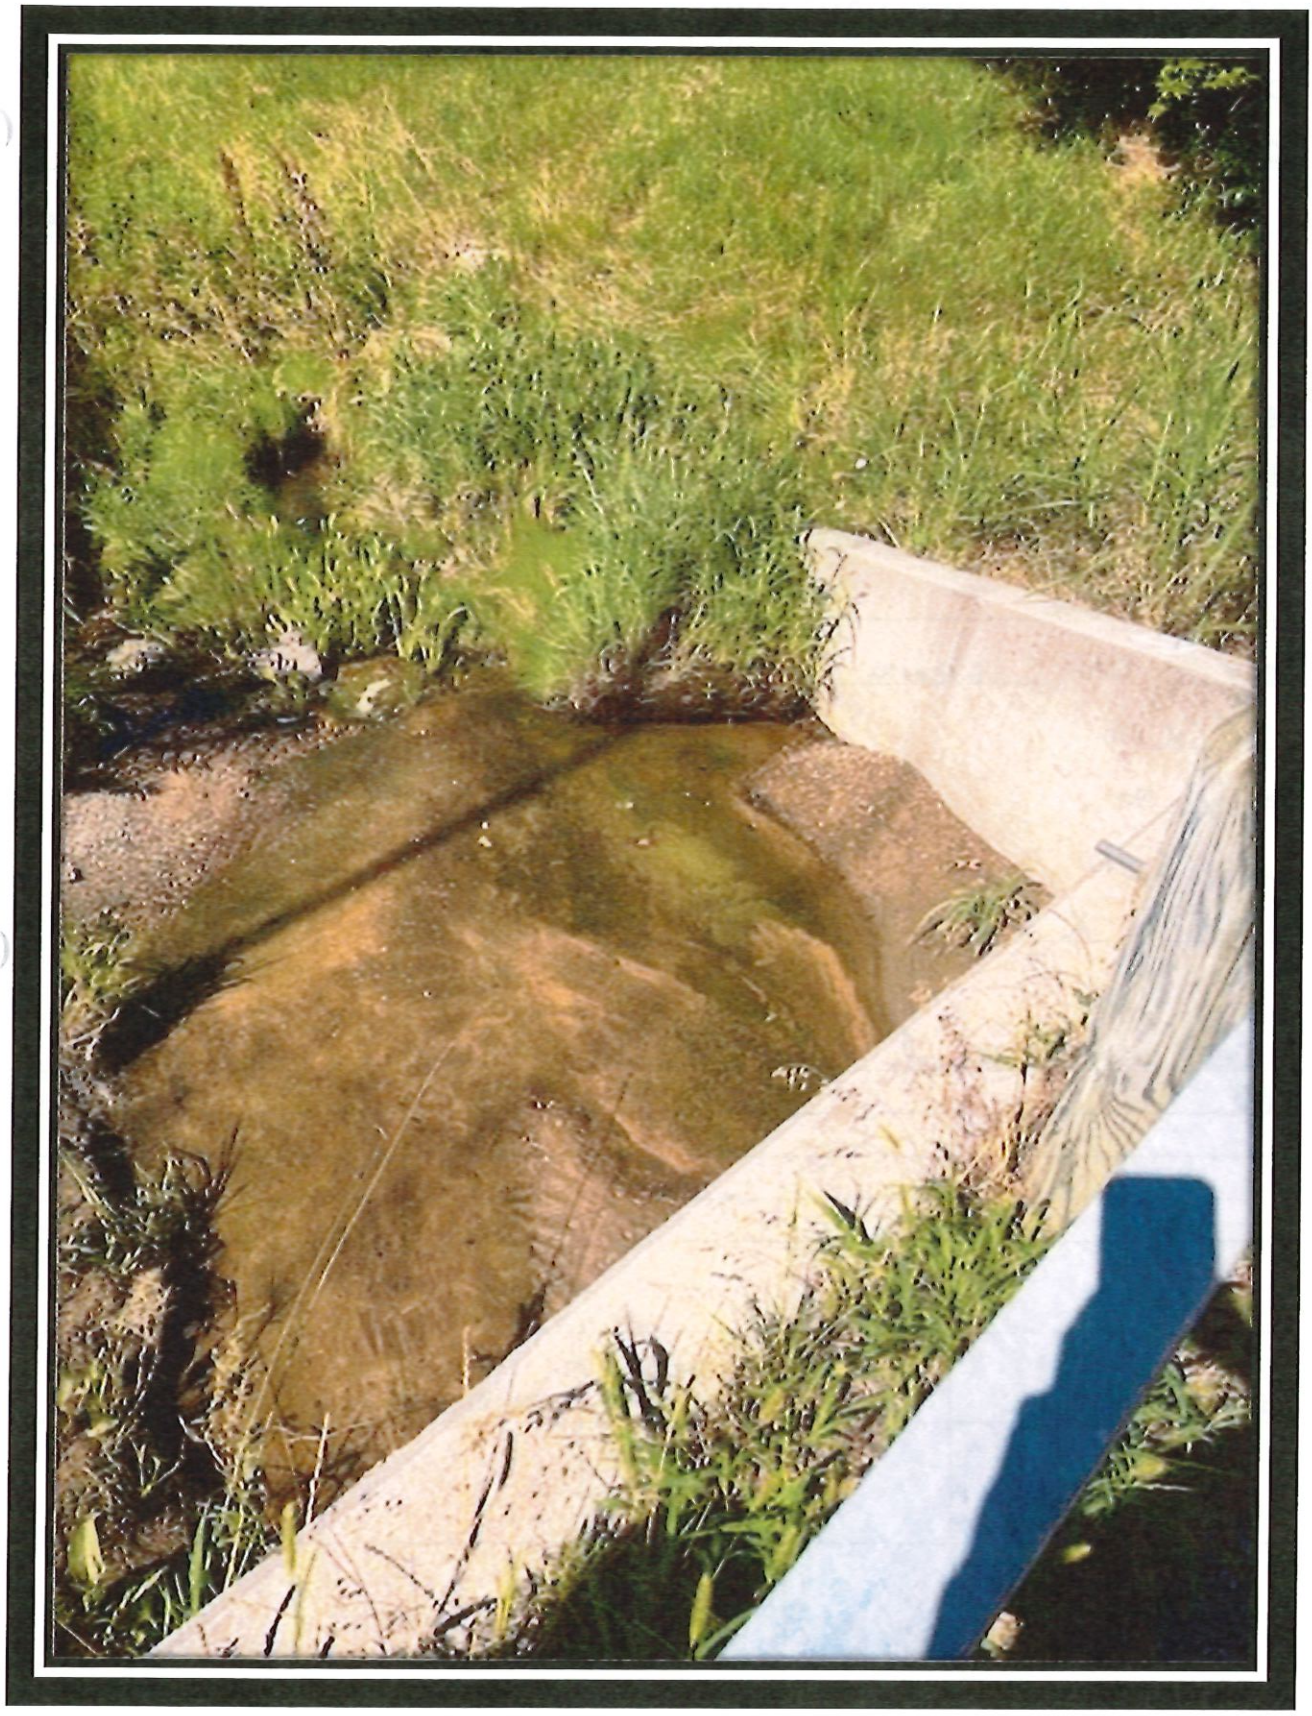
Outfall MGV 003 clear running water in the creek outfall as it passes under the culvert on the south side of Mean Green Village. View is to the southwest. 06.07.2024.

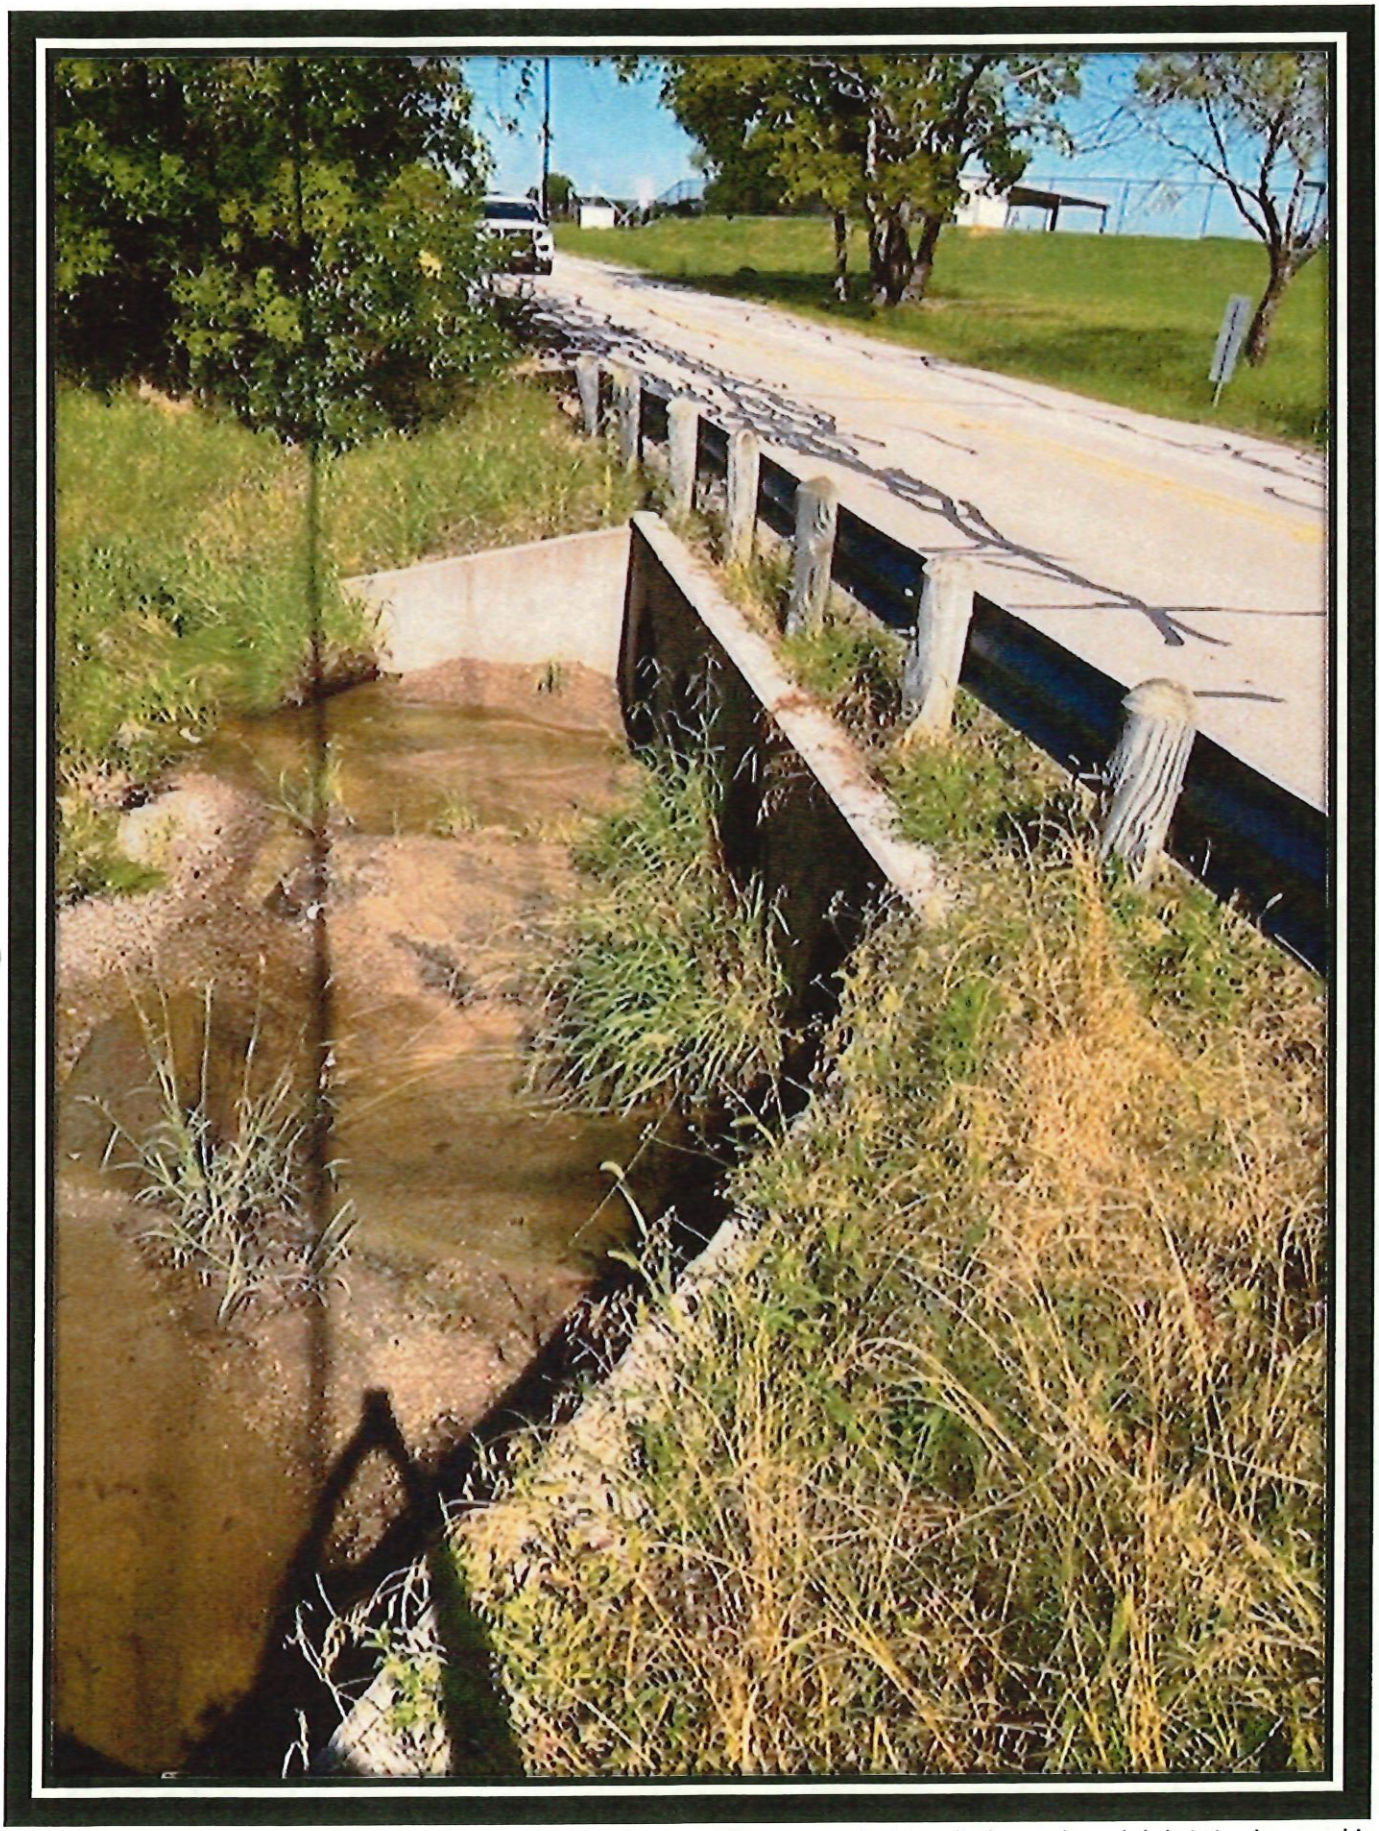
Outfall MGV 003 similar view as the one above only from a different angle. Very little trash and debris is observed in this photo. View is to the west on Willowwood Drive. 06.07.2024

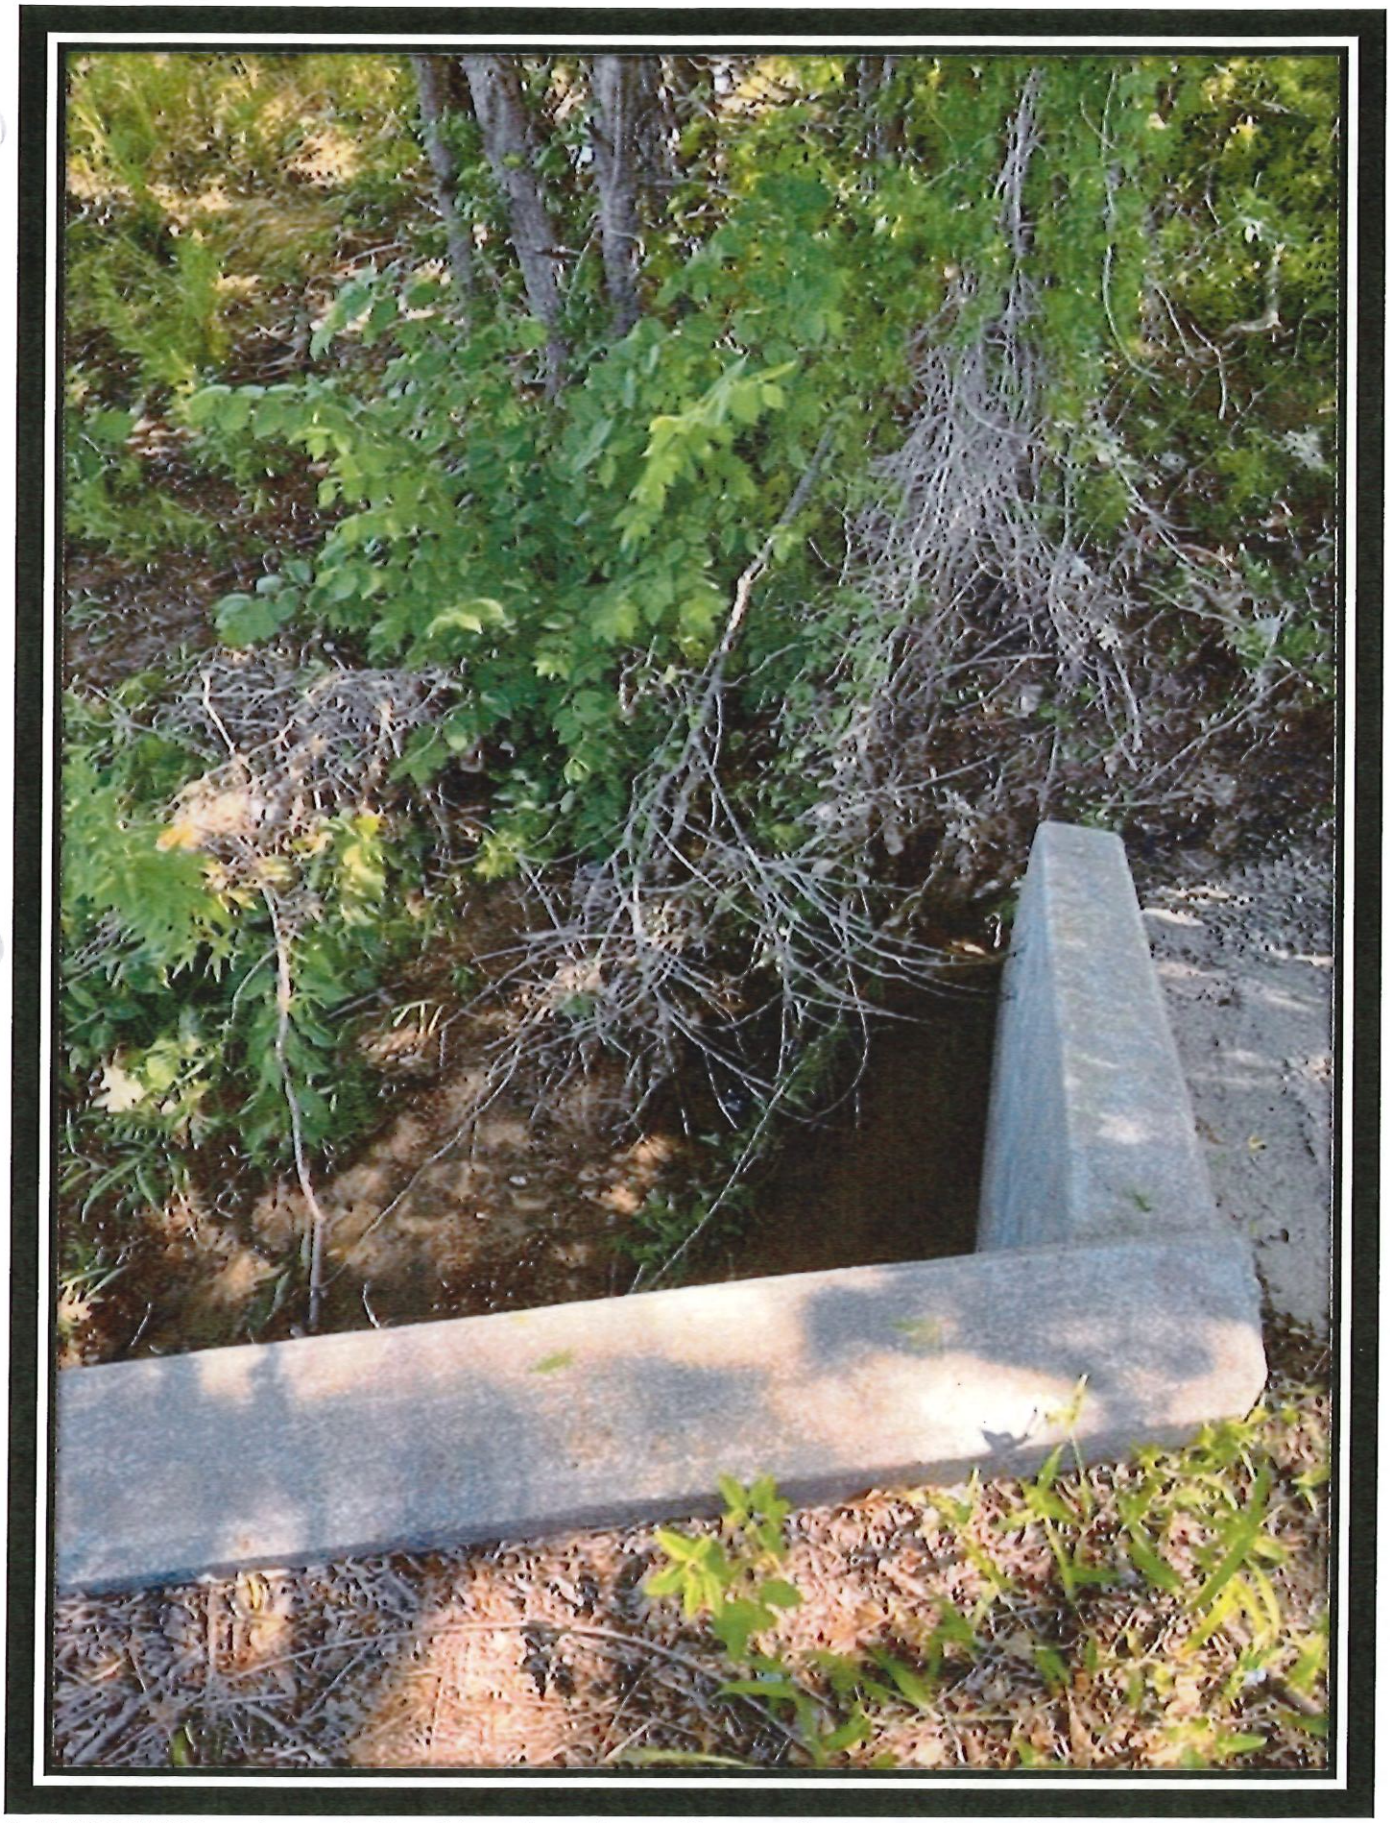
Outfall MGV 003 on the north side of the culvert along Willowwood Drive. Creek is to the right of the photograph flowing under the culvert. View is to the north. 06.07.2024

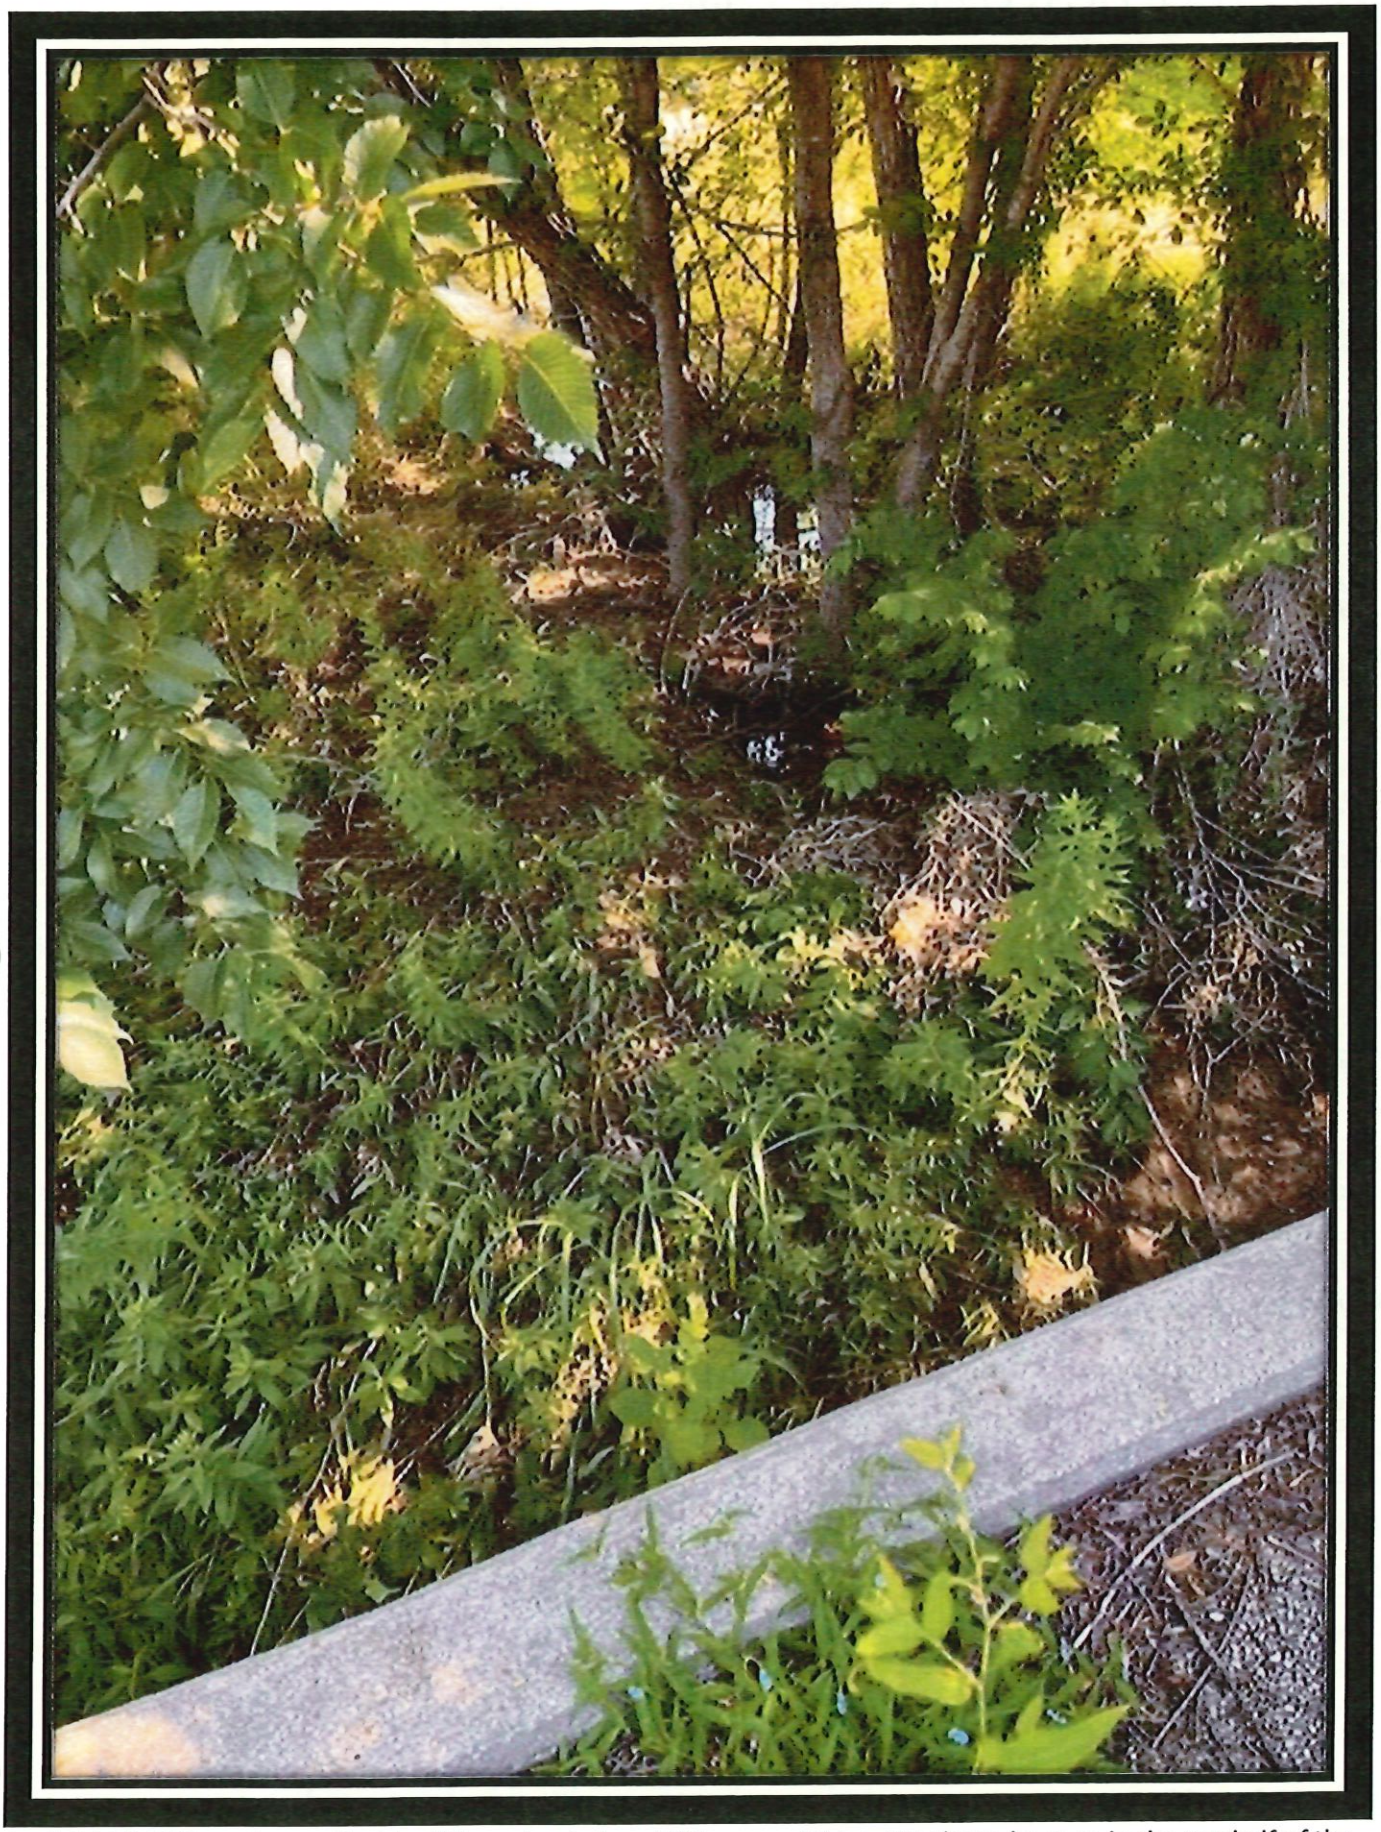
Outfall MGV 003 on the north side of the culvert along Willowwood Drive. Creek can be seen in the top half of the photo. Very little trash, but a lot of vegetation. View is to the north. 06.07.2024

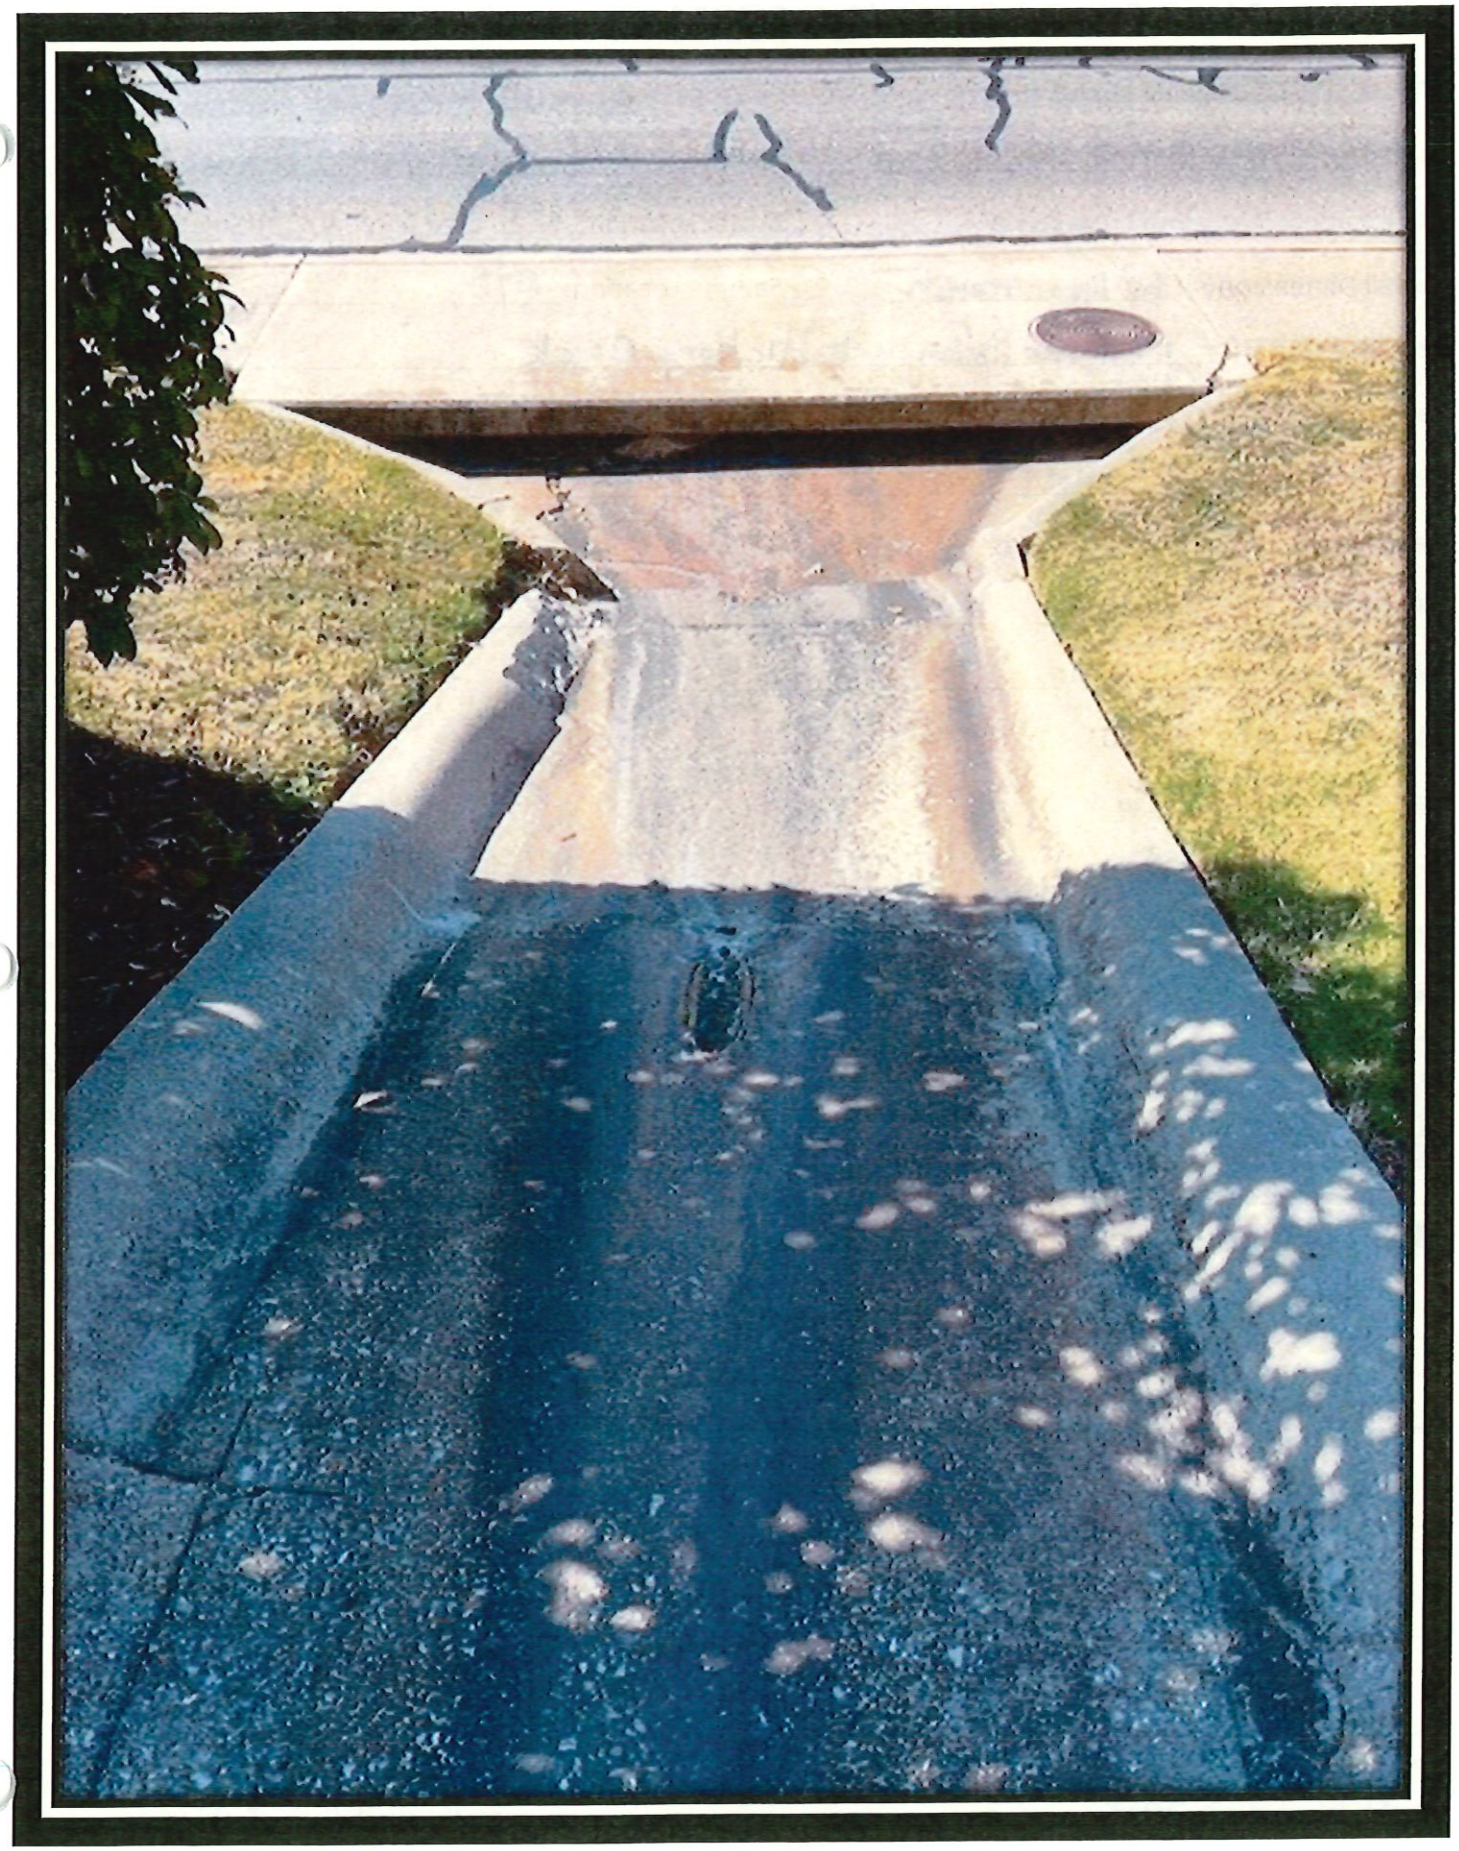
OUT_WHSQ_001: Stormwater curb inlet that captures stormwater flowing from east to west off of Woodhill Square at Teasley Lane. View is to the west.

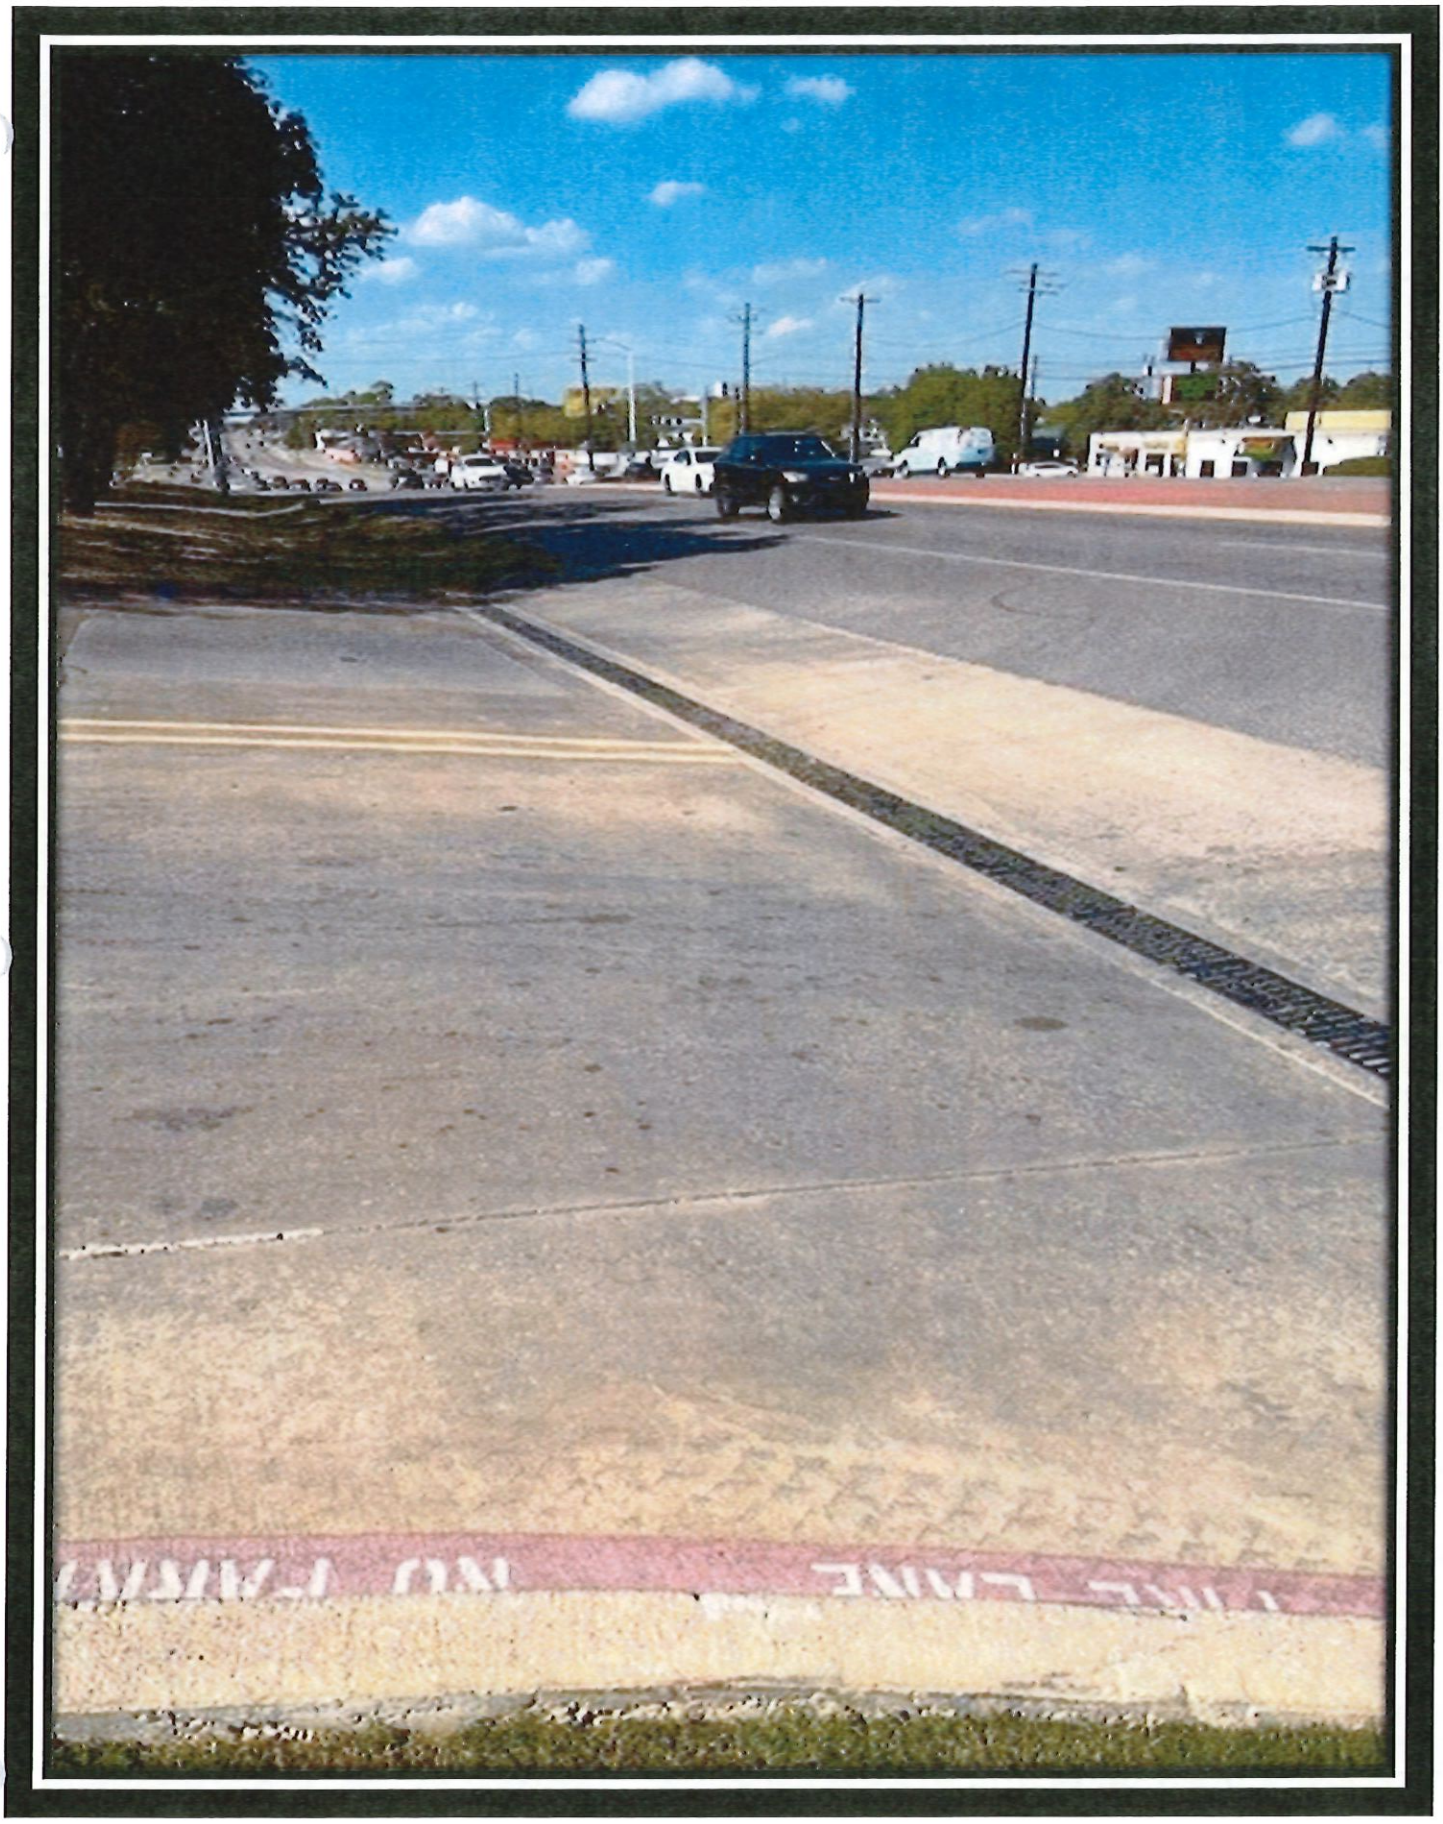
OUT_WHSQ_003: View of the unlined channel in the background where the stormwater grate empties prior to flowing into Fletcher Branch and then into Hickory Creek.

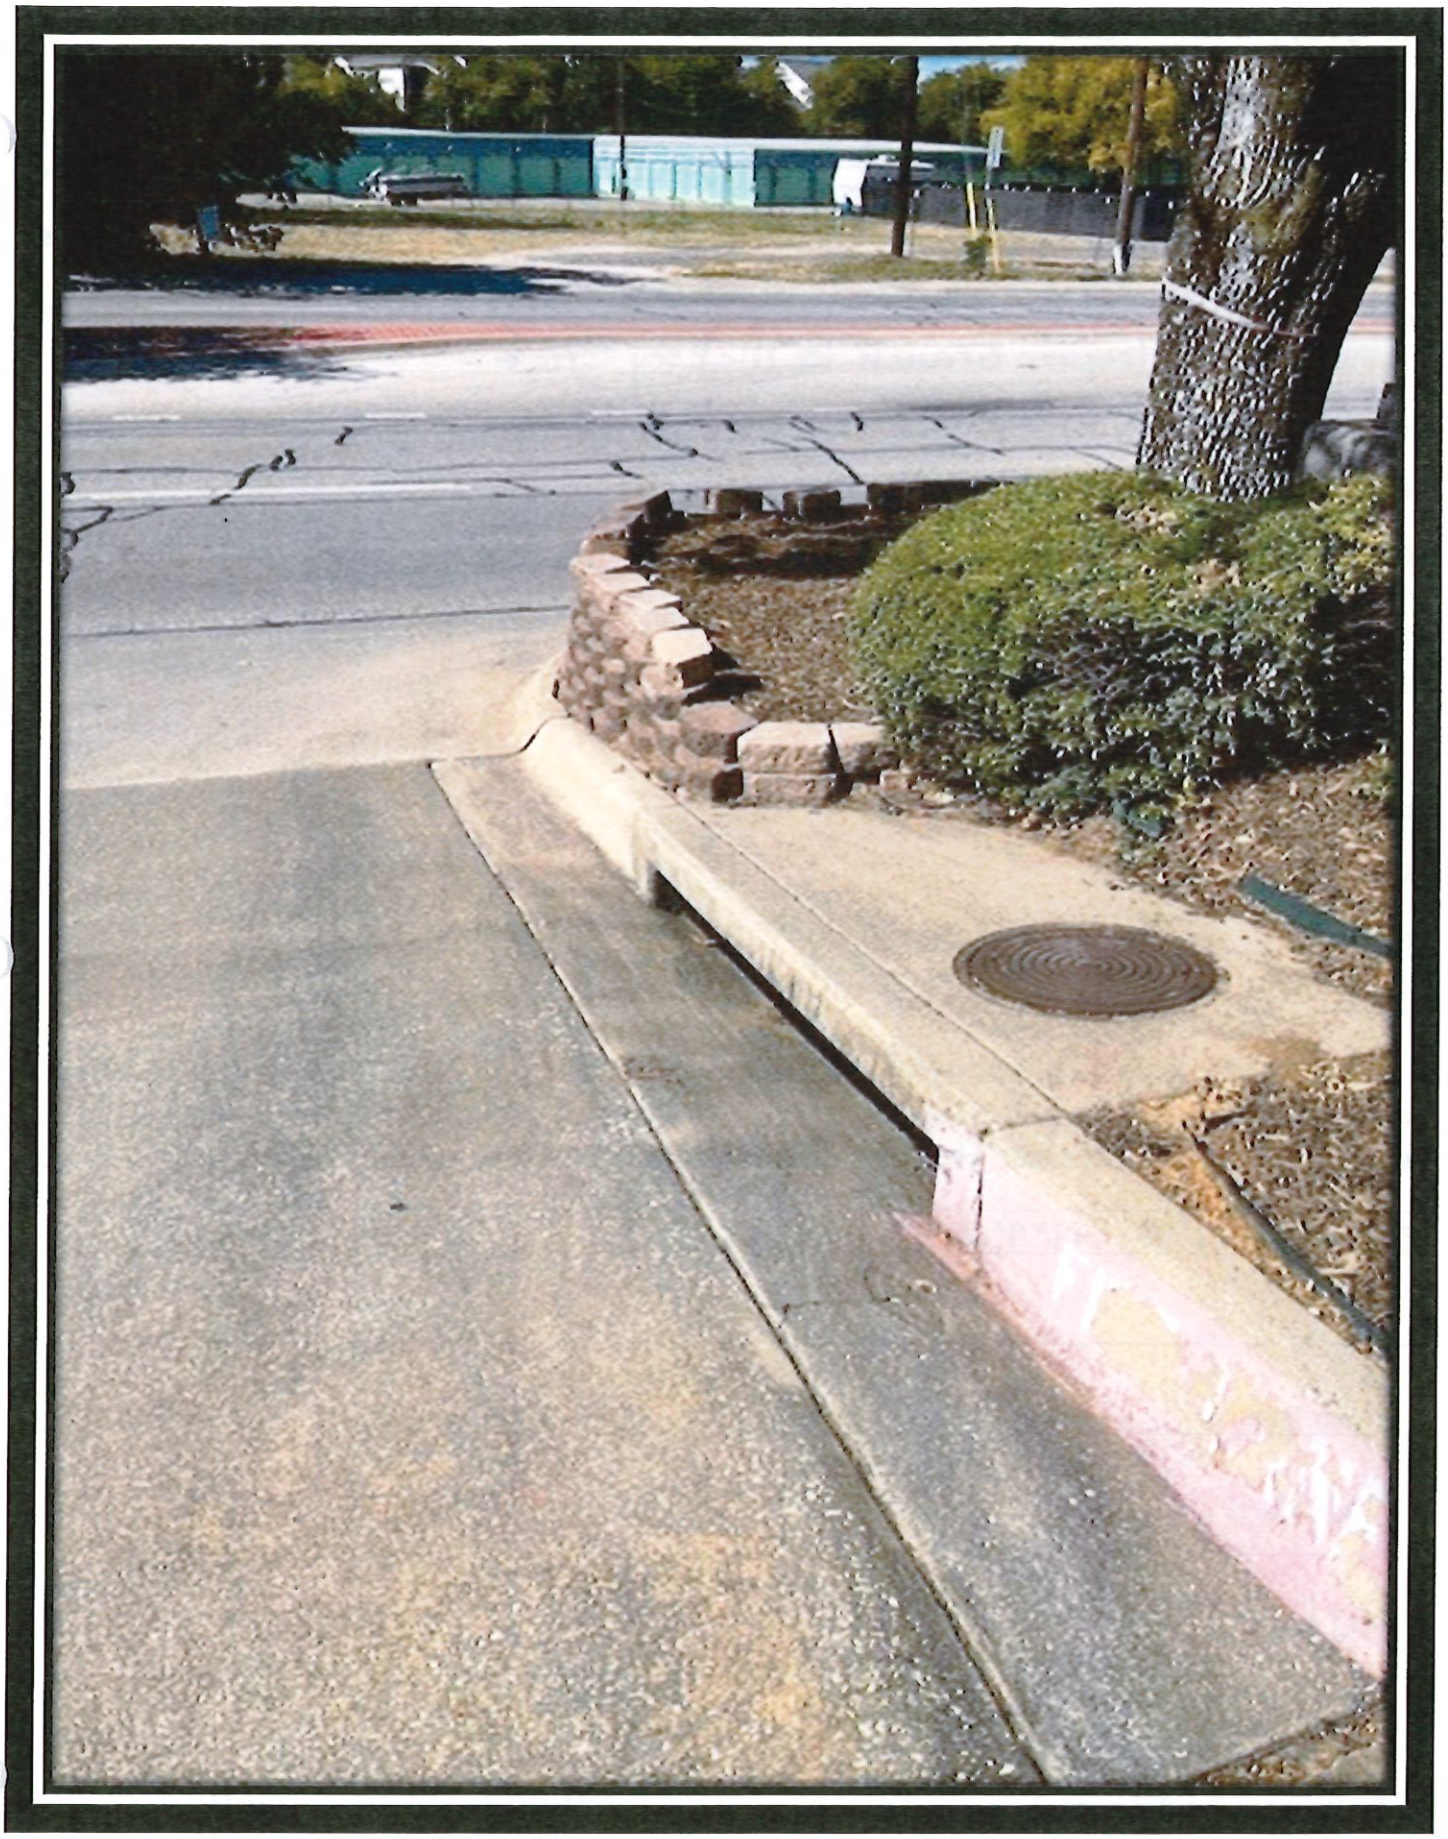
OUT_WHSQ_002: Stormwater curb inlet adjacent to the west driveway entrance to Woodhill Square. Stormwater flows toward the street, Teasley Lane. The slope of the driveway channels flow from this area of the property into the curb inlet.

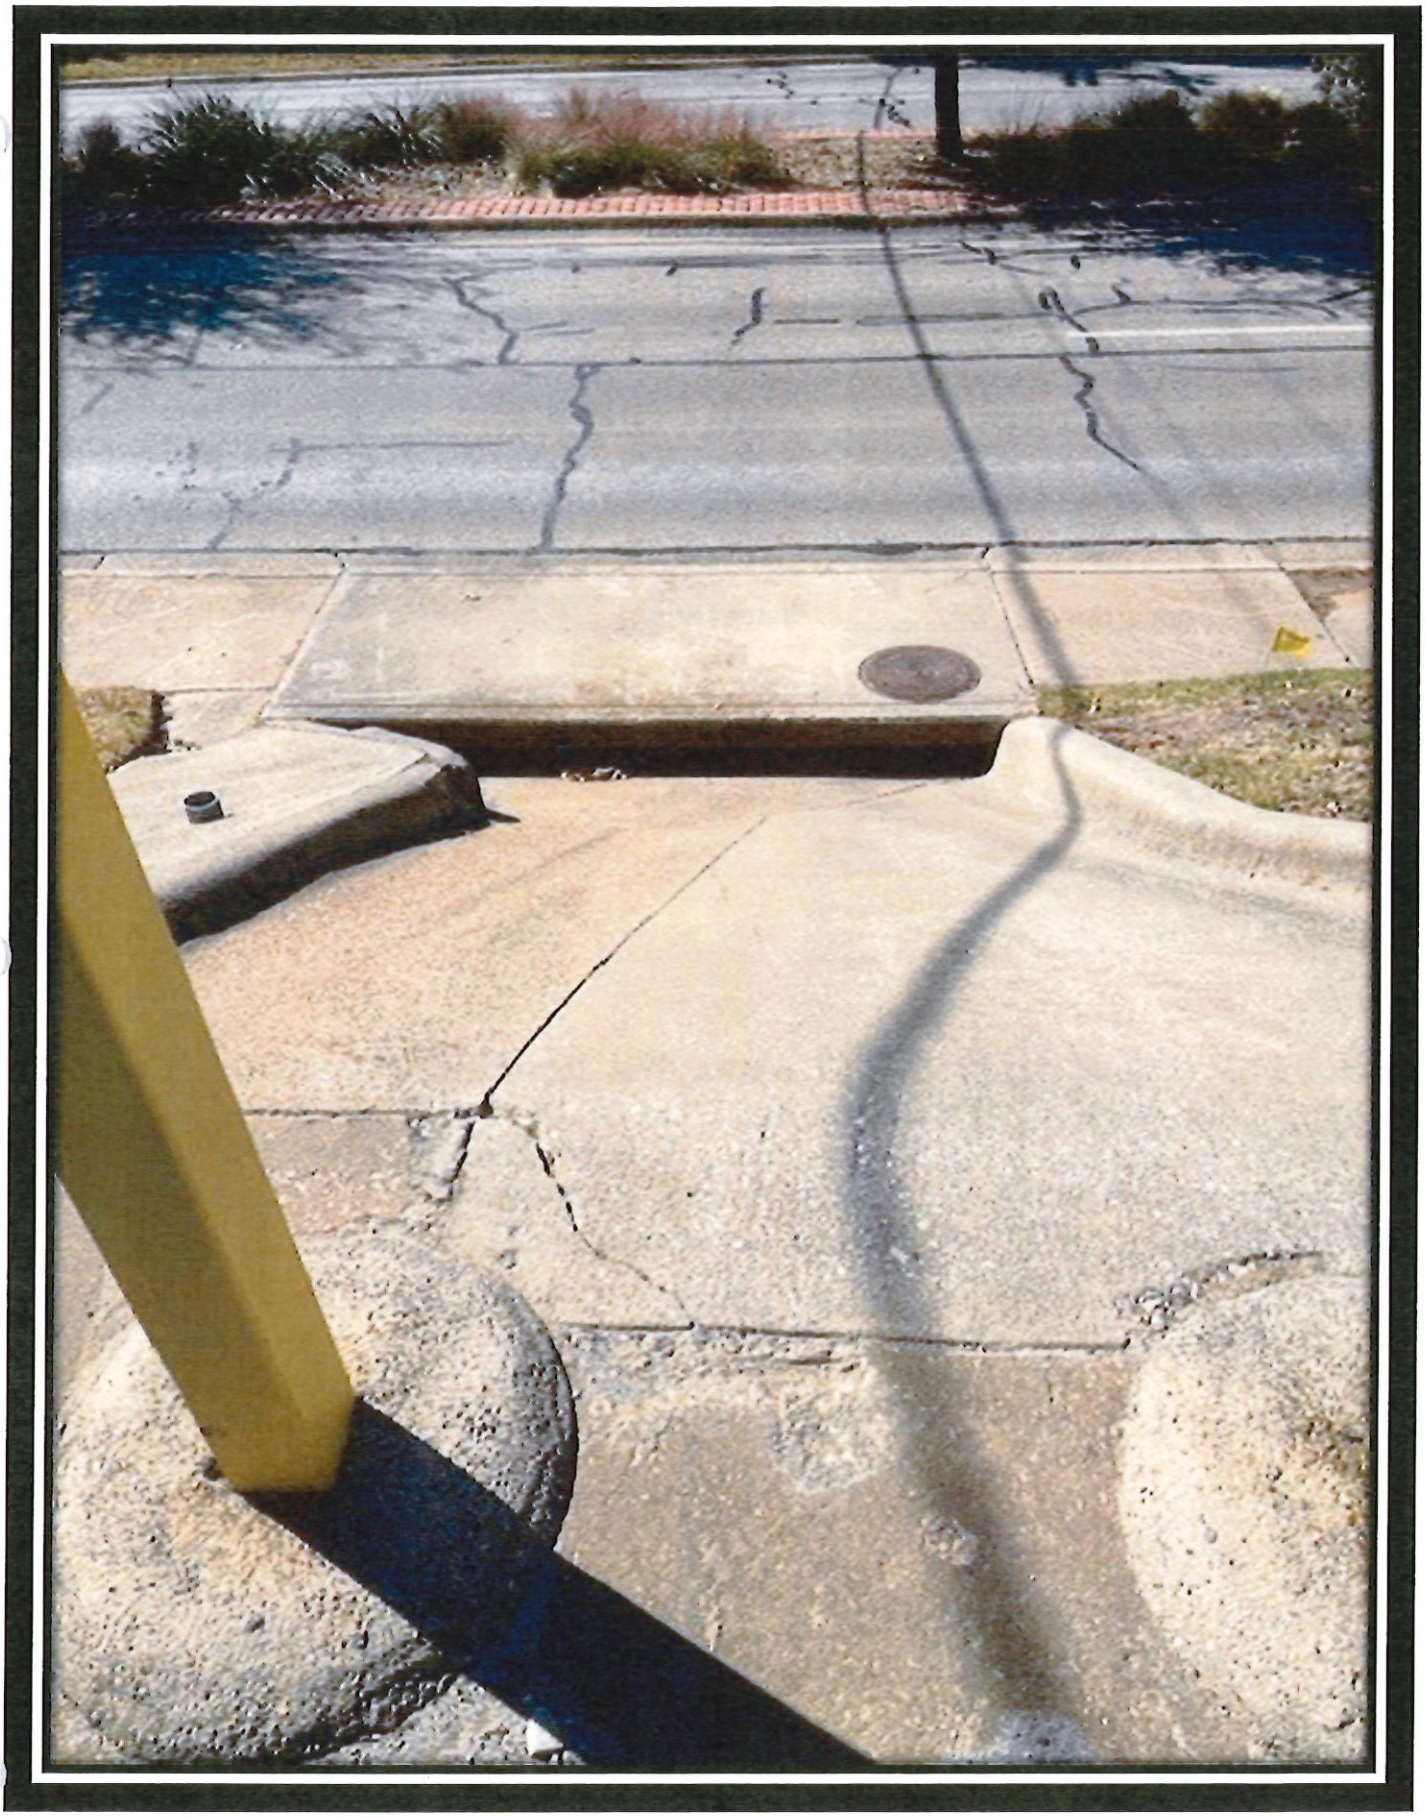
OUT_WHSQ_004: View of stormwater curb inlet where stormwater enters from rainfall and precipitation events from Woodhill Square. The curb inlet is adjacent to Teasley Lane.

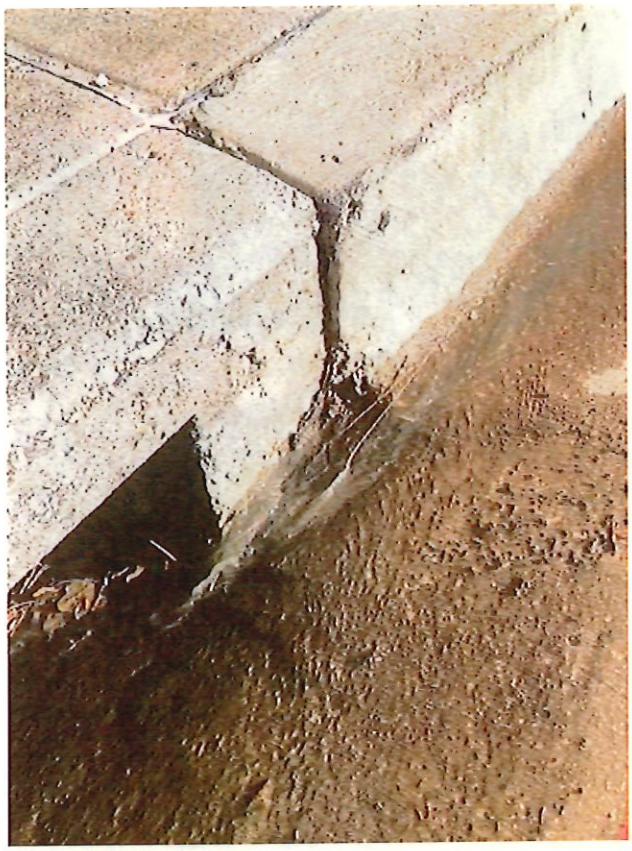
Water at NTB/Chestnut inlet
Ed Carrigan
Nov 21, 2024 10:48 AM

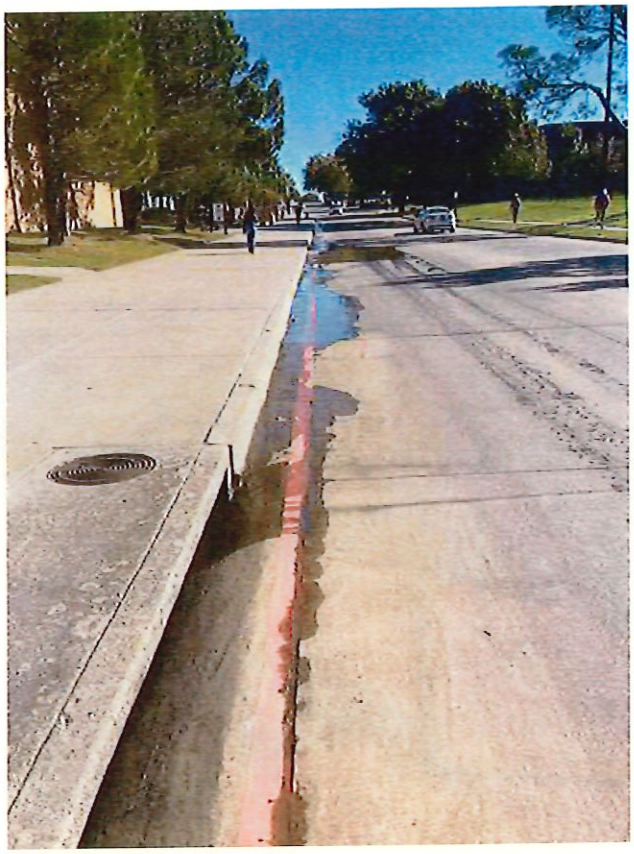
Water from S&T along Chestnut
Ed Carrigan
Nov 21, 2024 10:48 AM

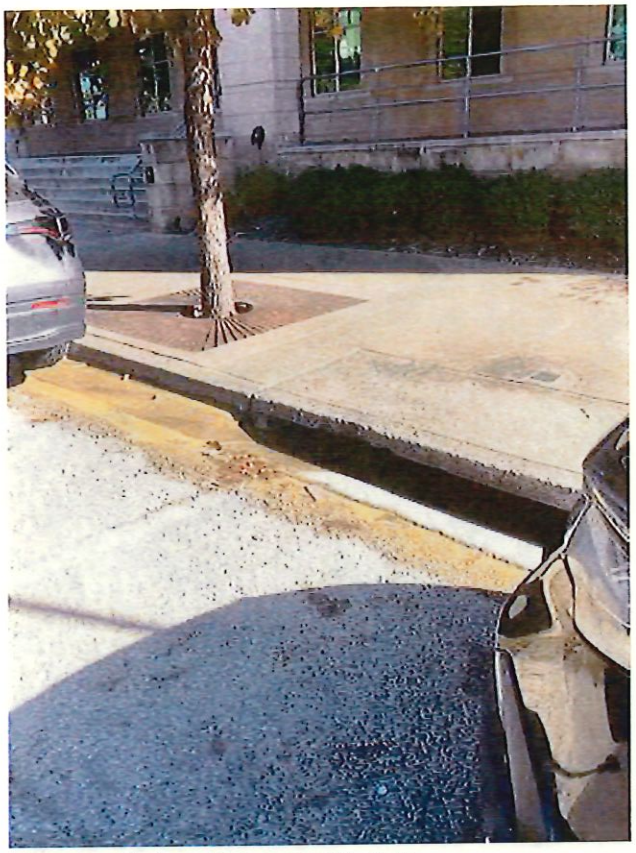
Inlet on Ave D between W. Sycamore/Chestnut
Ed Carrigan
Nov 21, 2024 10:44 AM

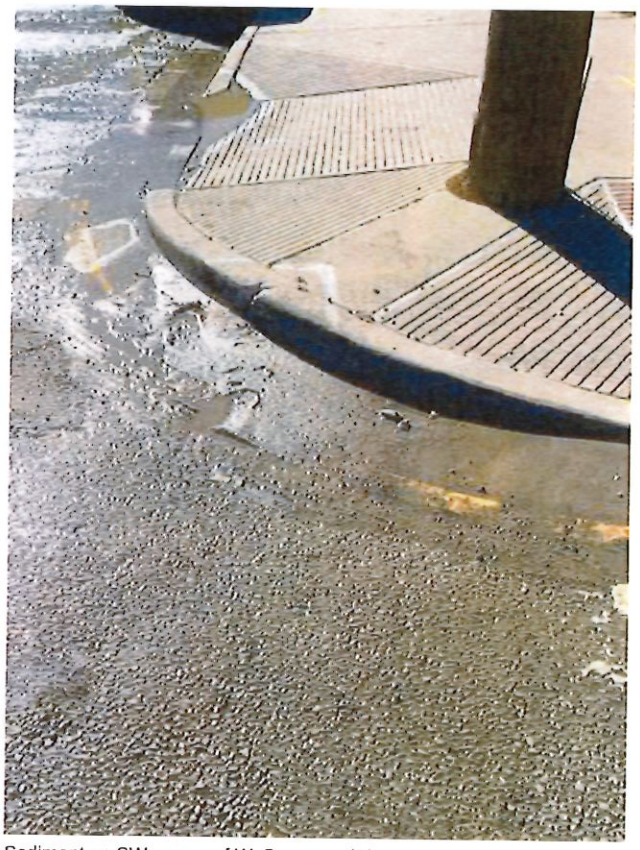
Sediment on SW corner of W. Sycamore/Chestnut
Ed Carrigan
Nov 21, 2024 10:43 AM
