2024 ANNUAL STORMWATER MANAGEMENT REPORT

University of North Texas
1155 Union Circle #311040
Denton, Denton County, Texas
76203-5017

Re: Phase II MS4 Annual Report Transmittal for University of North Texas
TPDES General Permit Authorization: TXR040066

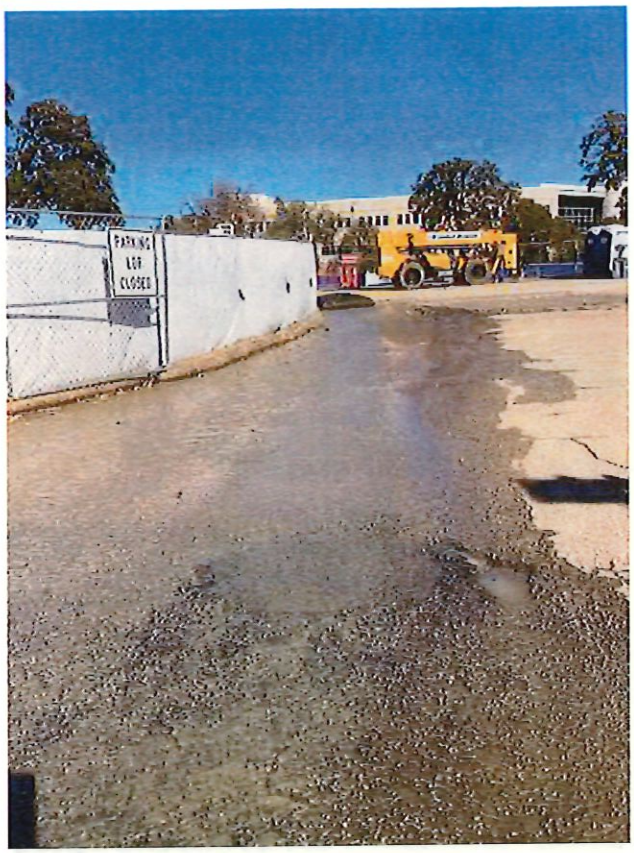
Filter bag
Ed Carrigan
Nov 21, 2024 10:40 AM

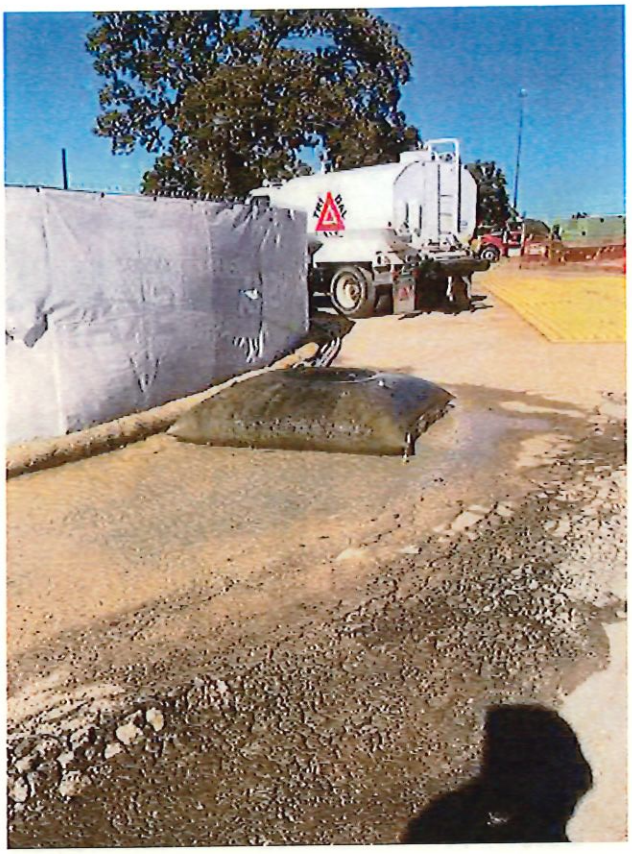
Filter bag
Ed Carrigan
Nov 21, 2024 10:39 AM

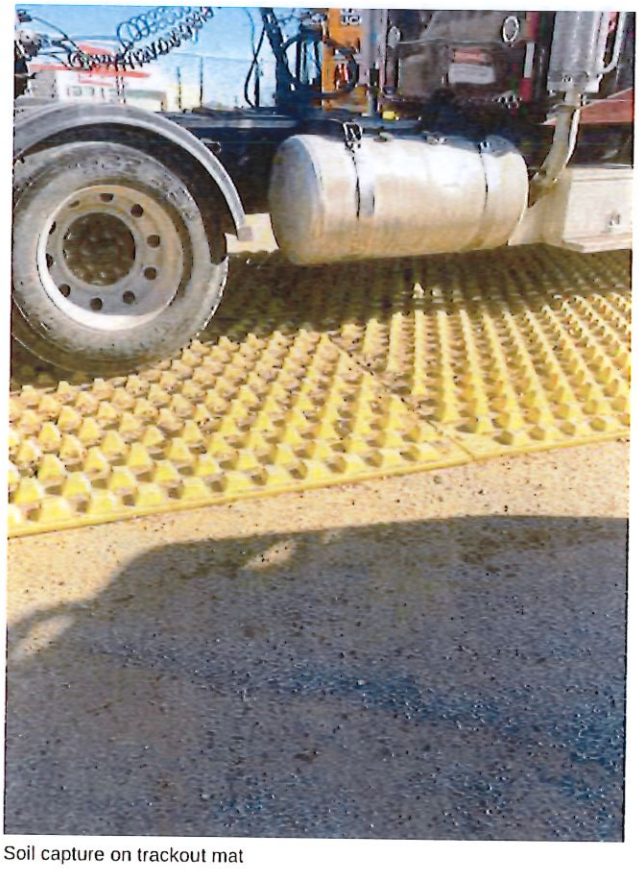
Soil capture on trackout mat
Ed Carrigan
Nov 21, 2024 10:38 AM

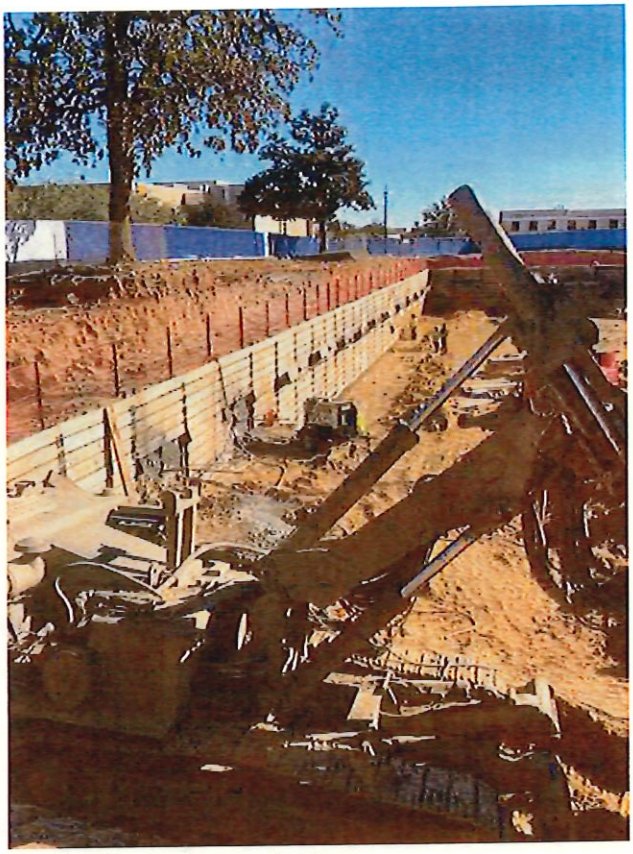
Berkel installing lagging on north side
Ed Carrigan
Nov 21, 2024 10:29 AM

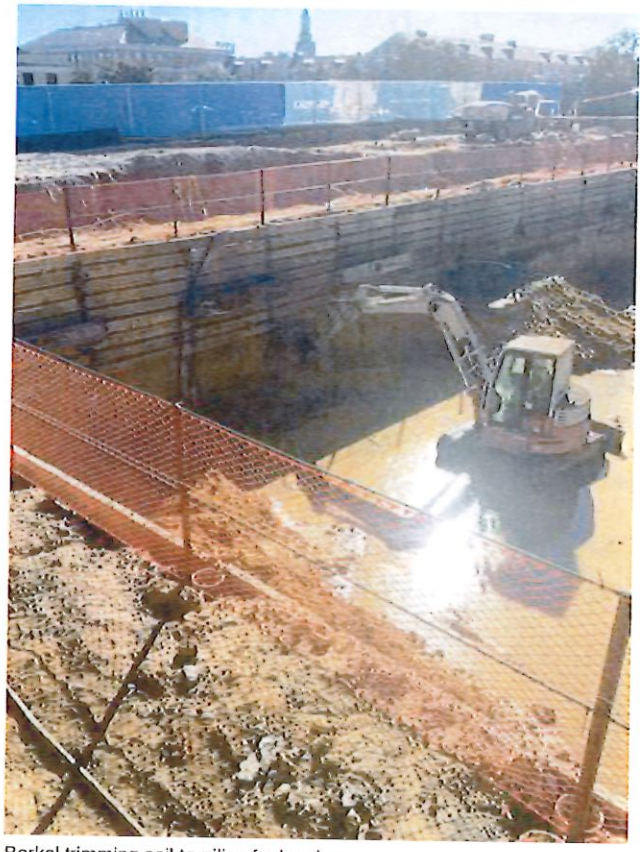
Berkel trimming soil to piling for lagging
Ed Carrigan
Nov 21, 2024 10:26 AM

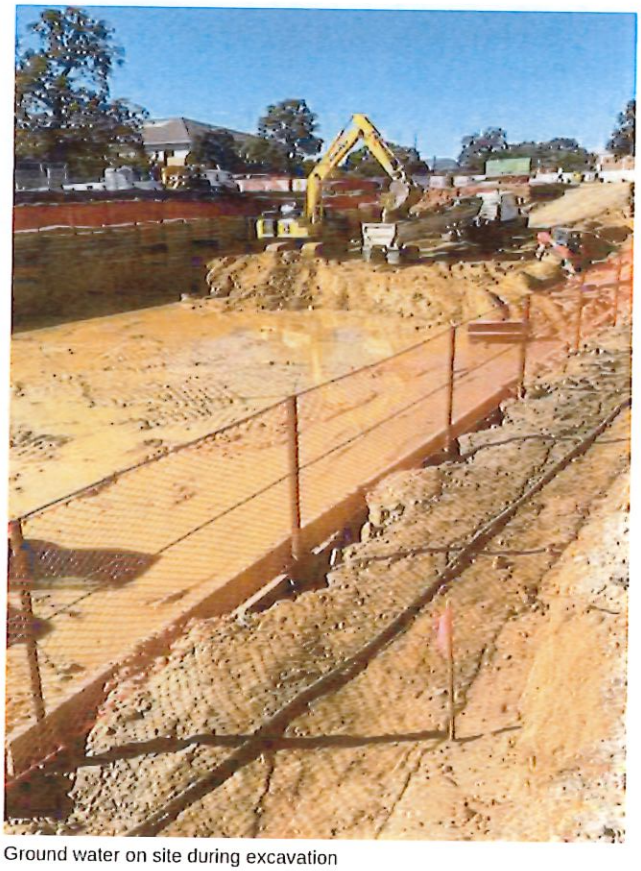
Ground water on site during excavation
Ed Carrigan
Nov 21, 2024 10:26 AM

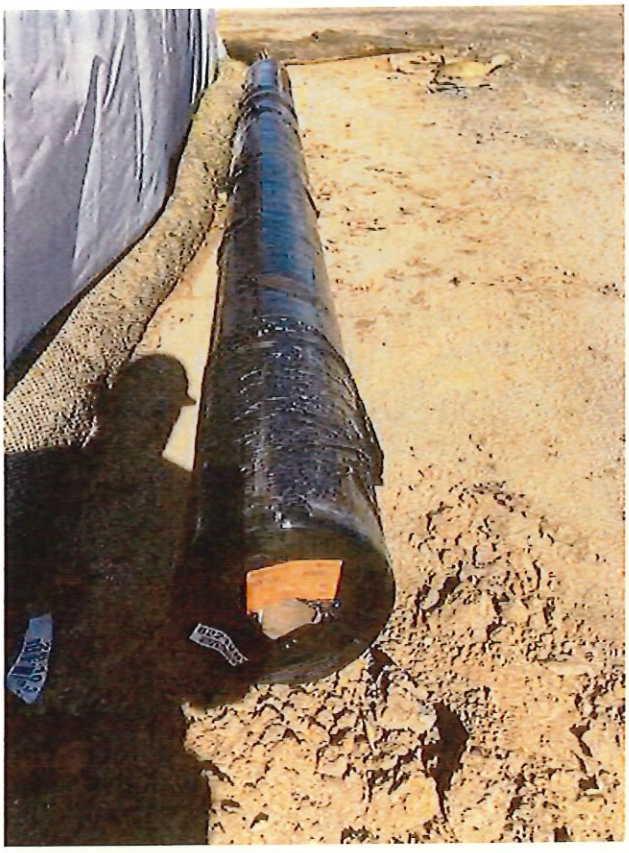
Fabric placed under dry soil being brought in
Ed Carrigan
Dec 11, 2024 12:18 PM

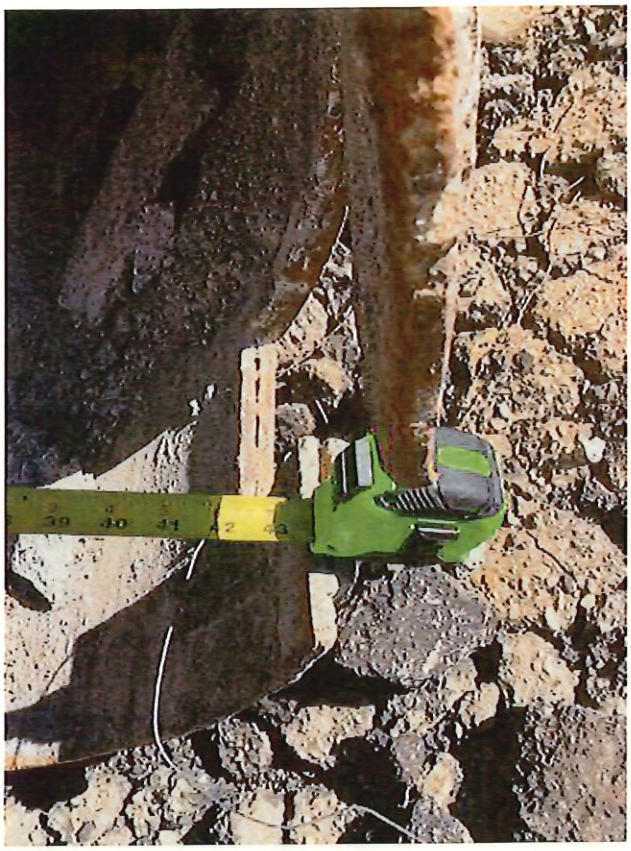
Rough Inside dimension of casing, 43"
Ed Carrigan
Dec 11, 2024 12:14 PM

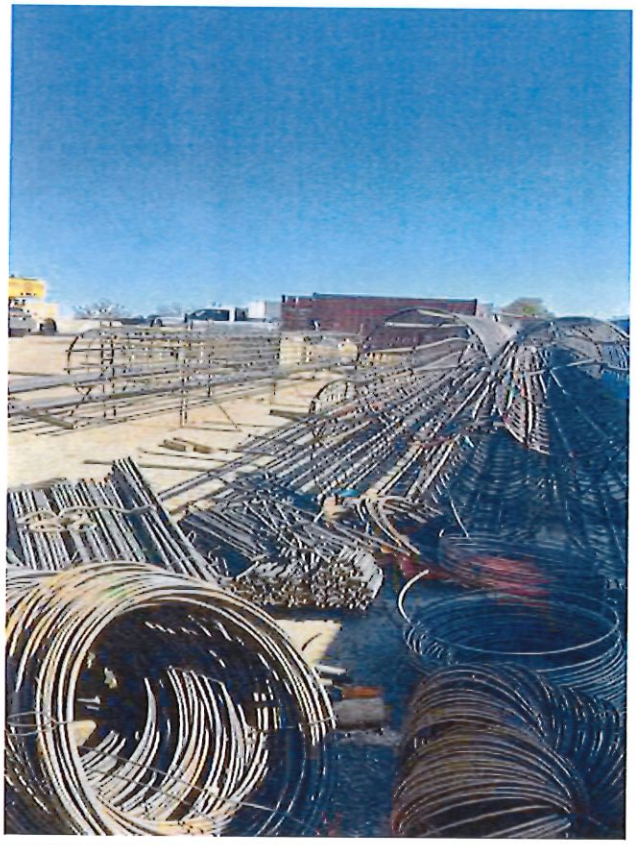
Reinforcement for piers staging/assembly area
Ed Carrigan
Dec 11, 2024 12:12 PM

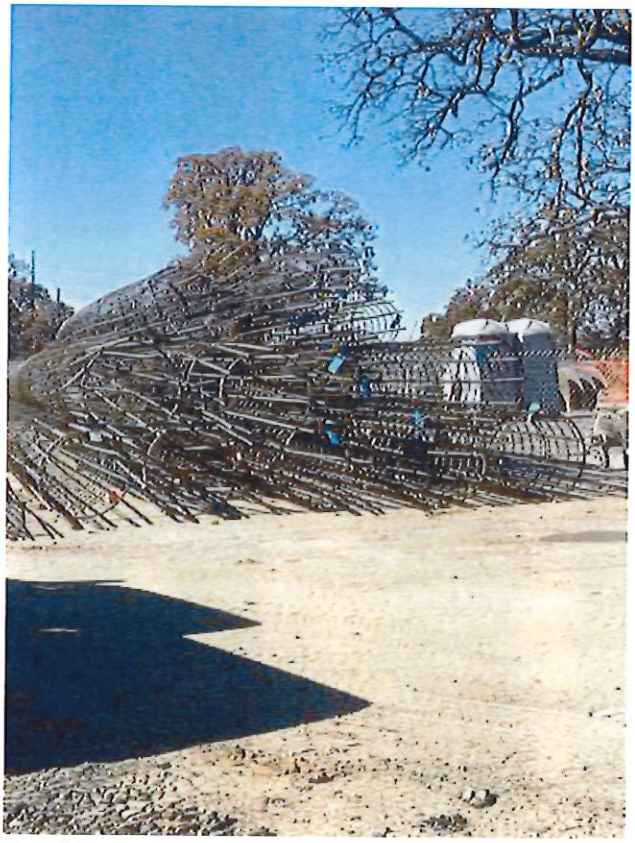
Tied reinforcement cage
Ed Carrigan
Dec 11, 2024 12:09 PM

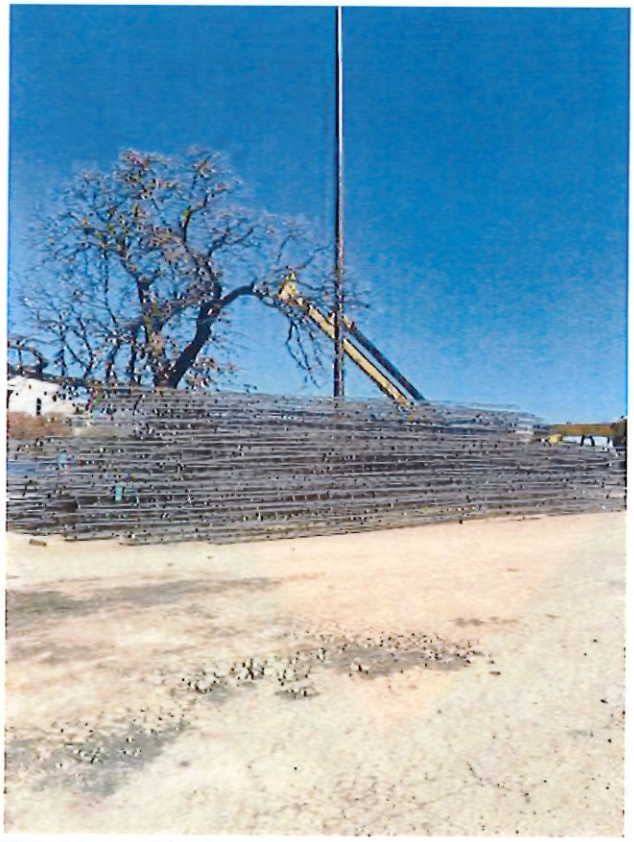
Tied reinforcement for piers
Ed Carrigan
Dec 11, 2024 12:09 PM

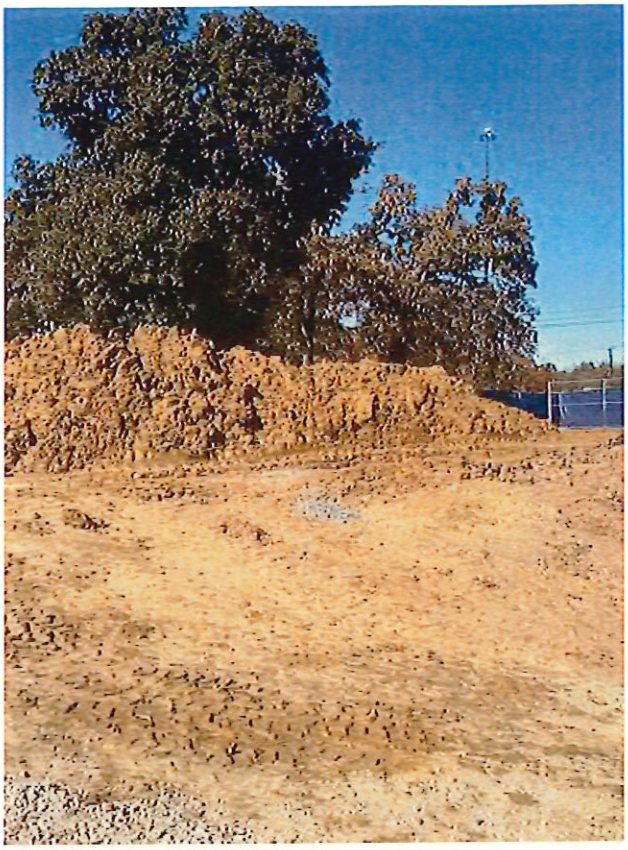
Wet soil staged near W. Mulberry Gate
Ed Carrigan
Dec 11, 2024 12:07 PM

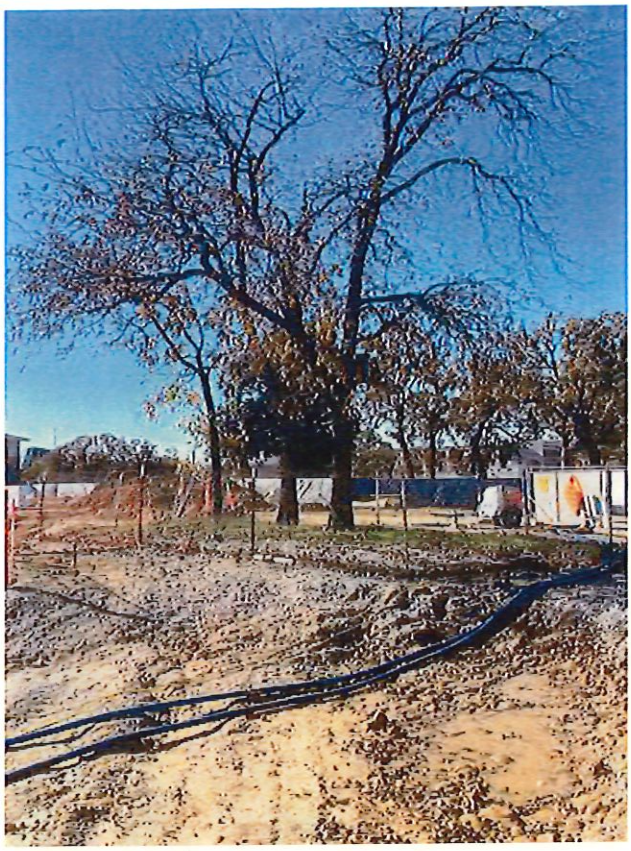
West Trees protected
Ed Carrigan
Dec 11, 2024 12:06 PM

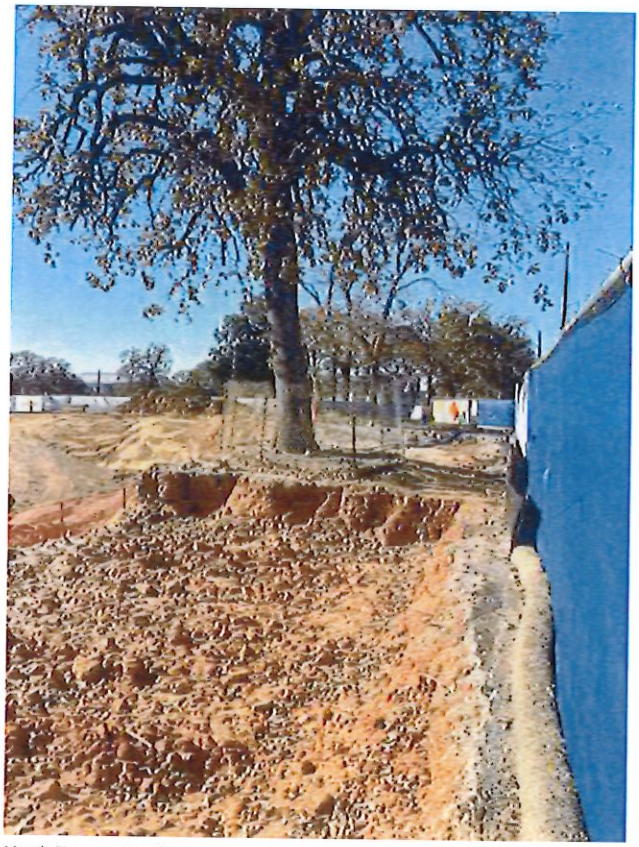
North Tree protection
Ed Carrigan
Dec 11, 2024 12:05 PM

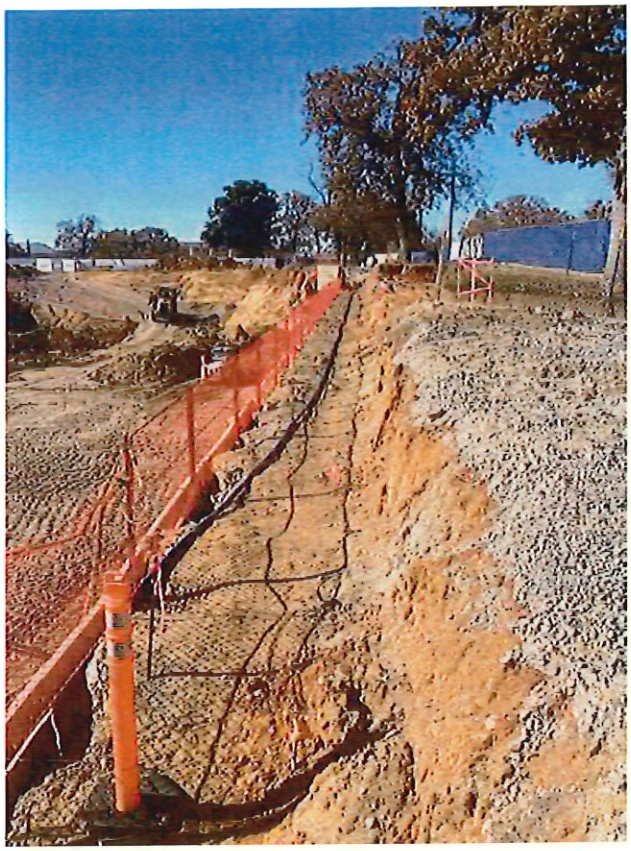
SWPPP measures at W. Mulberry and Ave. C
Ed Carrigan
Dec 11, 2024 12:03 PM

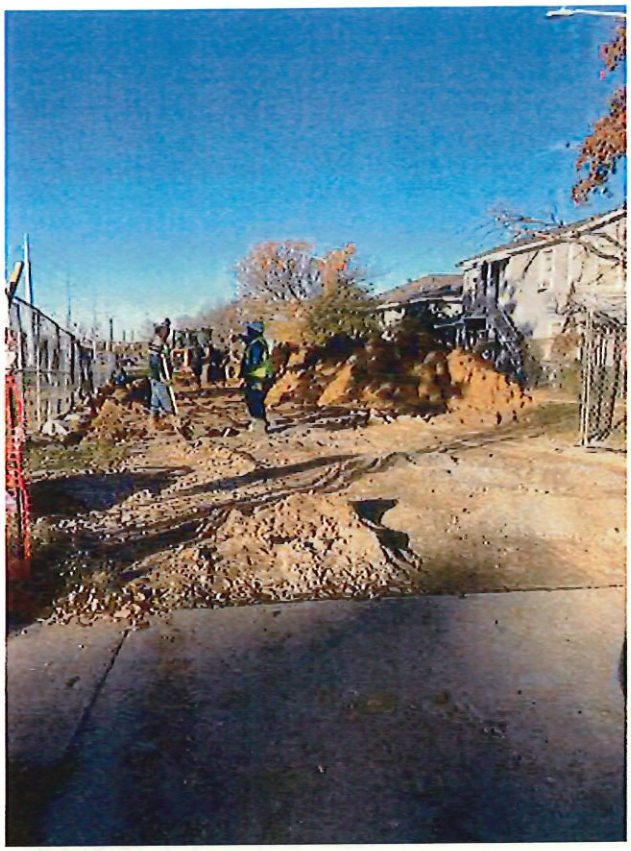
Wet soil staging on NE Corner of College Inn Demo
Ed Carrigan
Dec 11, 2024 8:38 AM

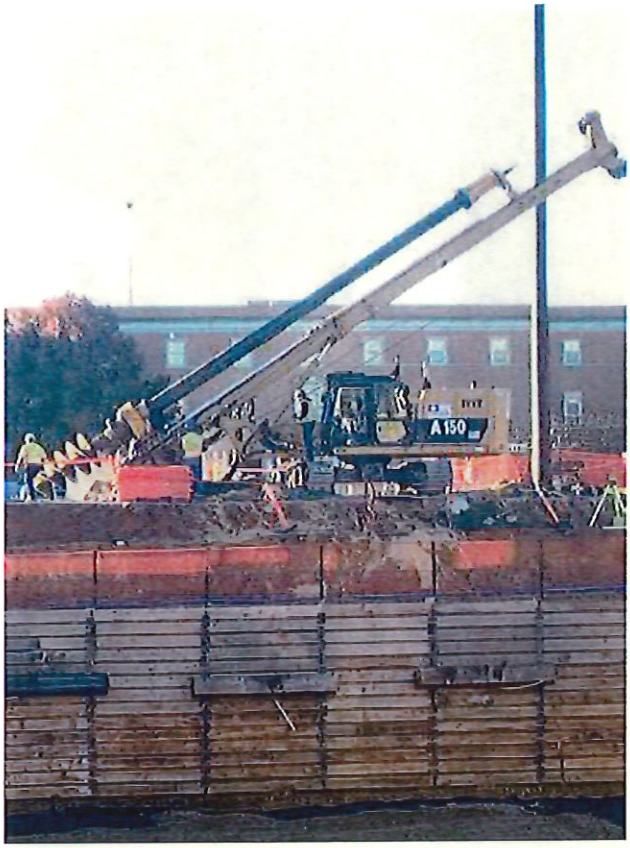
12.11, 8:12 am drill rig offline
Ed Carrigan
Dec 11, 2024 8:12 AM

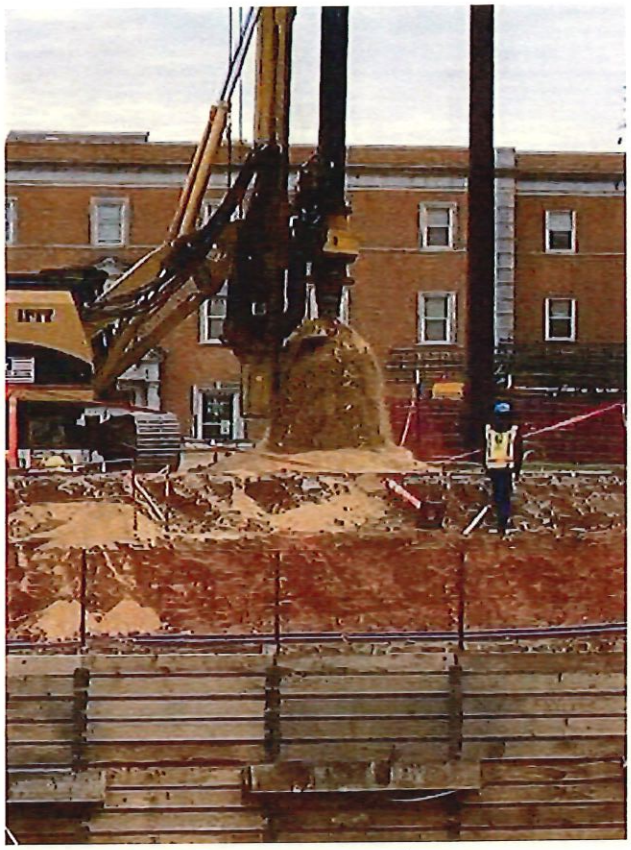
Tues.12.10 Operator spins auger to remove soil
Ed Carrigan
Dec 10, 2024 11:44 AM

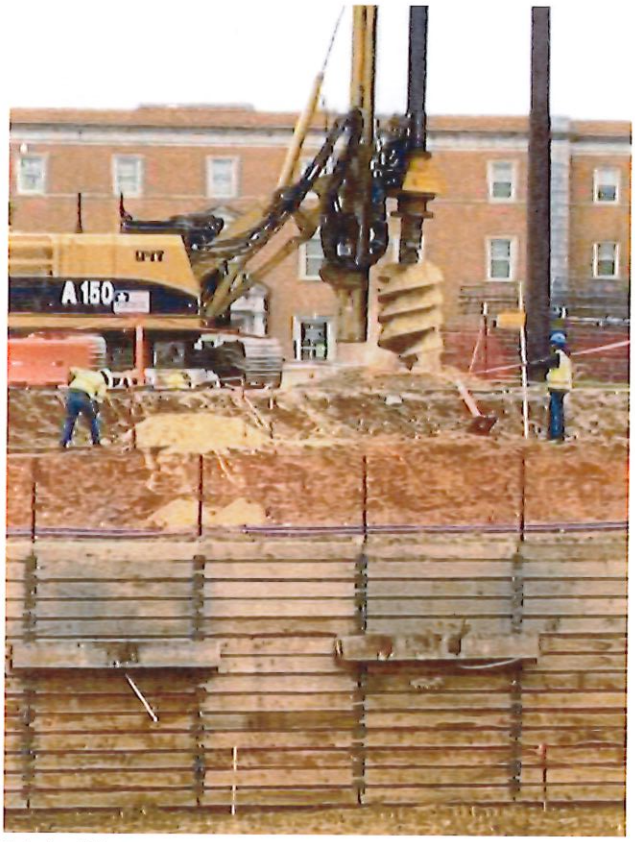
1st pier drilling
Ed Carrigan
Dec 10, 2024 11:42 AM
