# **2025 ANNUAL STORMWATER MANAGEMENT REPORT**

University of North Texas  
1155 Union Circle #311040  
Denton, Denton County, Texas  
76203-5017

Re: Phase II MS4 Annual Report Transmittal for University of North Texas  
TPDES General Permit Authorization: TXR040066

## Phase II (Small) MS4 Annual Report Form

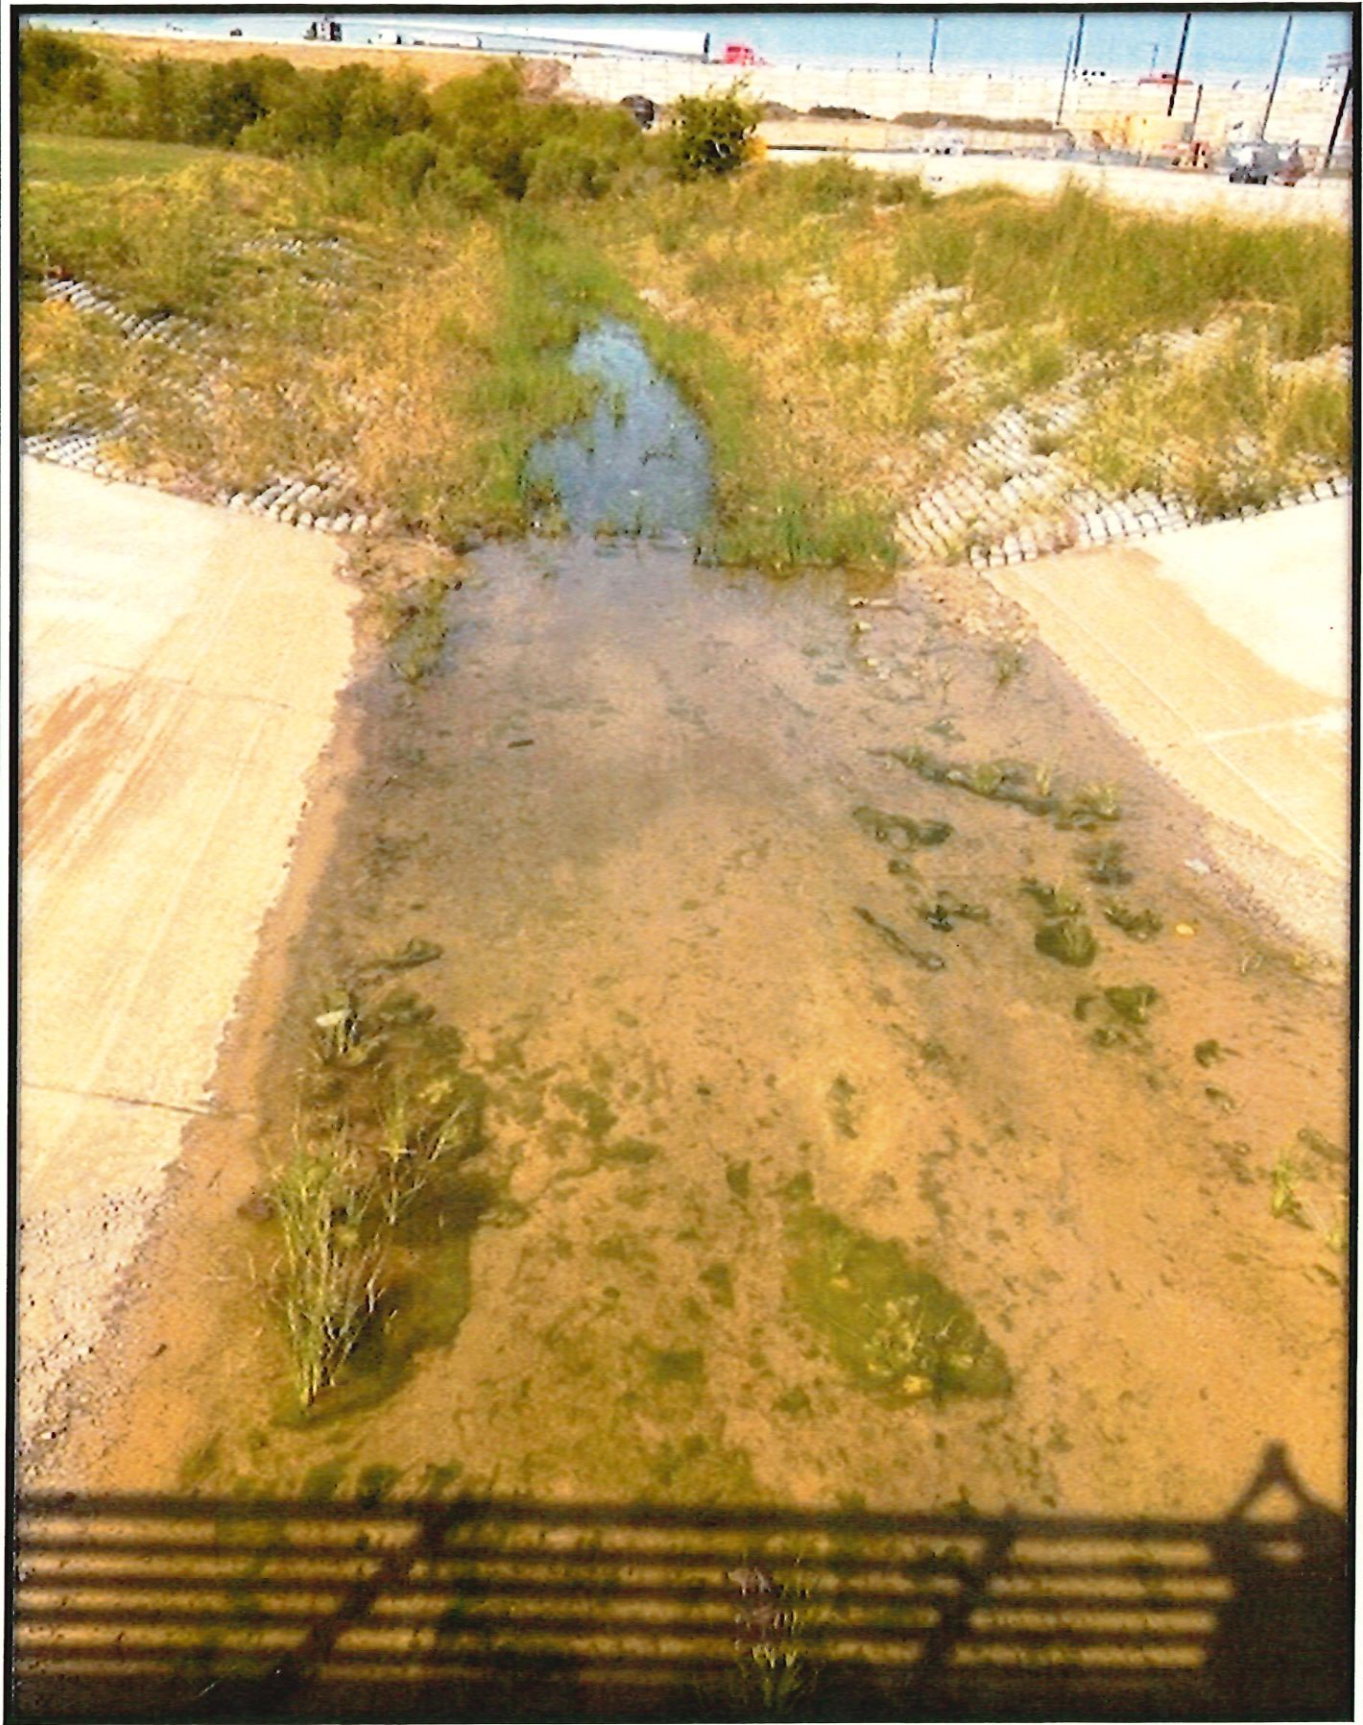
Stormwater outfall OUT\_MGV\_001 on west side of Bonnie Brae Street across from DATCU Stadium. Water quality samples were collected by EHS stormwater staff and evaluated for pH, conductivity, and temperature (September 2025).

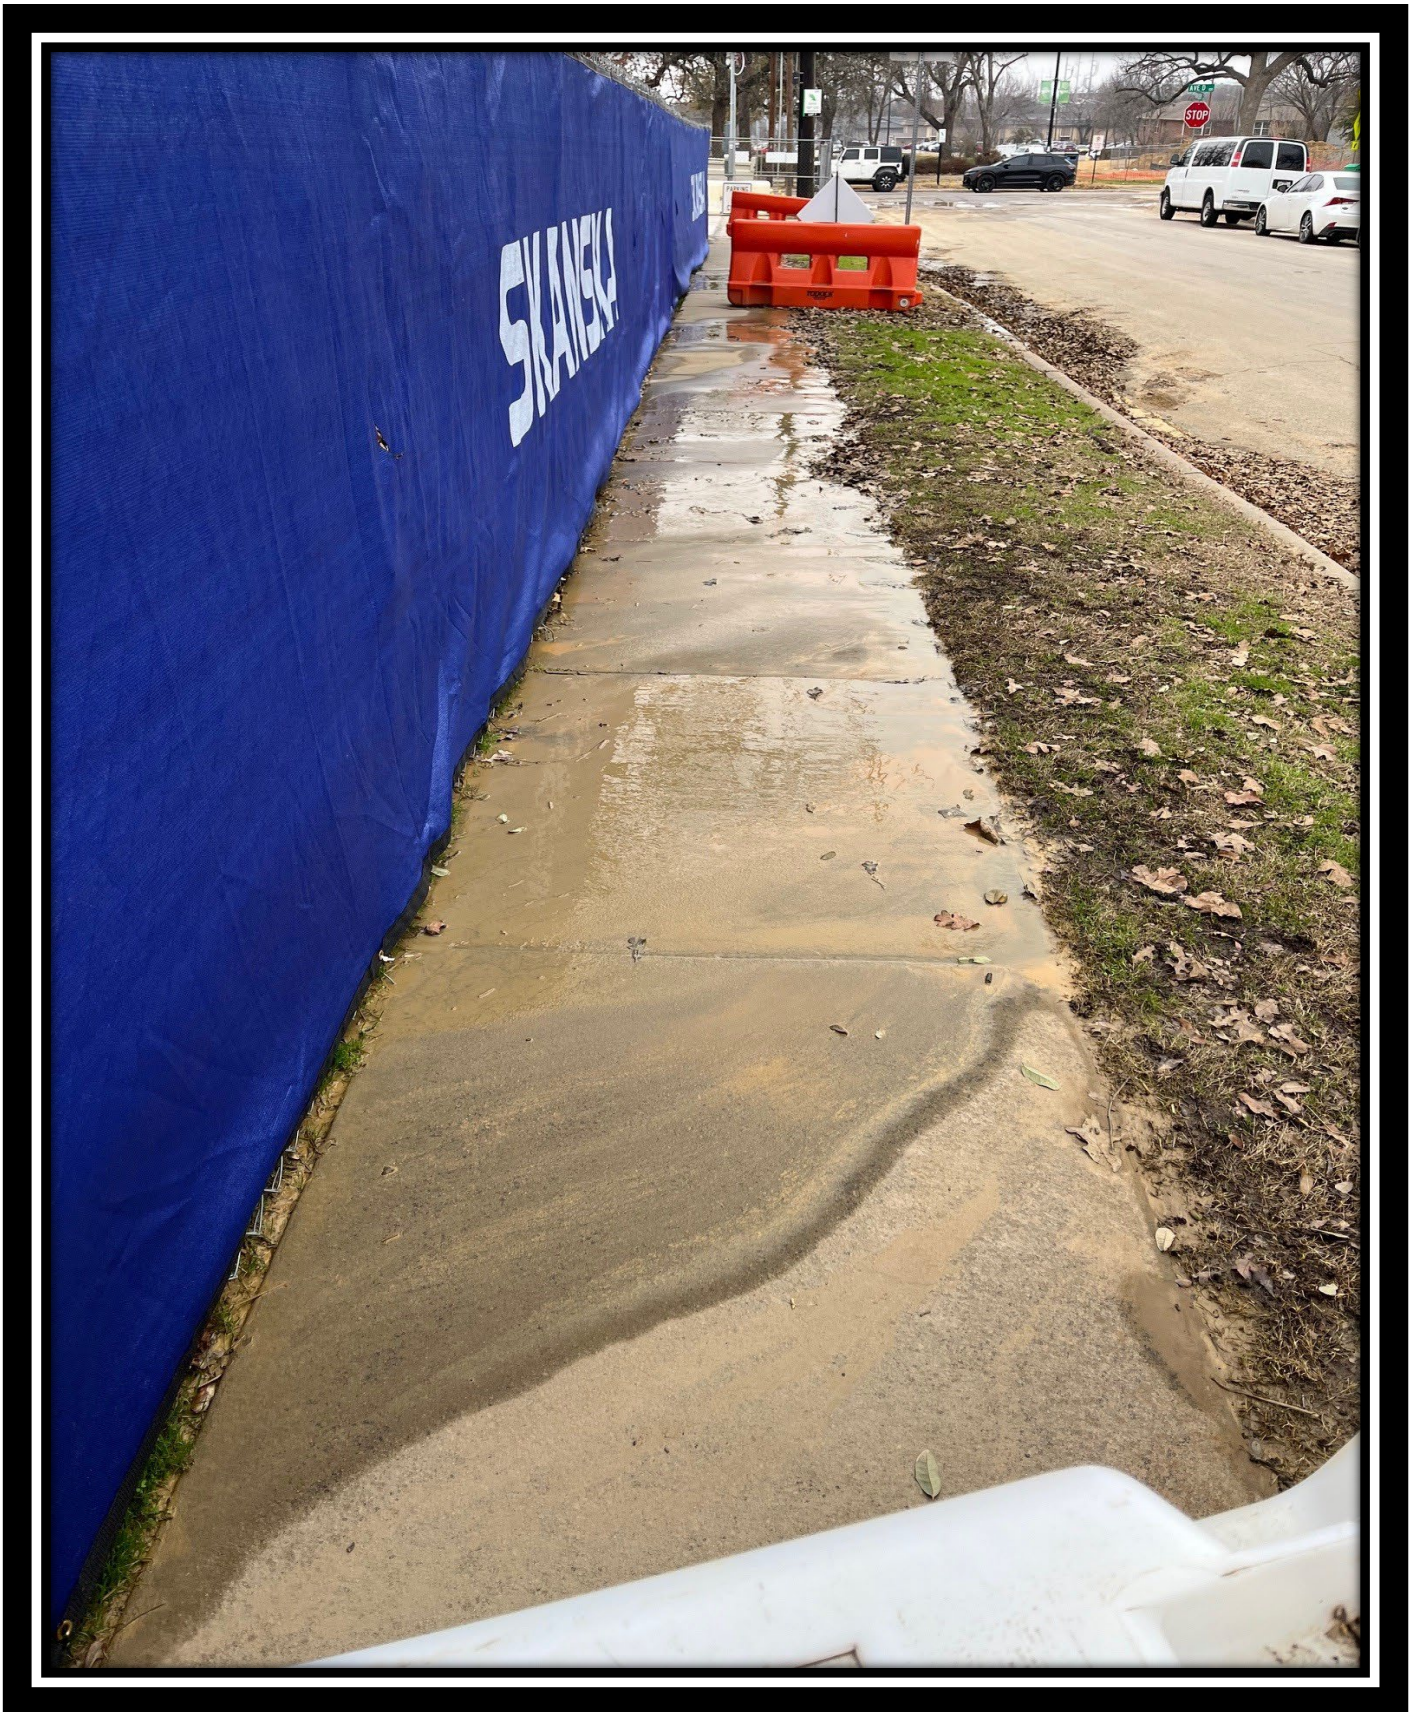
Dewatering the Science and Technology Building excavation pit. Precipitation in February contributed to the pit water. The construction contractor allowed it to run off onto the sidewalk and into the street. The sidewalk was cleaned by the construction contractor, and the pit water was eventually allowed it to infiltrate into the ground surface on-site. (February 2025)

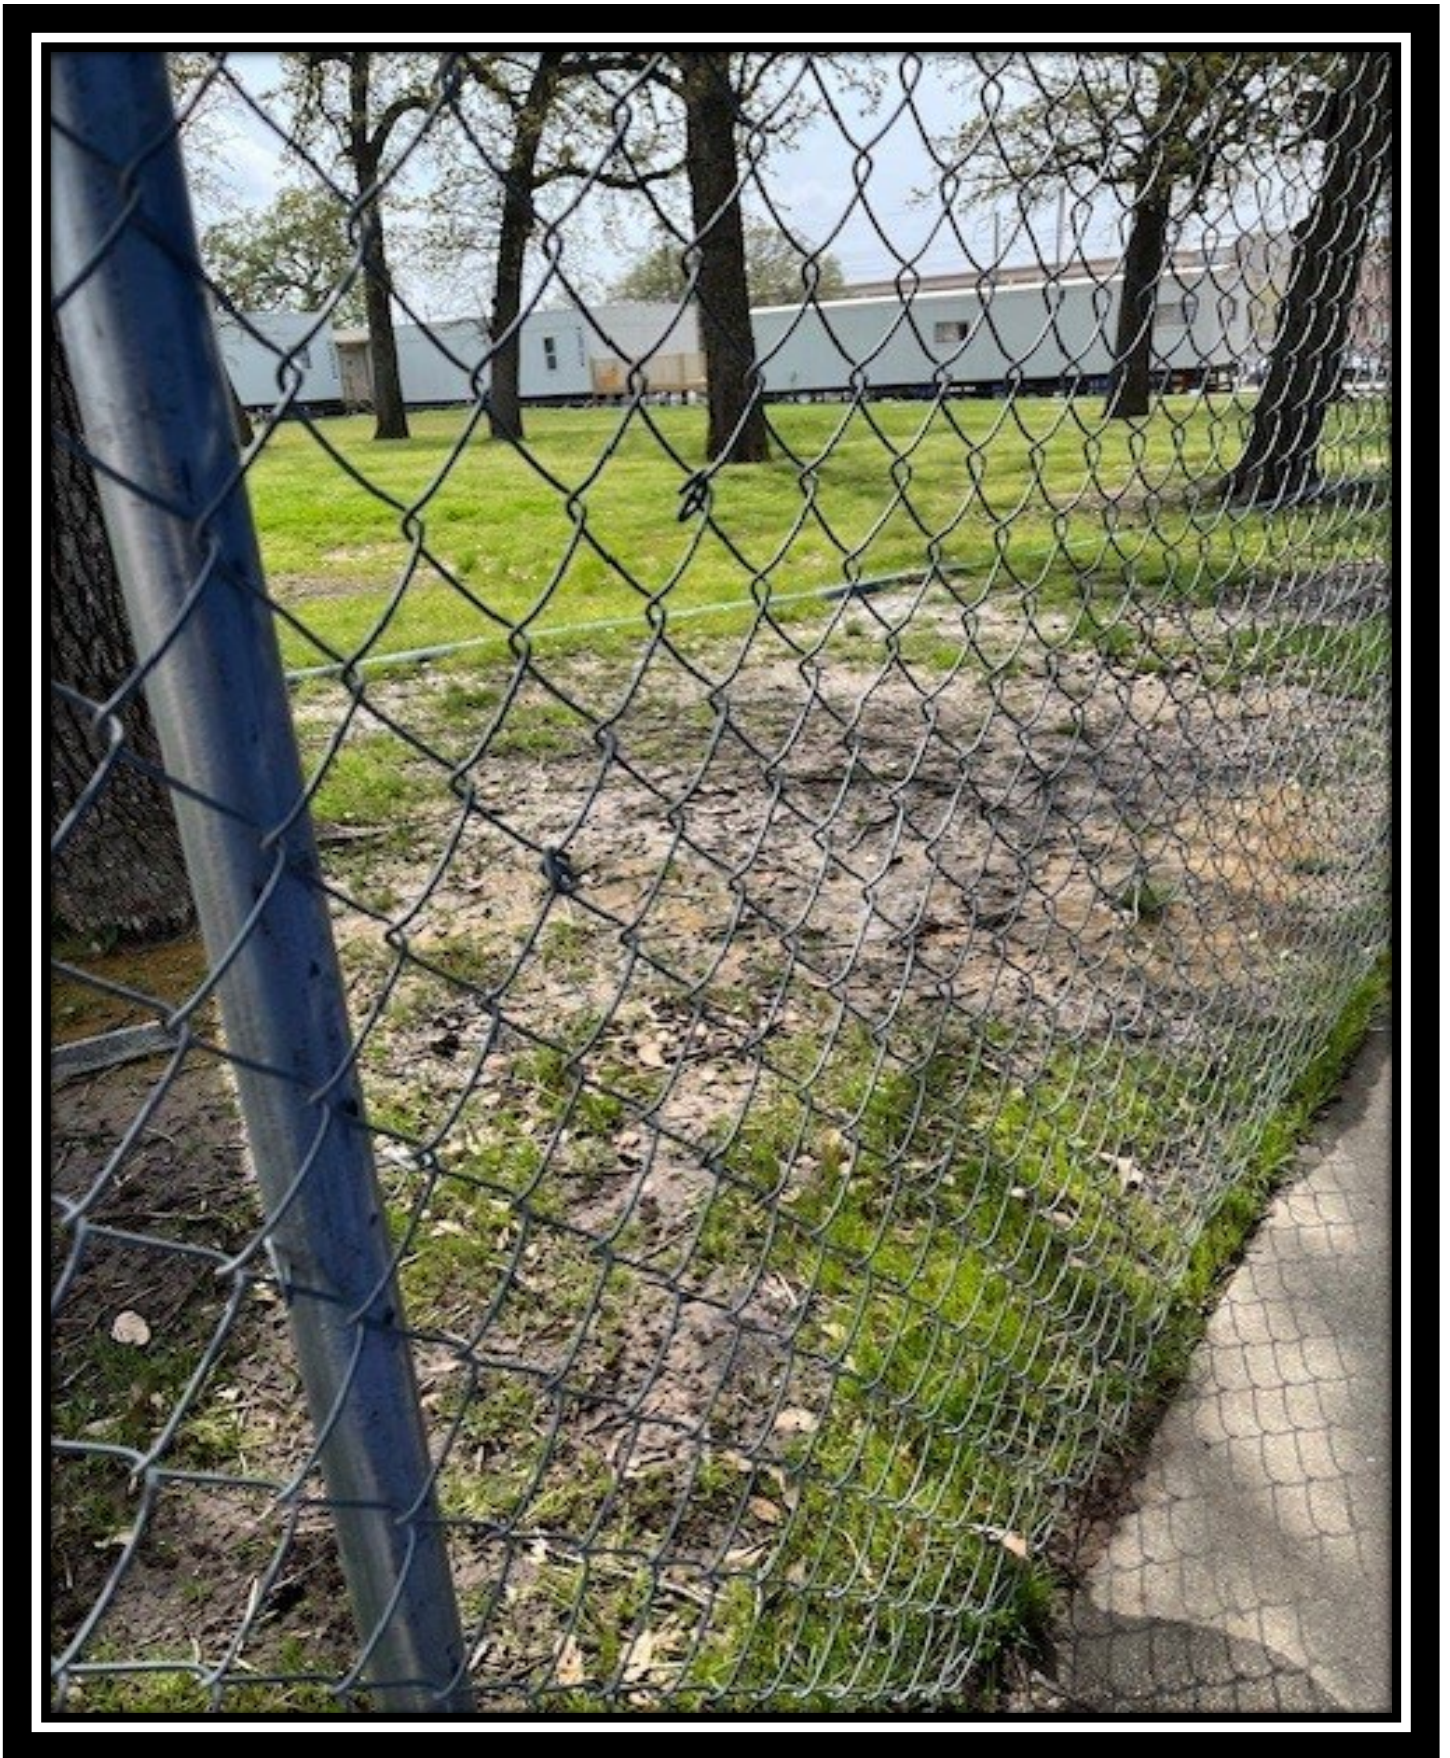
3-inch diameter blue hose dewatering construction pit for new Science and Technology building construction site. EHS asked the construction project manager to allow the pit water to infiltrate onto the ground surface rather than onto the sidewalk and Mulberry Avenue (April 2025).

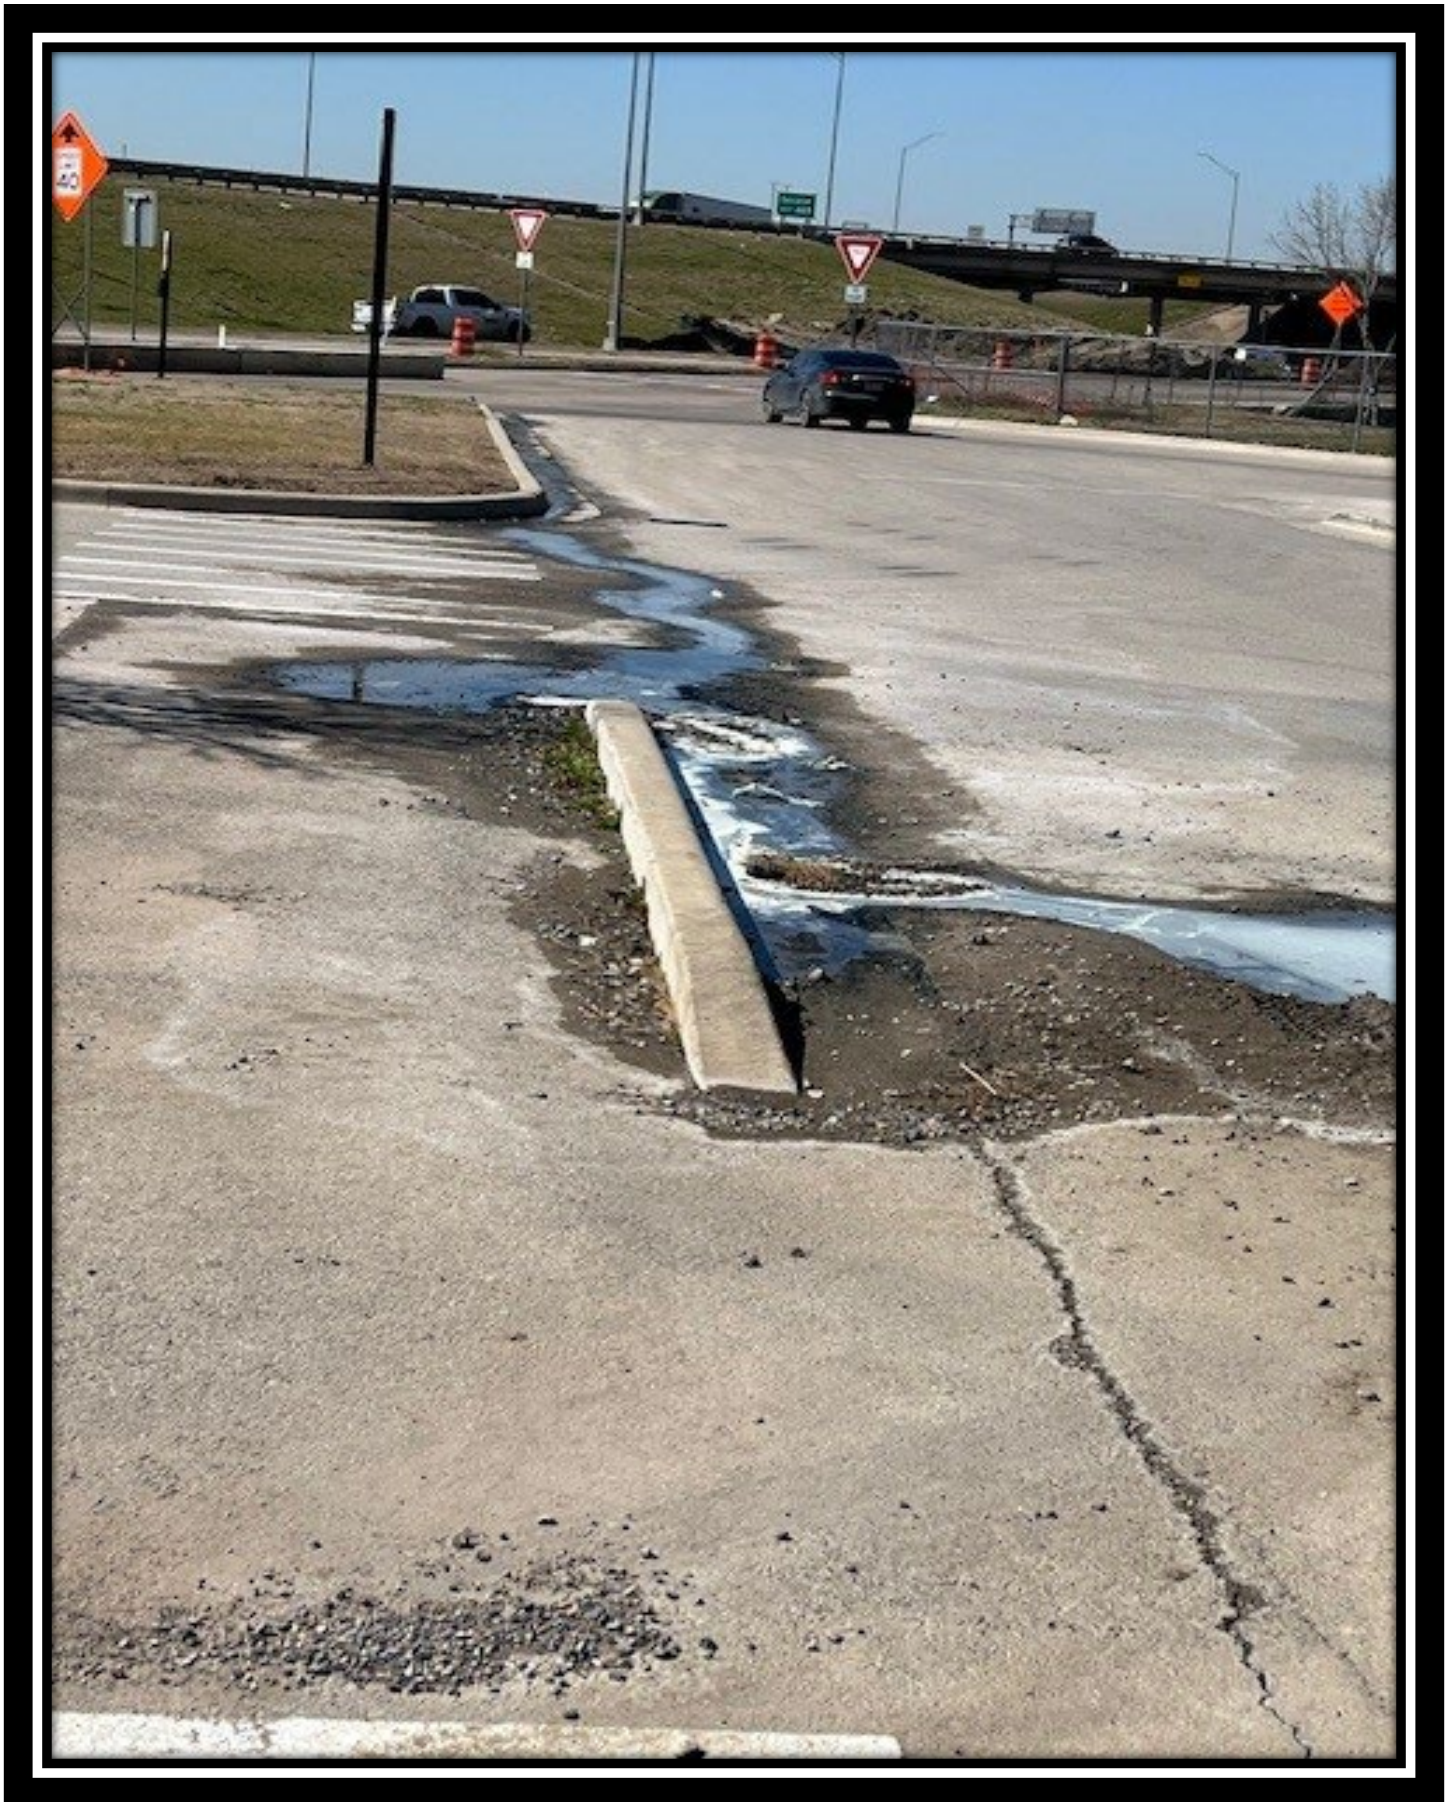
Sanitary sewer line break in Parking Lot 20 (February 2025). UNT Facilities repaired the broken sewer line in summer 2025.

| MCM | BMP | Information Used | Quantity | Units | Does the BMP Demonstrate a Direct Reduction in Pollutants? (Answer Yes or No, and explain.) |
|---|---|---|---|---|---|
| | | | | | <p>The City of Denton performed a windshield inspection in February 2025 and noted two issues, one adjacent on Traditions Band Practice Field and one on Parking Lot 20. 1) a water sprinkler box was leaking with noticeable discharge and runoff on the band practice field, and 2) a sewer line break was previously noted by EH&amp;S personnel on Parking Lot 20 and reported to UNT's Facilities Department.</p> <p>The water sprinkler was repaired in March 2025. The sewer line repair occurred over the summer of 2025.</p> |

| MCM(s) | Measurable Goal(s) | Explain progress toward goal or how goal was achieved<br>If goal was not accomplished, please explain |
|---|---|---|
| | | showed signs of leakage. The pipe was repaired in the summer and leakage ceased. |

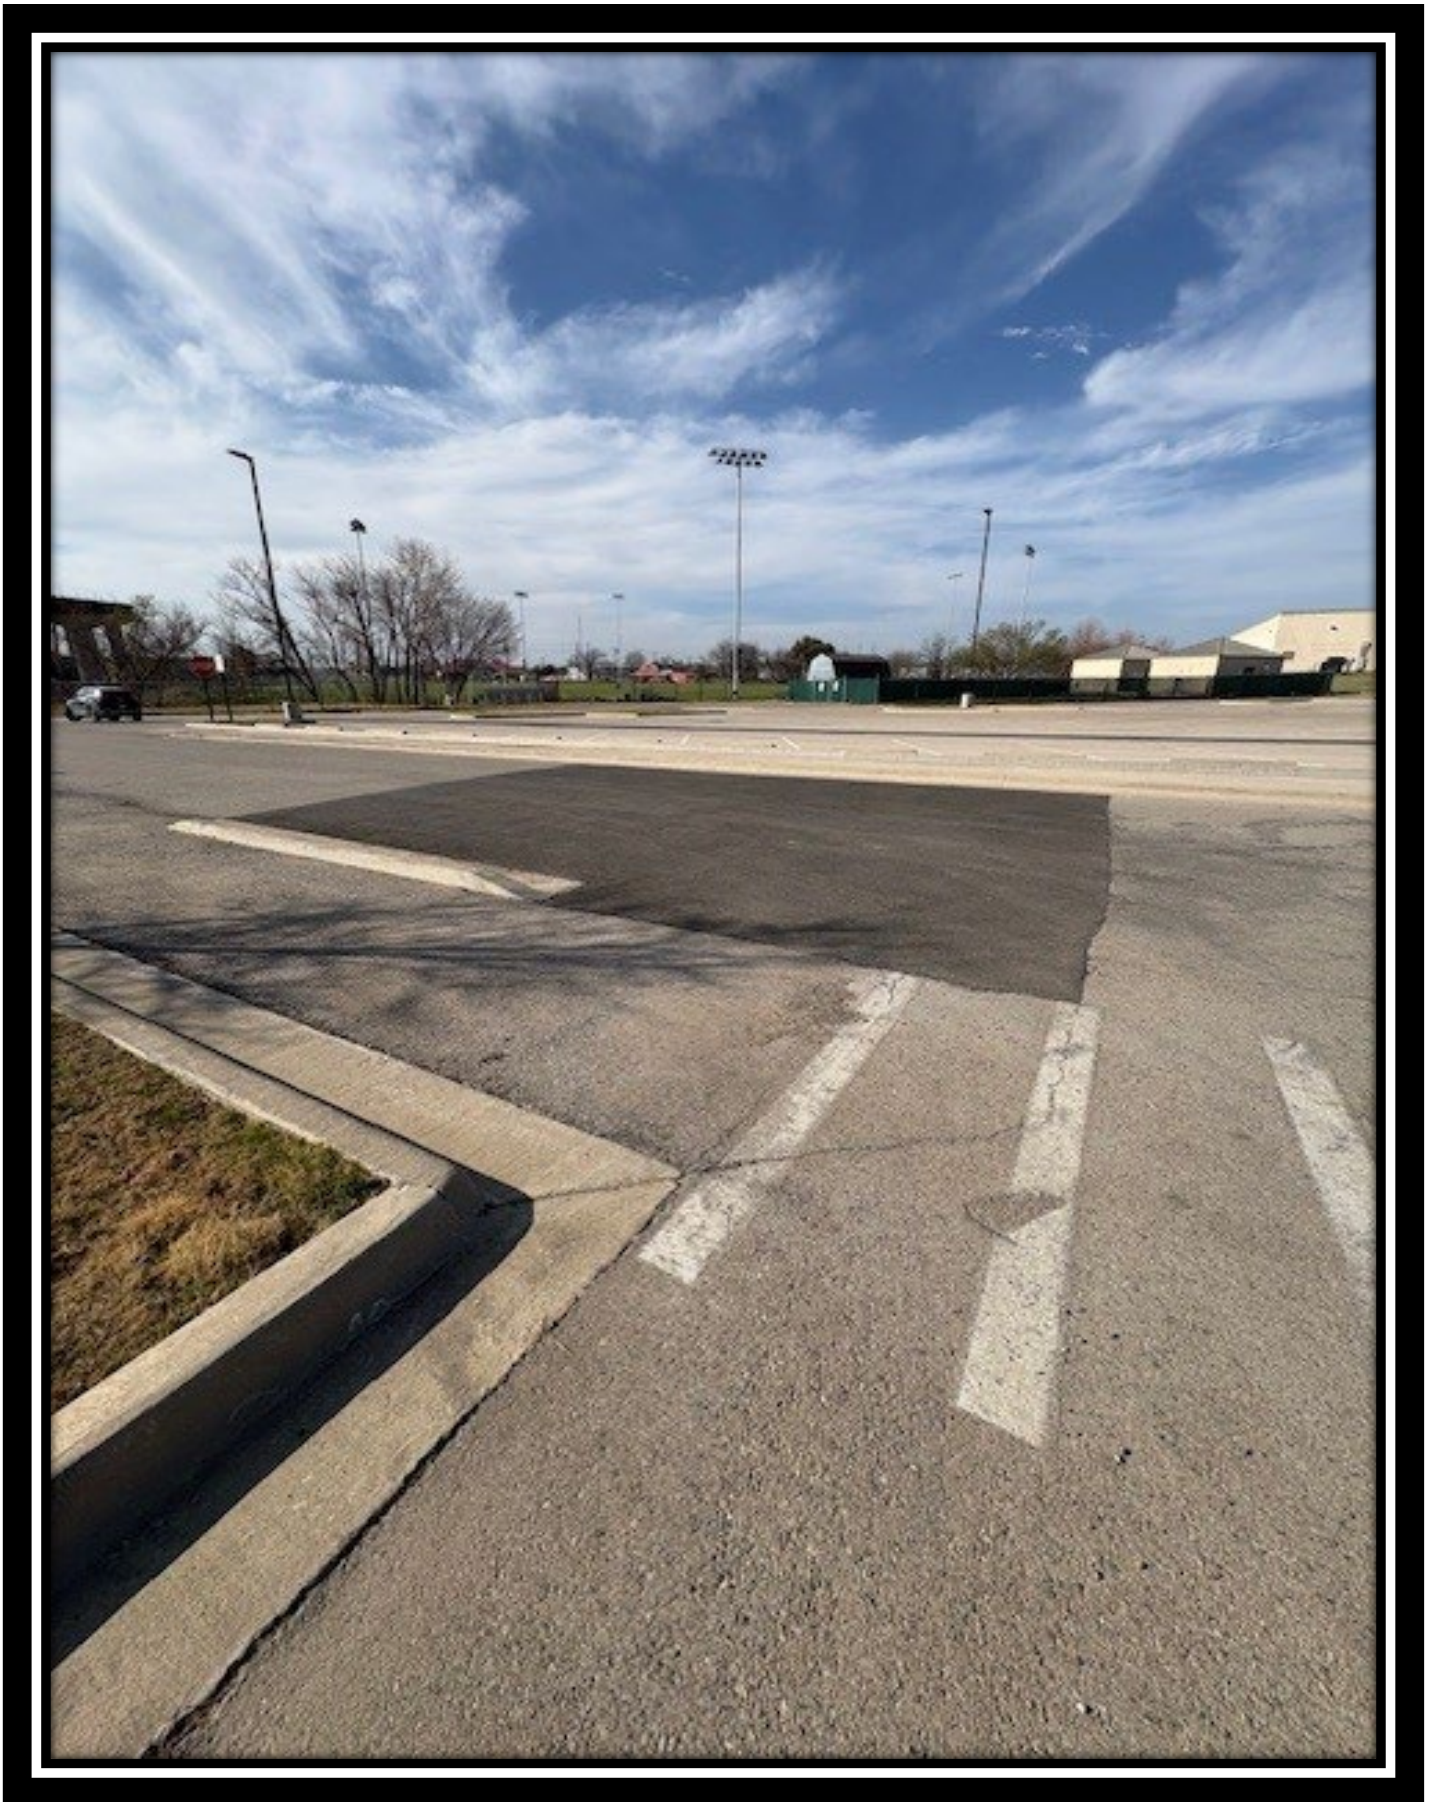
Sanitary sewer line repair completed in summer 2025 in Parking Lot 20.

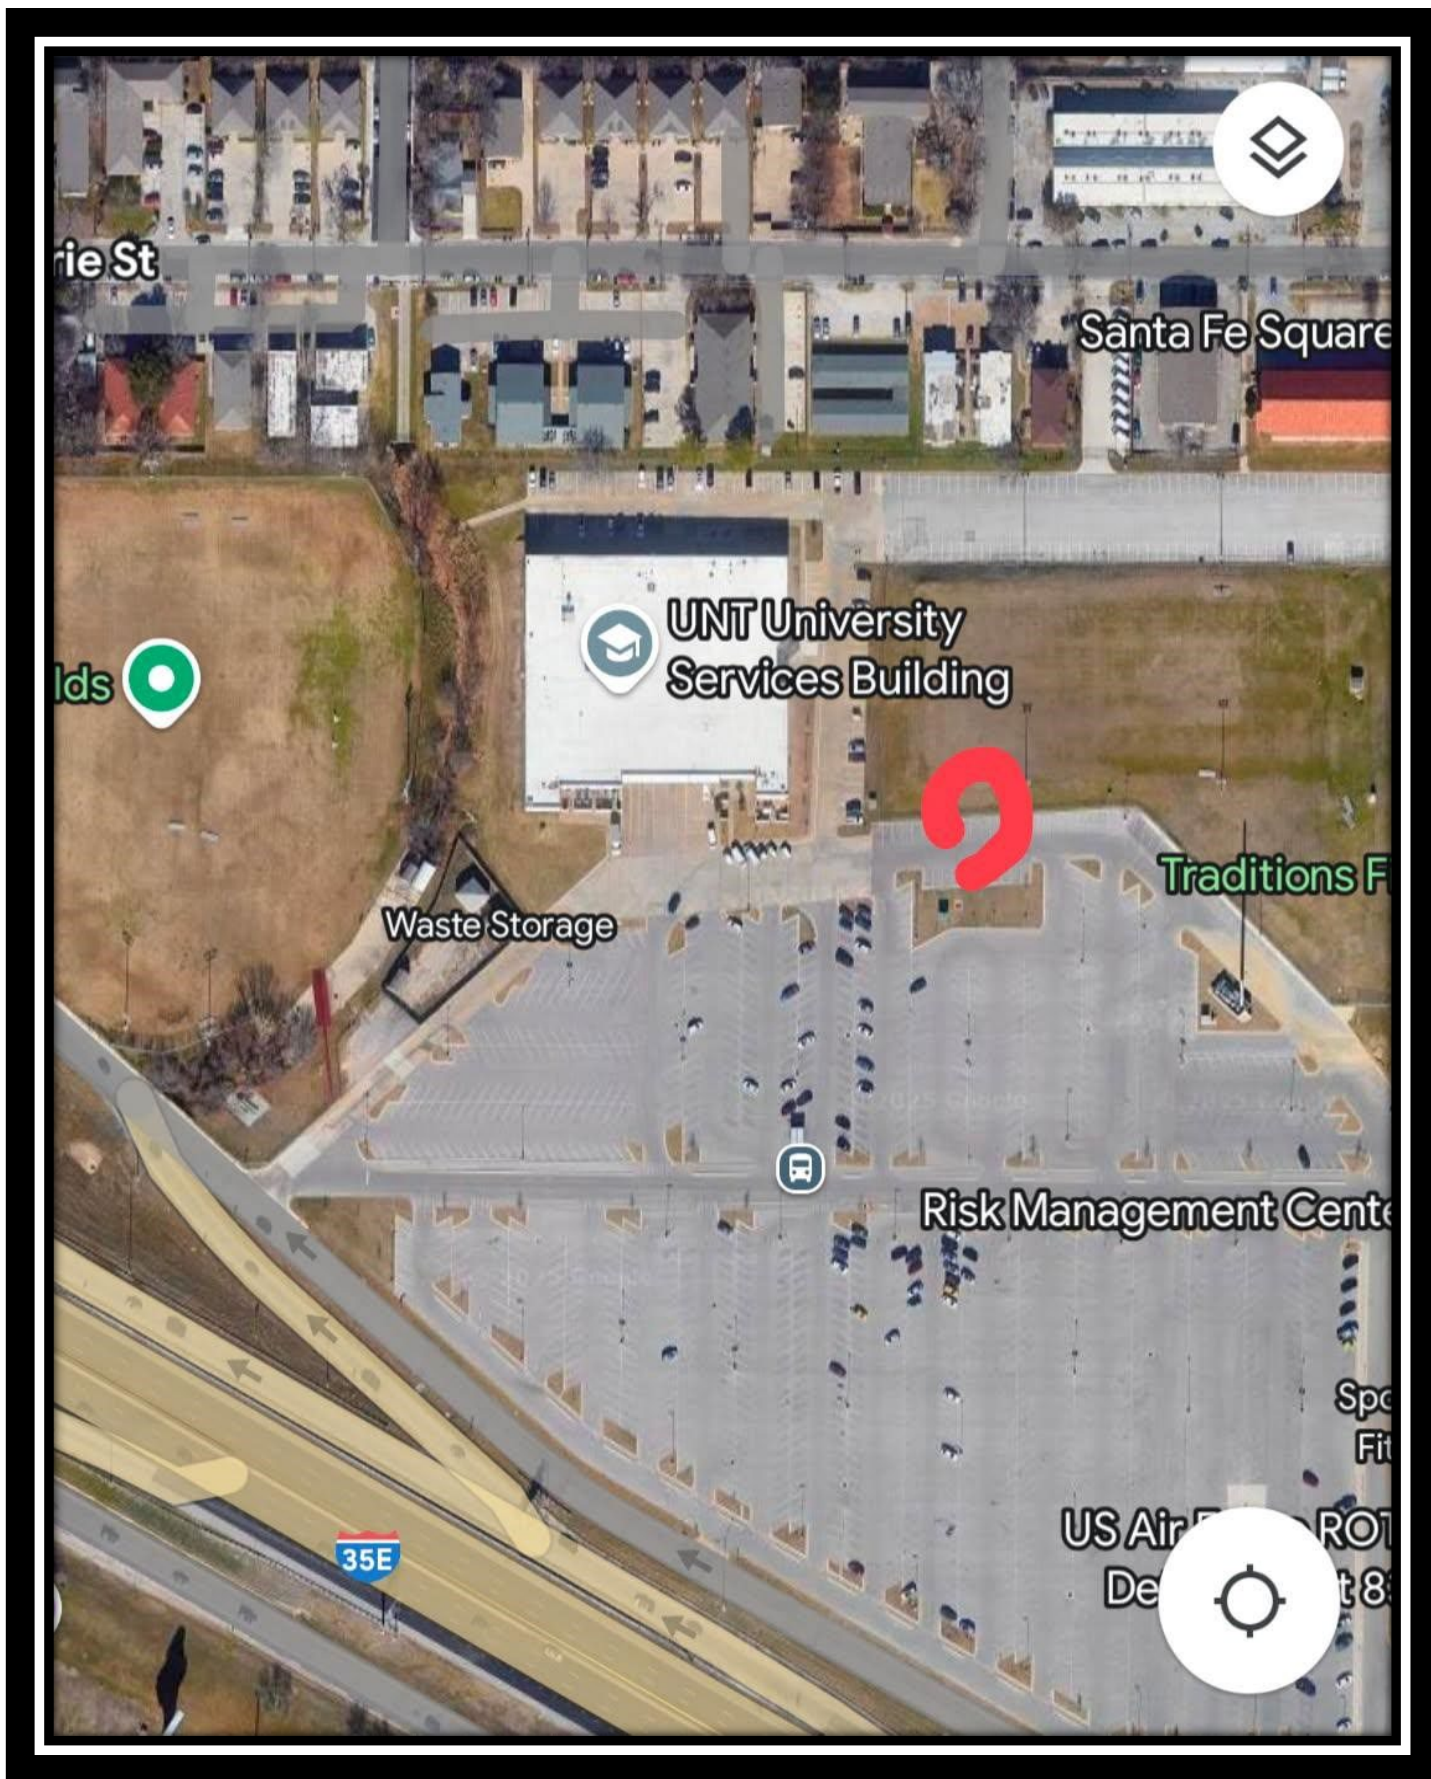
Location of broken water sprinkler on Traditions Band Practice field (February 2025).

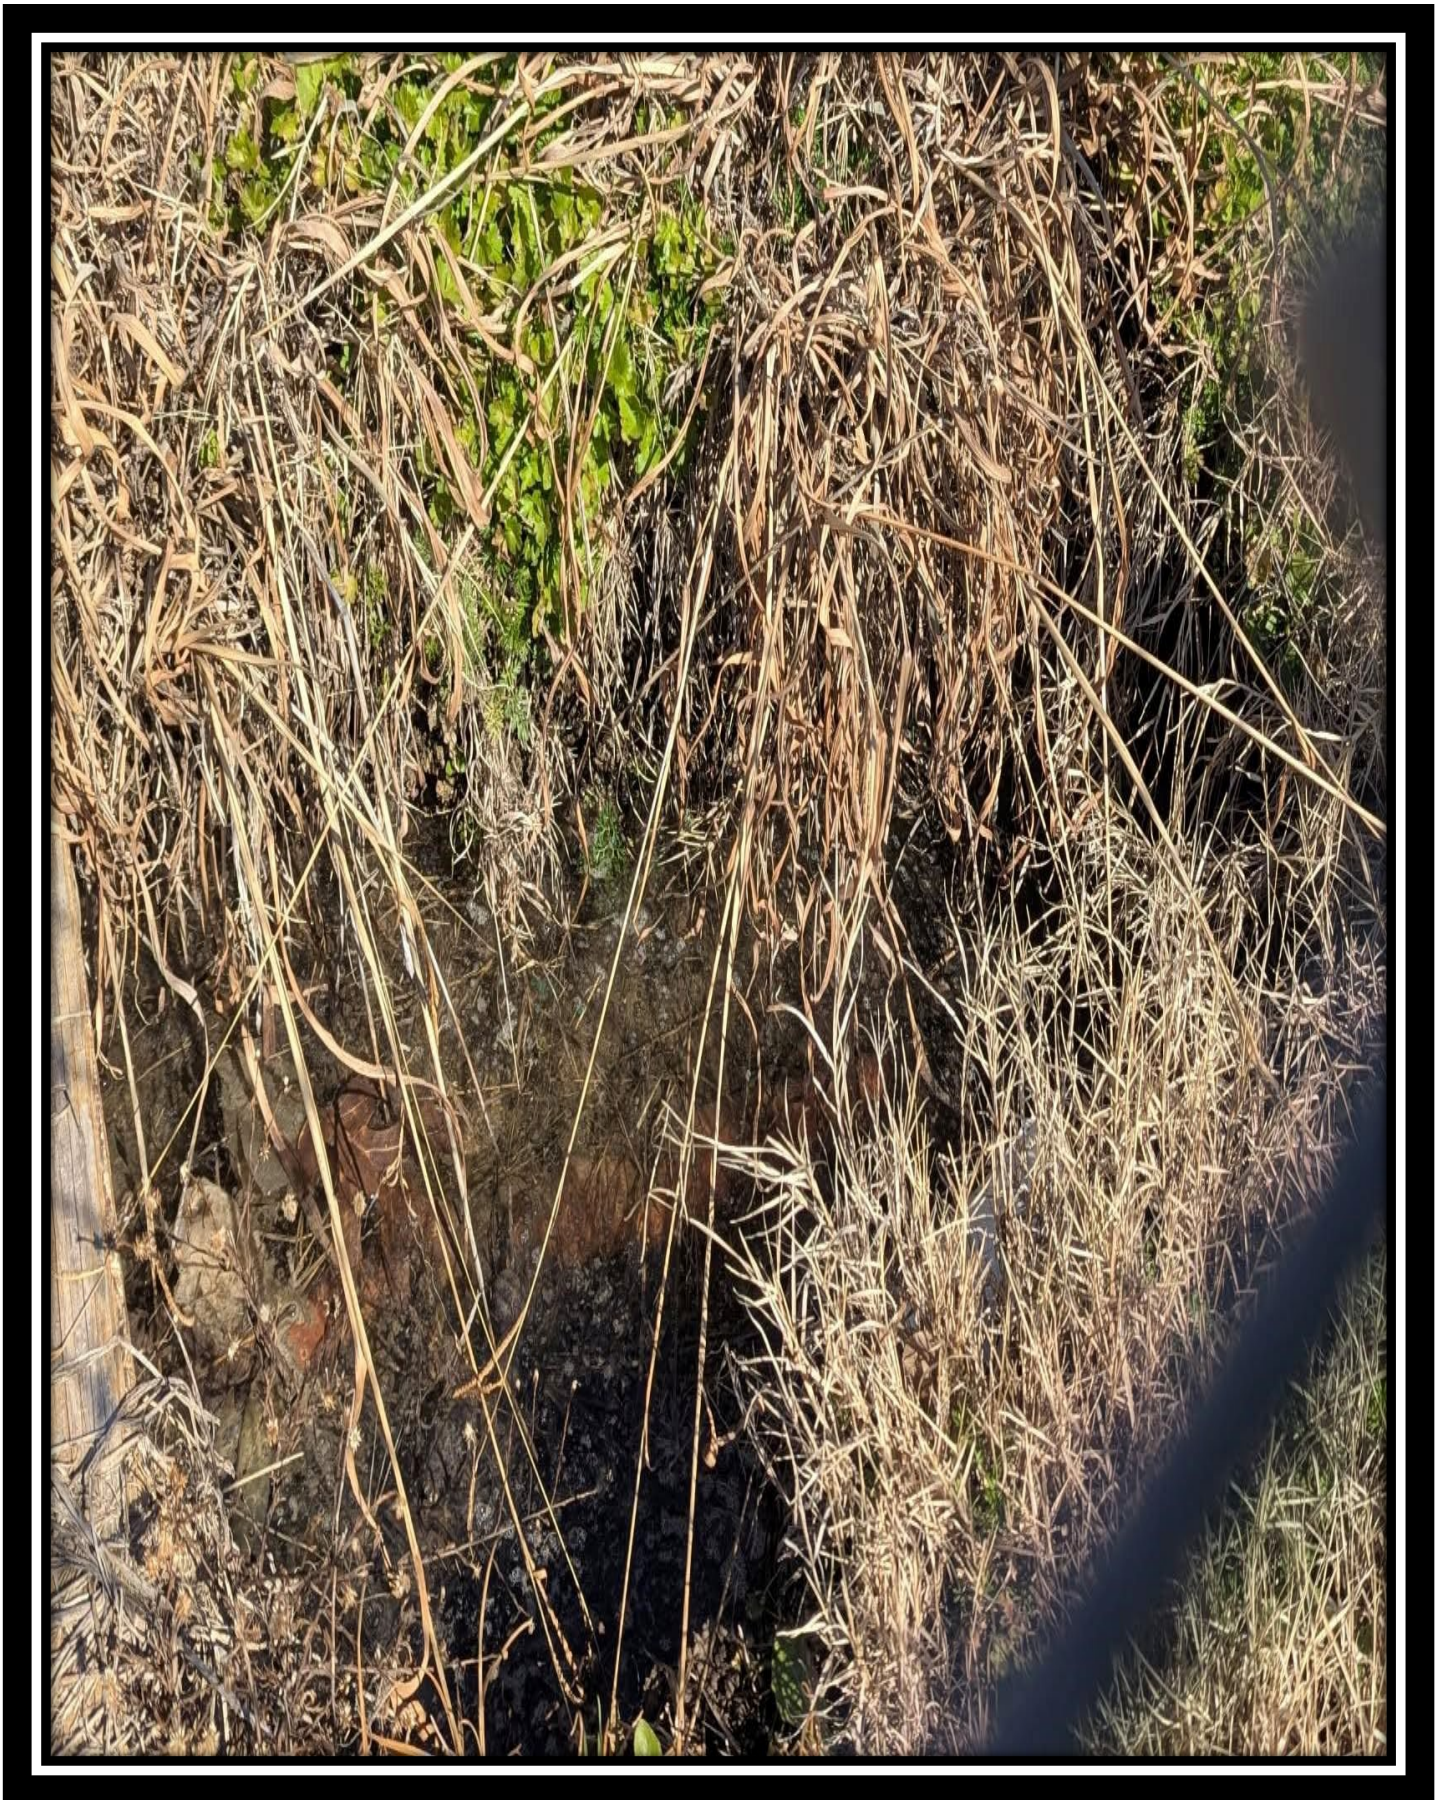
Broken water sprinkler on Traditions Band Practice field (February 2025).

| MCM(s) | Measurable Goal(s) | Explain progress toward goal or how goal was achieved<br>If goal was not accomplished, please explain |
|---|---|---|
| 3 | Regulatory enforcement and citizen complaints regarding construction sites. | Goal met. No citizen complaints were received by UNT for the construction sites in 2025. The City of Denton did not submit any violation notices or citizen complaints for the few construction projects that occurred at UNT in 2025. However, the City of Denton notified UNT regarding the sewer line leak and a broken sprinkler head in Parking Lot 20. The City was notified that bids were prepared to fix the sanitary sewer leak. A contractor was selected, and the sewer line was repaired during the summer. UNT Facilities repaired the sprinkler head in March 2025. |

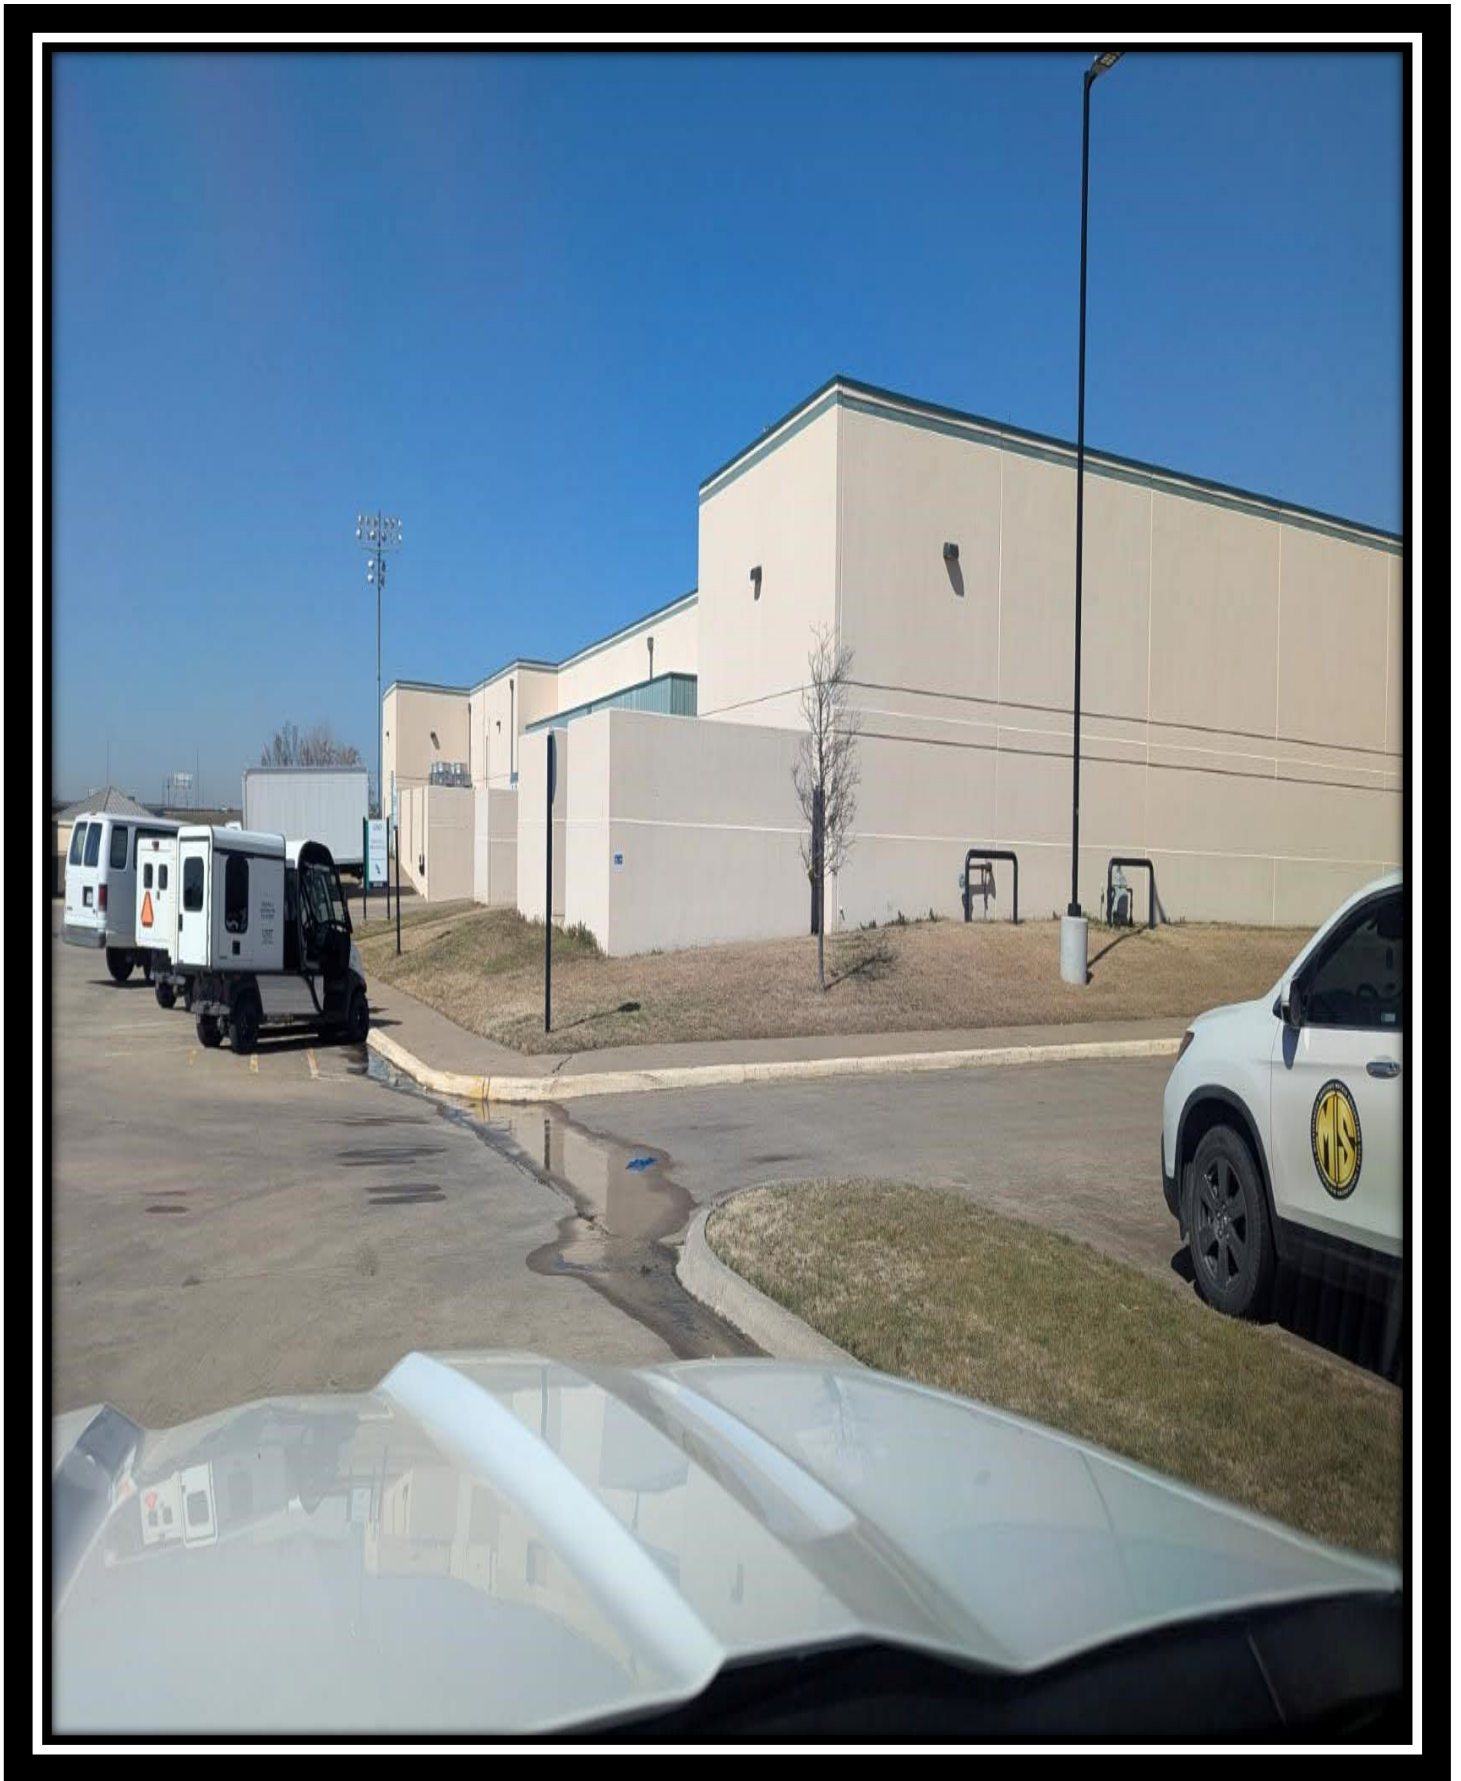
Broken water sprinkler runoff from Traditions Band Practice field (February 2025).
