# **2025 ANNUAL STORMWATER MANAGEMENT REPORT**

University of North Texas  
1155 Union Circle #311040  
Denton, Denton County, Texas  
76203-5017

Re: Phase II MS4 Annual Report Transmittal for University of North Texas  
TPDES General Permit Authorization: TXR040066

## Phase II (Small) MS4 Annual Report Form

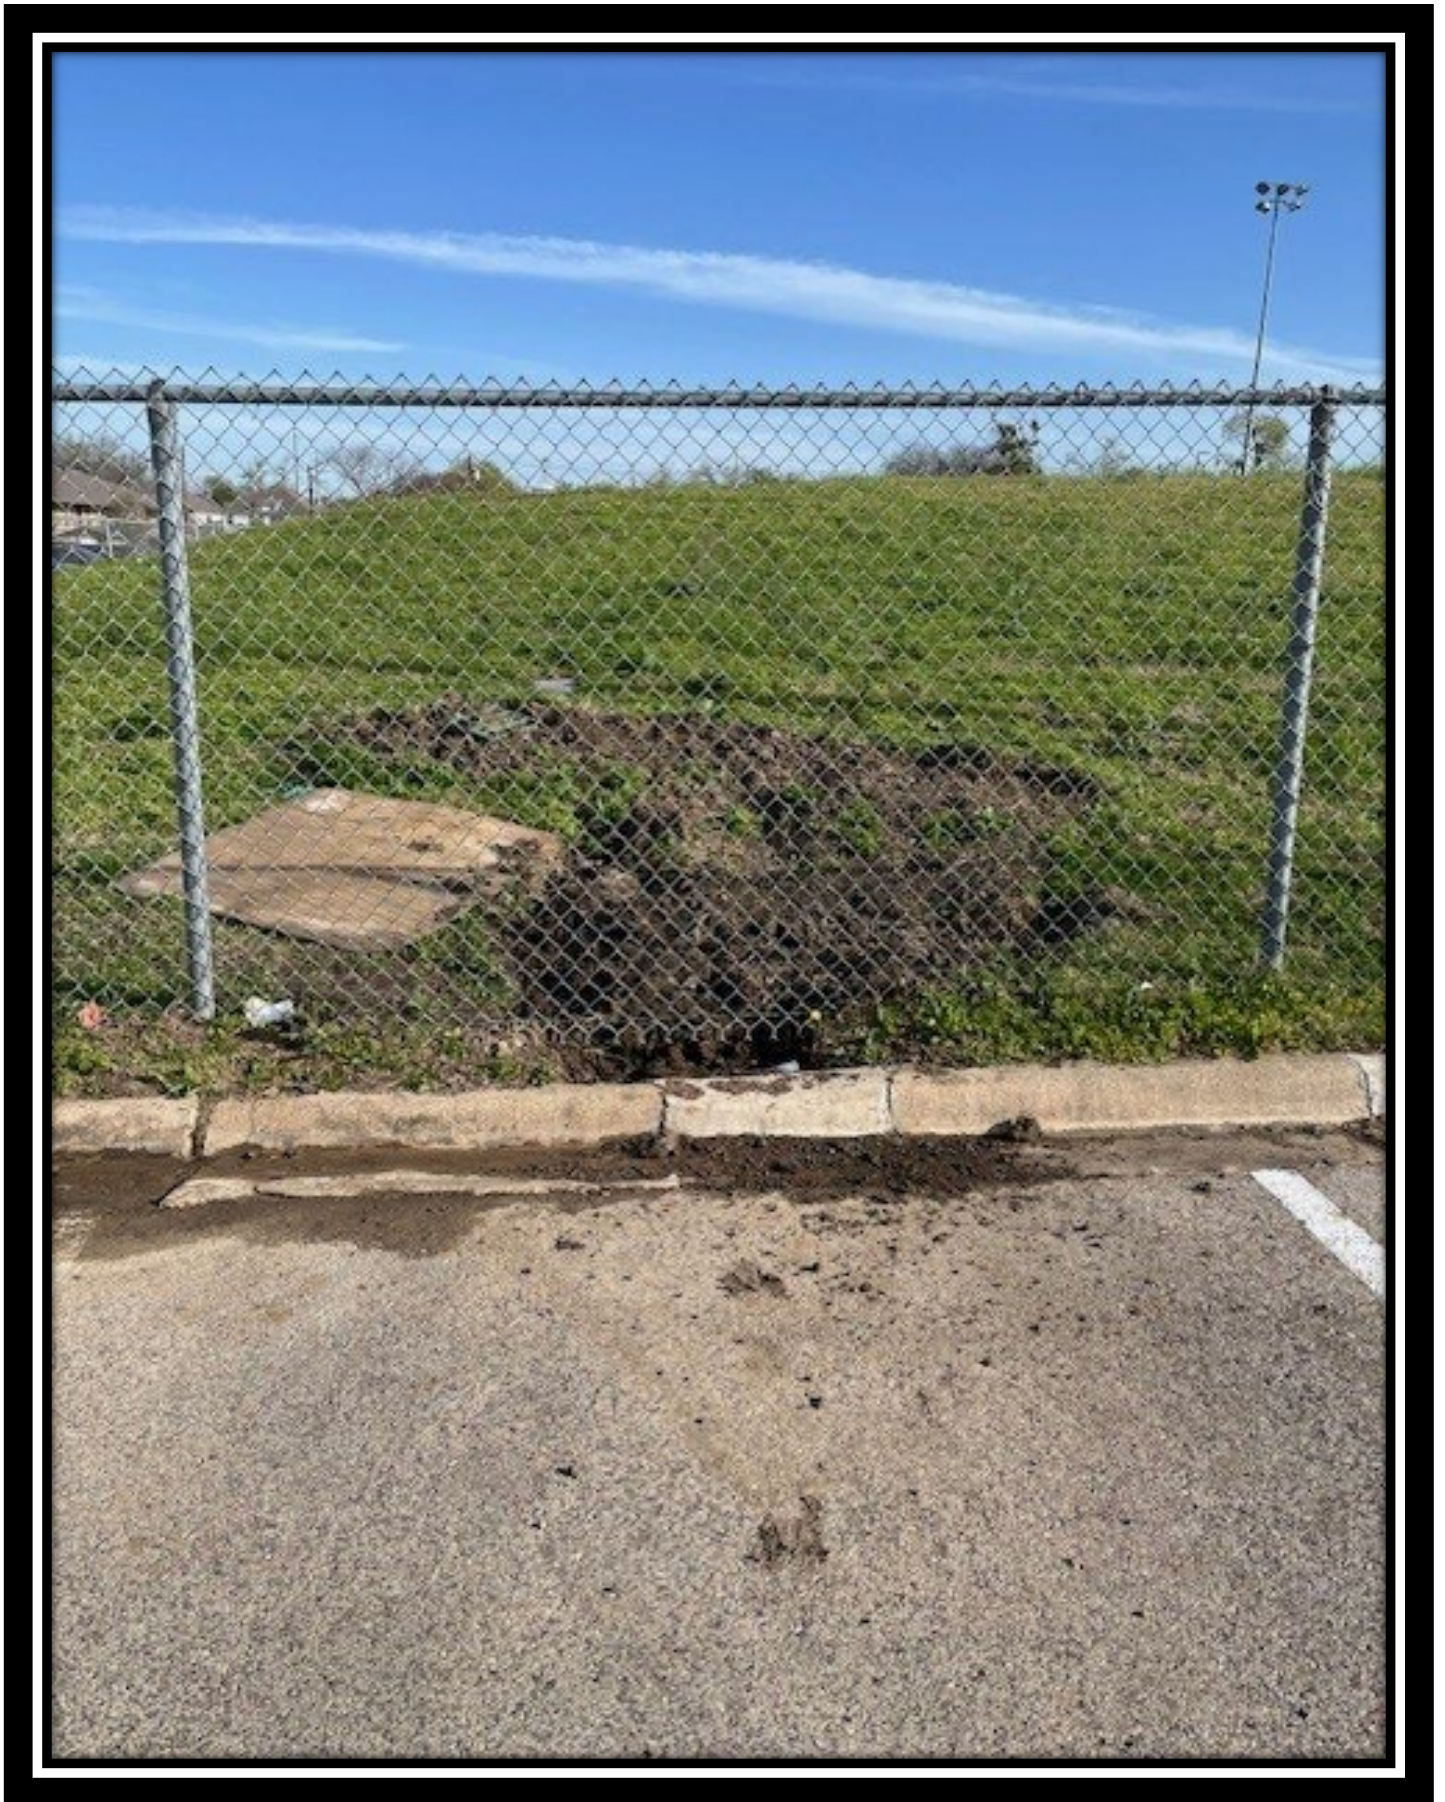
Repaired broken water sprinkler on Traditions band practice field. (March 2025)

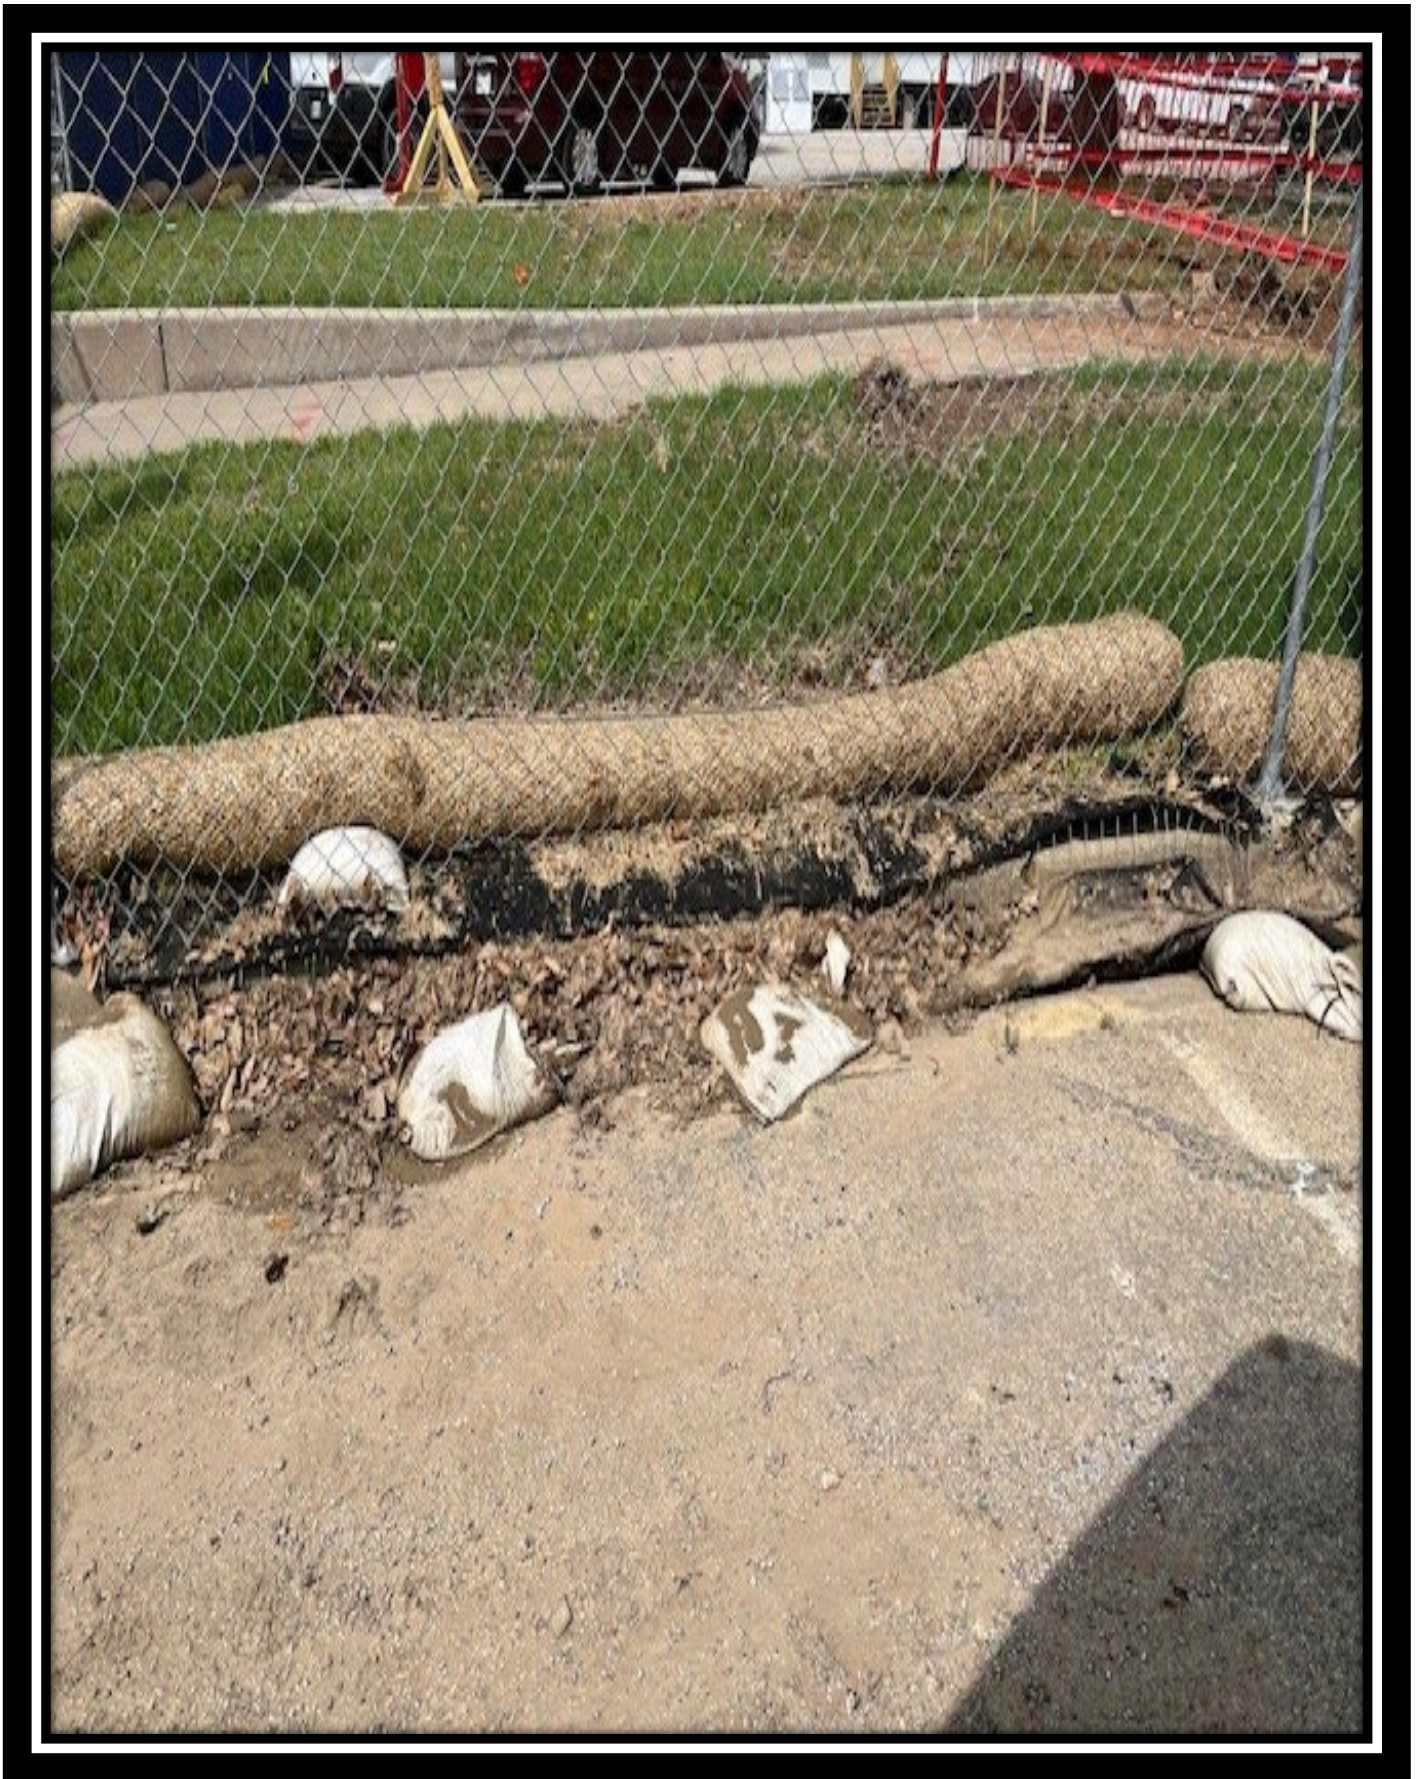
Stormwater curb inlet clogged Avenue D and Sycamore Street from runoff during the new Science and Technology Building construction project. (April 2025)

| MCM | BMP | Information Used | Quantity | Units | Does the BMP Demonstrate a Direct Reduction in Pollutants? (Answer Yes or No, and explain.) |
|---|---|---|---|---|---|
| 3 | 3.3 Construction Site Inspections relating to reported potential violations | Inspections | 4 | Locations | <p>Yes. UNT's EH&amp;S stormwater personnel performed periodic inspections. Two potential violations were documented in February and April 2025 at the new Science and Technology construction site. 1) water was observed running off from the site through a 3-inch diameter hose and onto Mulberry Street; 2) a stormwater curb inlet drain was clogged with silt and leaves. The first one was corrected by allowing the water to infiltrate onto the ground's surface inside the construction zone and the second one was corrected by removing the clogged filter fabric and leaves then replaced with new filter fabric.</p> |

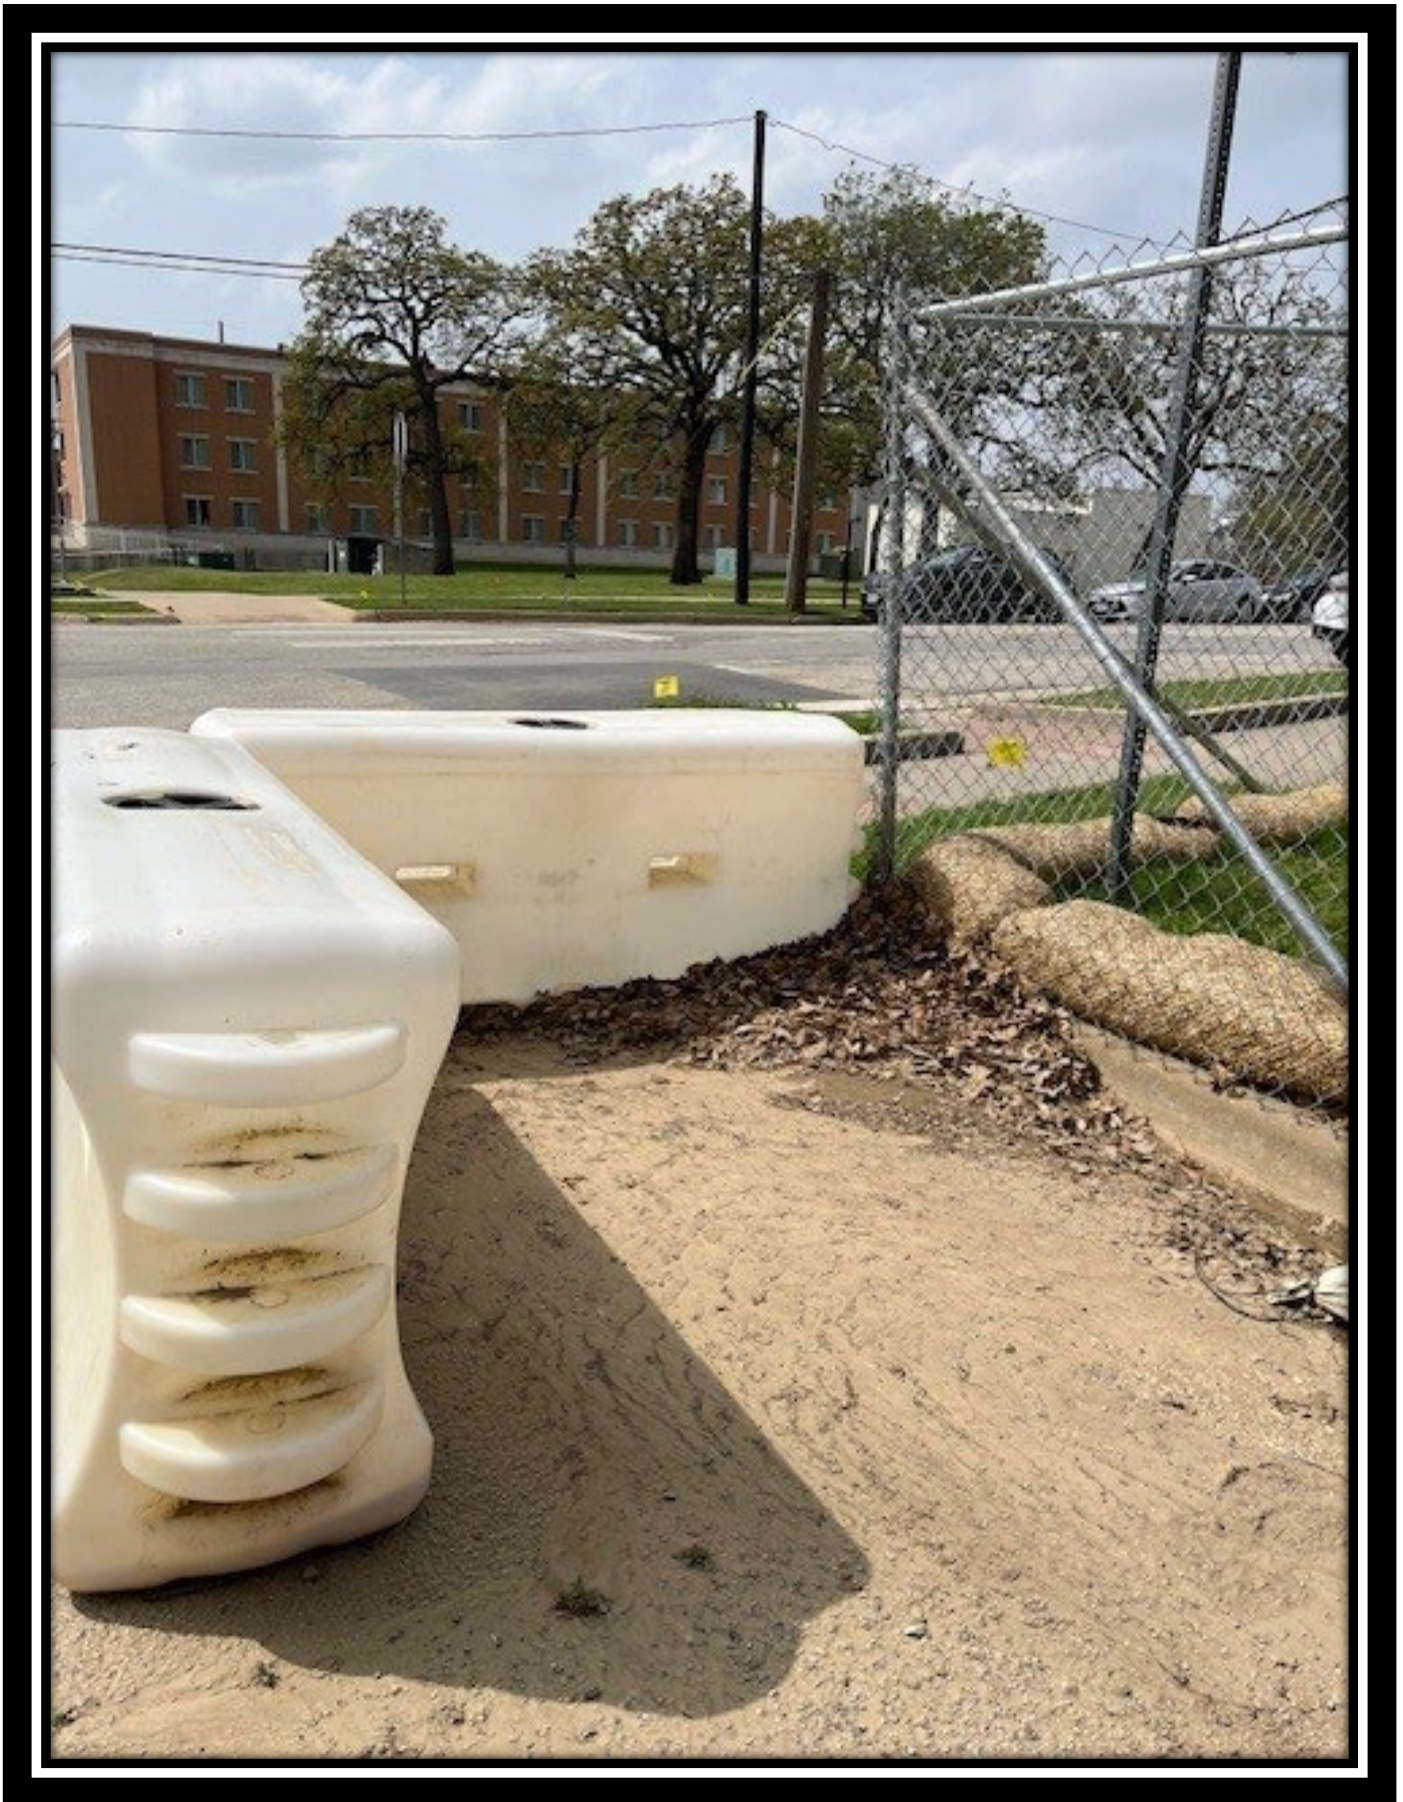
Soil and leaf litter build up at Avenue D and Sycamore Street during construction of the Science and Technology Building. (April 2025)

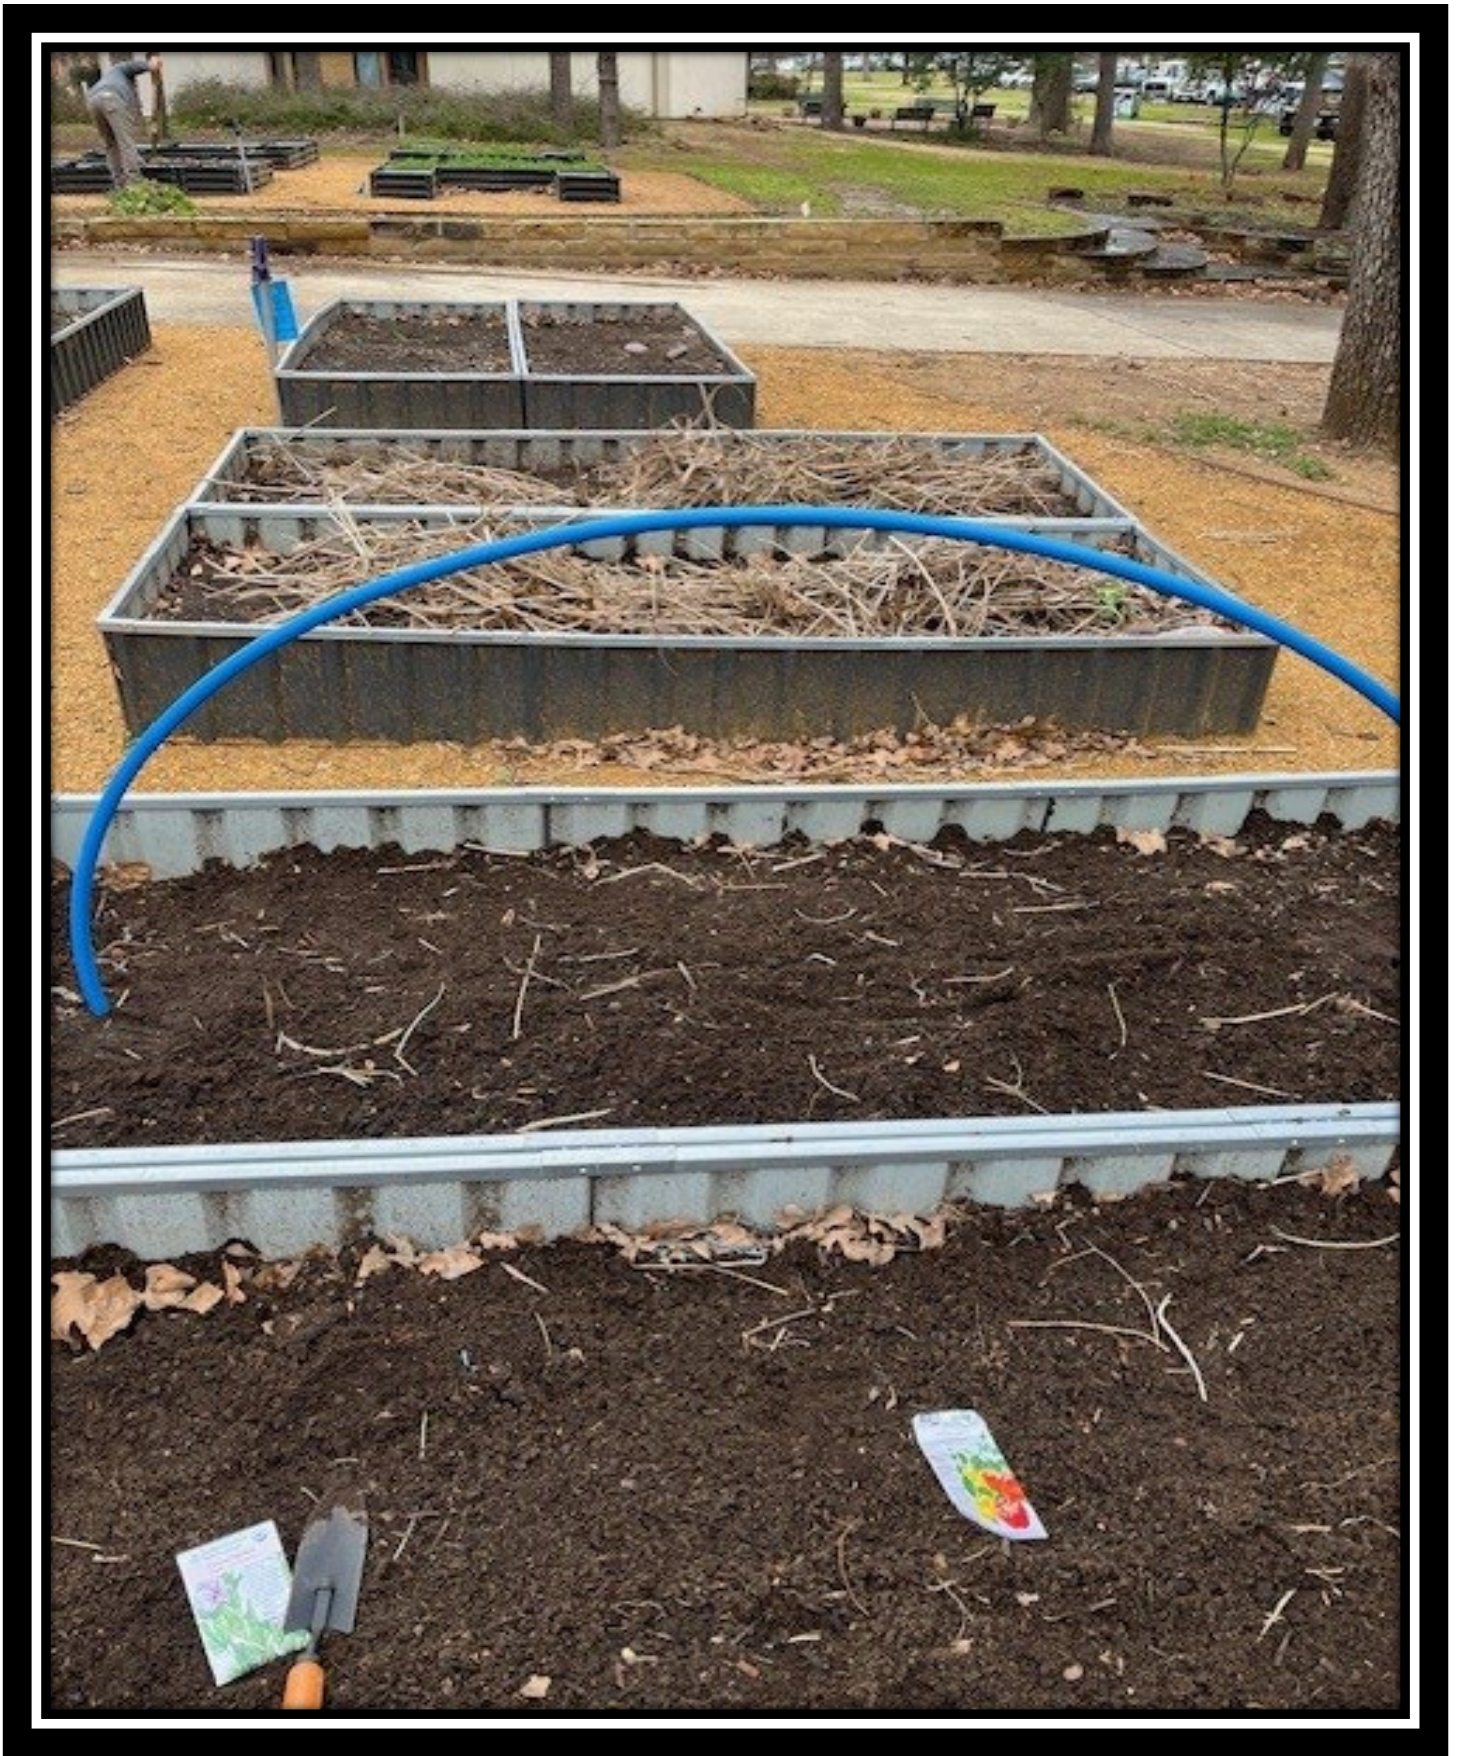
Community Garden kick-off event on March 4, 2025. Beds are inside large, fabricated, lined boxes to prevent unnecessary stormwater run-off during rainfall events. Organic pesticides and herbicides were used throughout the growing season.
